WOLCOTT DAM VT 00179

DOCUMENT IDENTIFICATION
JUNE 1980

REPORT ON WOLCOTT DAM

Wolcott Dam - VT 00179
Wolcott, Vermont
May 6, 1980

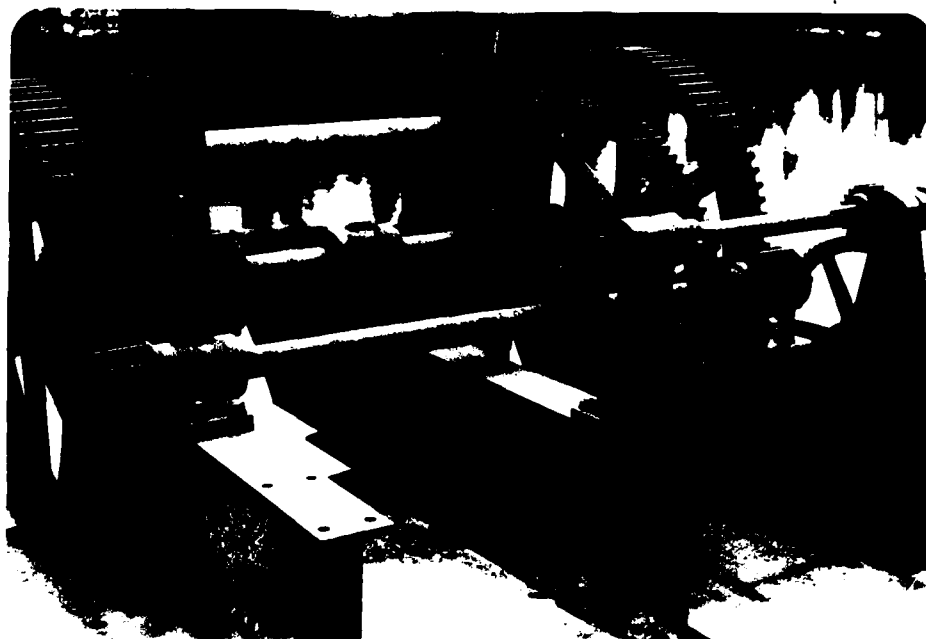
(8) Reservoir Outlet Gate Controls
May 6, 1980

AREA EVALUATED	CONDITION
<u>OUTLET WORKS - TRANSITION AND CONDUIT</u>	
General Condition of Concrete	Good
Rust or Staining on Concrete	Rust stains below conduit outlet
Spalling	None
Erosion or Cavitation	Moderate erosion of sluice control enclosure at water line
Cracking	
Alignment of Monoliths	N.A.
Alignment of Joints	No misalignment
Numbering of Monoliths	N.A.

- a. The eroded concrete on the sluice gate control enclosure should be repaired by the owner.
- b. The crack at the bend in the left abutment wall should be repaired by the owner.
- c. The spalled concrete on the face of the dike should be removed and the areas patched by the owner.
- d. Areas of seepage at the base of the dam and the dike should be monitored monthly by the owner, and technical assistance sought upon any major quantity increase.

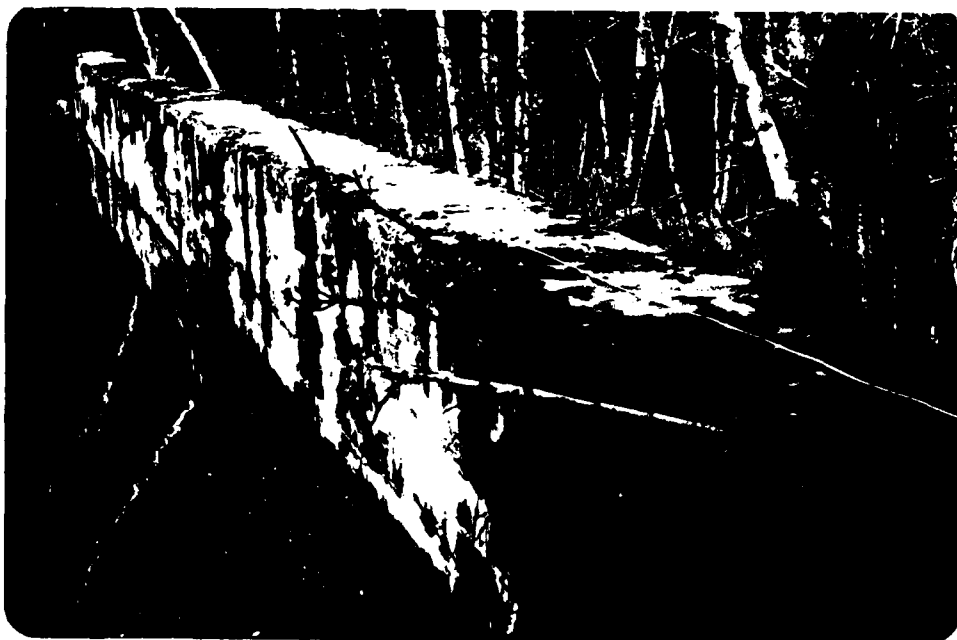
(9) Concrete Dike Upstream of Dam
May 8, 1980

Moss and debris have accumulated on the outside of the dike wall in sufficient quantity to make observation of concrete condition and seepage sources difficult.

About 150 yards upstream of the dam site, on the right side of the reservoir, is a concrete dike 125 feet long, 3 feet across the top and 16 feet high at its highest point. The dike prevents by-passing of the dam by overflow from the reservoir via a gully through which the Lamoille Valley Railroad tracks pass. It appears in good structural condition with some spalling of the surface concrete.
