NATIONAL PROGRAM FOR INSPECTION OF NON-FEDERAL DAMS  
NICHOLS POND DAM (VT.) (U) CORPS OF ENGINEERS WALTHAM MA  
NEW ENGLAND DIV APR 80

Nichols Pond Dam VT00184

APR 1980

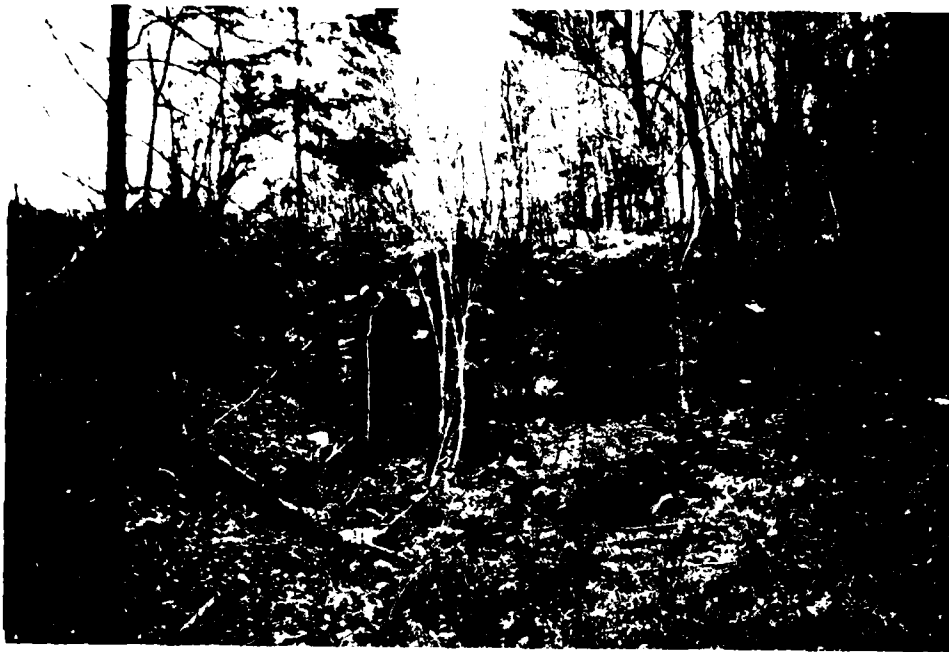
b. Dam. The dam consists of an earthen embankment with a dry masonry downstream face (photo 1) and a concrete upstream face (photo 2). The upstream face of the dam is a vertical concrete wall (photo 3). A new wall has been built immediately upstream of the original wall. The exposed part of the new wall appears in good condition with only minor spalling and cracking, while the old wall shows severe spalling in its exposed upper part (photo 4). The old wall appears to have settled slightly, on the right side of the spillway. The new wall does not show evidence of settlement.

1. Downstream face of left side of dam

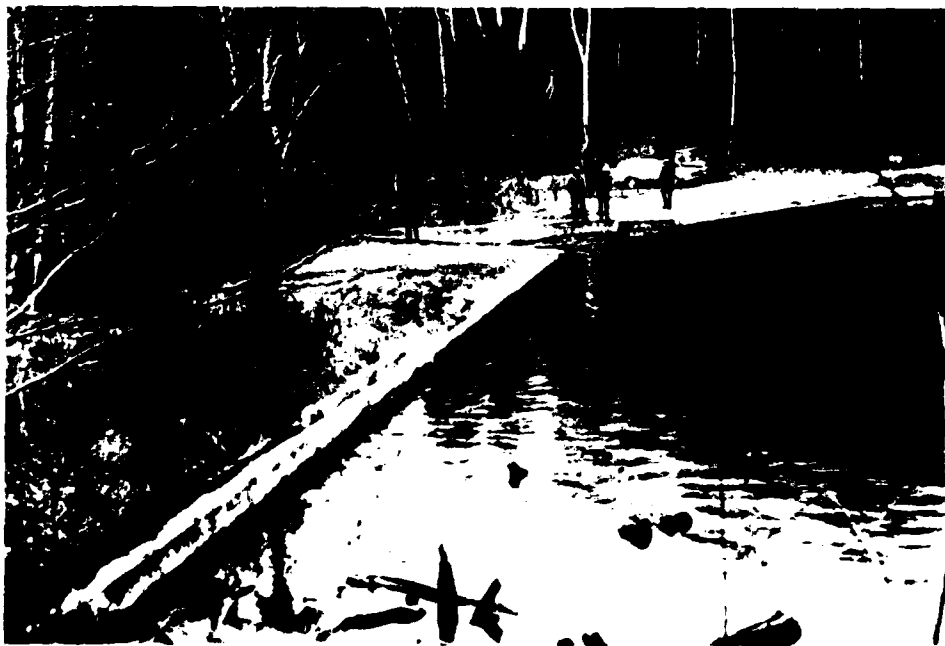
2. Upstream view of dam from left

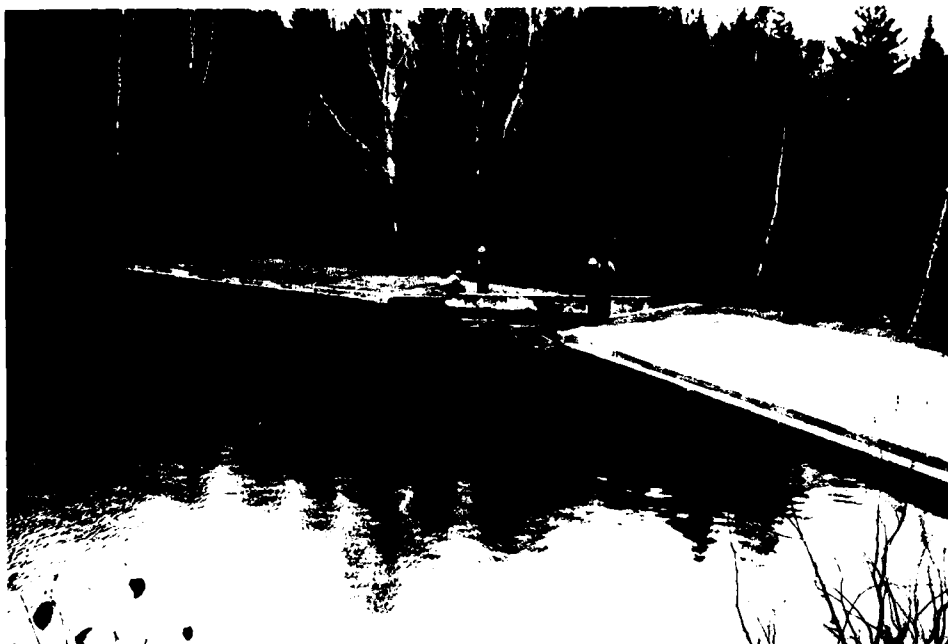
3. Upstream view of dam from right abutment

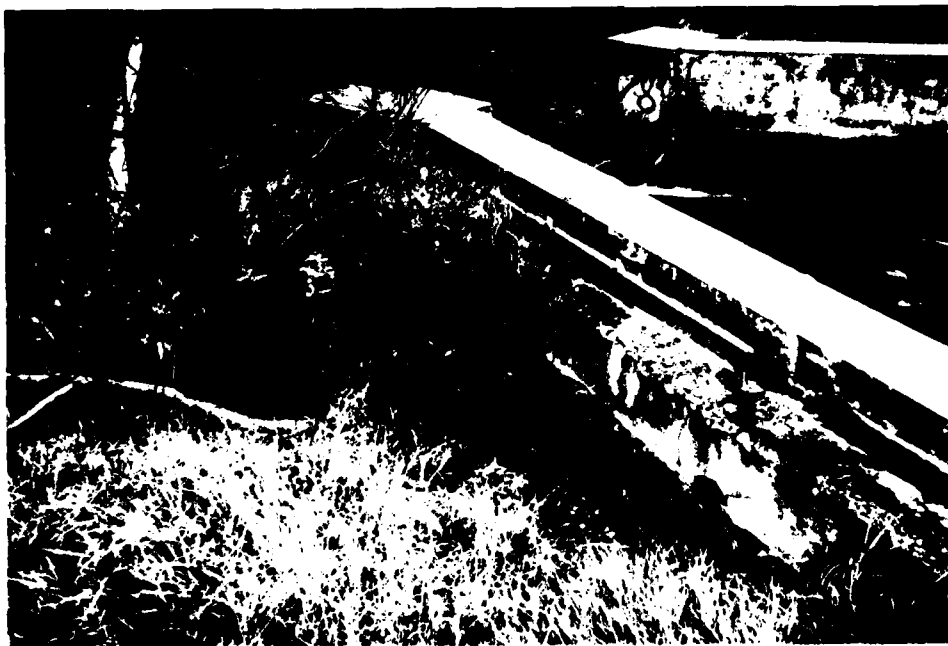
- b. A cavity produced by erosion of earth fill against the left spillway wall, if enlarged, can result in damage to the spillway floor and left wall which in turn could cause flow into the cavity and further erosion. Enlarging of the cavity will develop rapidly in case of overtopping of the dam.

- e. The scour or spalling of the spillway walls may indicate a serious problem with the original design of the spillway. The unusual throat configuration at the downstream end of the spillway may become the hydraulic control, thereby forcing a hydraulic jump in the middle of the spillway. The resulting roller could be the origination of the scour to the left of the spillway as shown in photo 6.

6. Cavity to the left of spillway

1. Remove trees and bushes growing on the crest and overhanging the downstream channel.
2. Fill the cavity next to the spillway left wall with lean concrete or compacted clayey soil.
3. Repair cracked and spalled concrete on the principal spillway.
4. Restrict trespassing from the crest of the structure.
5. Establish a program of annual technical inspections by a registered qualified engineer.
6. Develop a formal surveillance and downstream flood warning plan including round-the-clock monitoring during heavy precipitation.

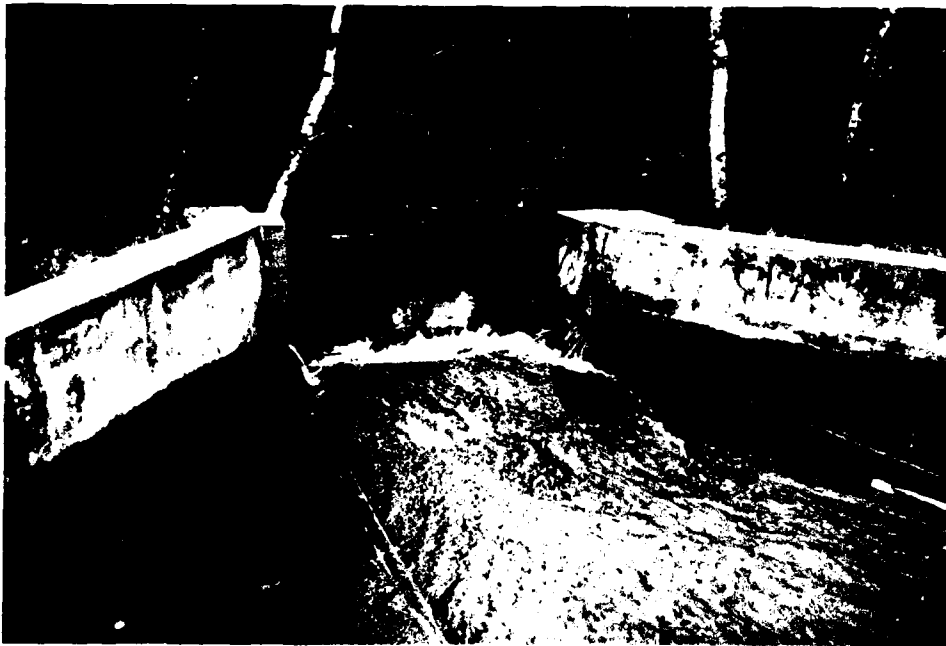
c. Appurtenant Structures The spillway walls and floor appear in good condition (photo 11) with some apparent spalling of the floor near the downstream end, (photo 12) Minor cracks in the spillway walls are typical of the cracks caused by concrete shrinkage (photo 13). The downstream face of the spillway could not be observed due to a large amount of debris accumulated against it (photo 14). An undesirable effect of the accumulated debris is a lateral deflection of the water flow resulting in erosion of the banks of the downstream channel adjacent to the dam. The erosion is evident on the left back of the downstream channel (photo 14) where the stump of a tree has rotated about 90°. This erosion could be responsible for the undermining of the concrete wall, as discussed in the previous section. Due to the debris accumulation, it was not possible to observe the condition of the downstream wall of spillway and of the downstream channel bottom immediately downstream for evidences of scour (photo 15).

11. Spillway looking downstream
