NATIONAL PROGRAM FOR INSPECTION OF NON-FEDERAL DAMS  
SPRAGUE UPPER RESERVOIR (U) CORPS OF ENGINEERS WALTHAM  
MA NEW ENGLAND DIV JUN 79

*SPRAGUE UPPER RESERVOIR DAM*  
DOCUMENT IDENTIFICATION  
*JUNE 1979*  
*R103105*

SPRAGUE UPPER RESERVOIR DAM RI 03105

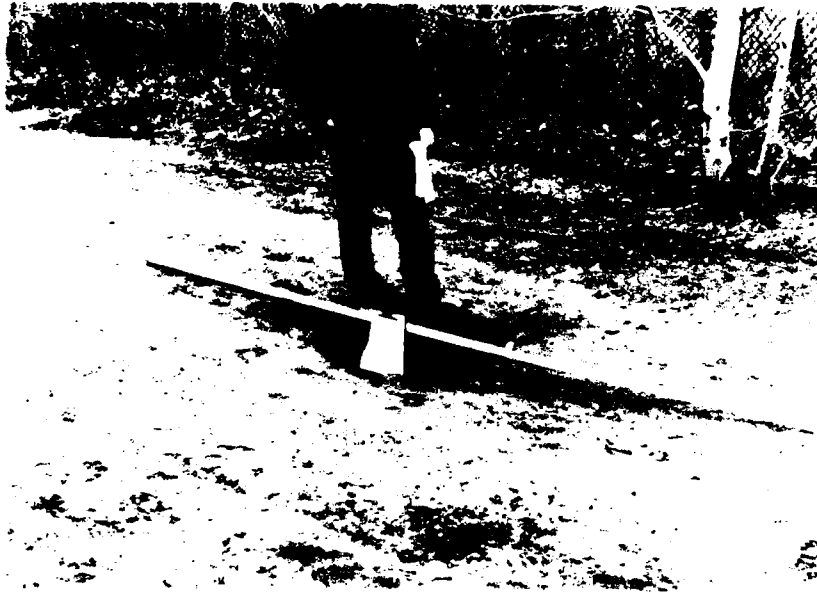
There is a small pothole or sinkhole, located at the center of the dam in line with the outlet pipe and gatehouse, or about 96 ft. left of the right abutment and 66 ft. right of the left abutment. It measures approximately 3 ft. in diameter and about 14 in. deep. Previous inspection reports have indicated that this condition has existed for several years. However, generally this condition was referred to as a slight depression. Discussions with the operator indicated that the sinkhole has appeared recently (see Photo Nos. 3 & 4, Appendix C).

3. View of sinkhole at mid-length of dam crest.

c. Urgency. The recommendations and remedial measures enumerated below should be implemented by the owner within one year after receipt of the Phase I Inspection Report, except that the investigations of the sinkhole at the crest of the dam should be carried out within three months.

- (1) Make soils and foundation studies, and determine the cause of the sinkhole at the crest of the dam.
- (2) Determine the cause of the seepage at the toe of the dam.
- (3) Determine whether the dam should be raised and/or additional spillway capacity provided to prevent an overtopping of the dam.
- (4) Determine whether the existing outlet culvert and slide gate are repairable and of adequate size for emergency evacuation of the reservoir.
- (5) Determine whether the outlet culvert headwall requires repair.

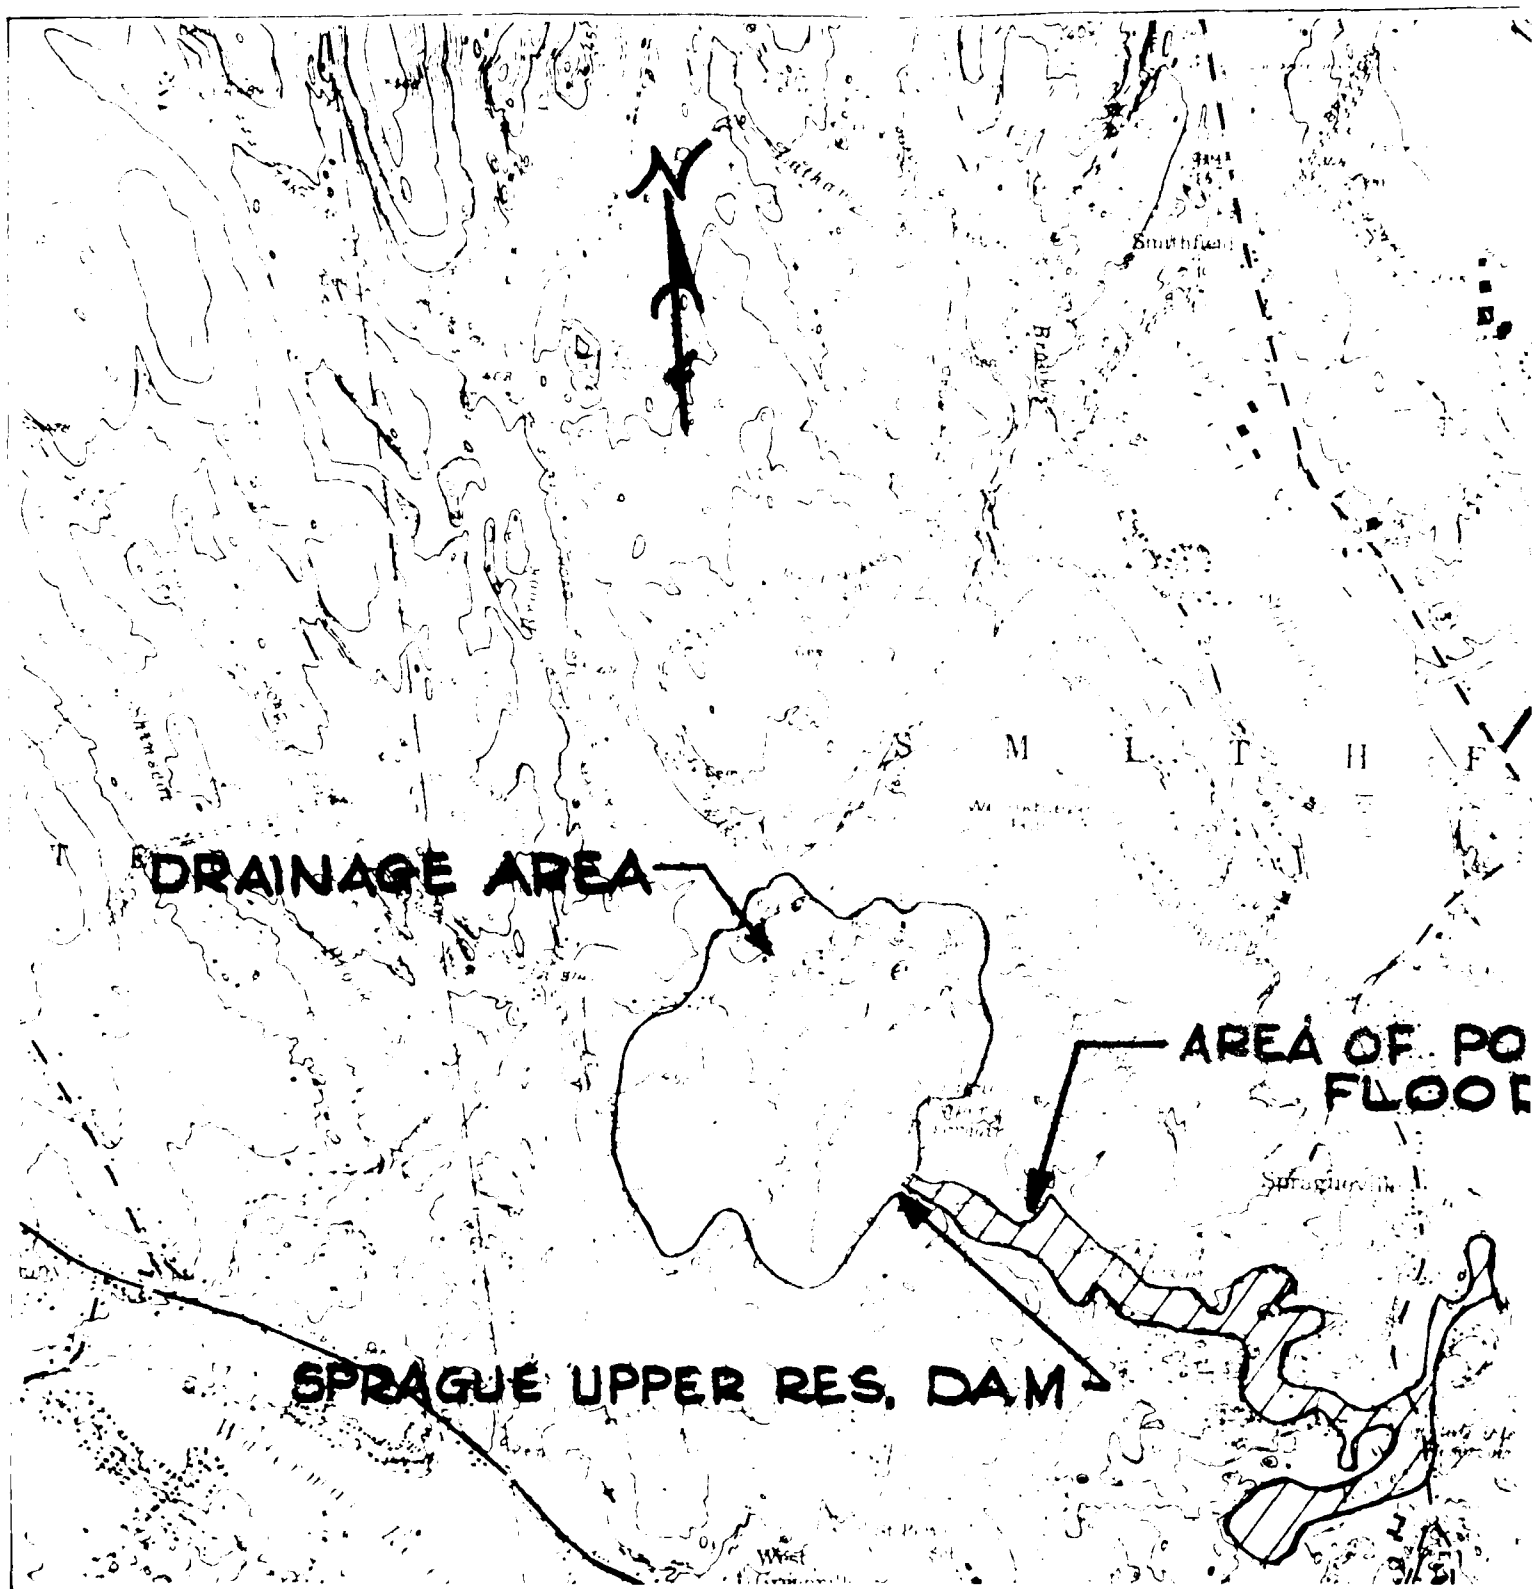
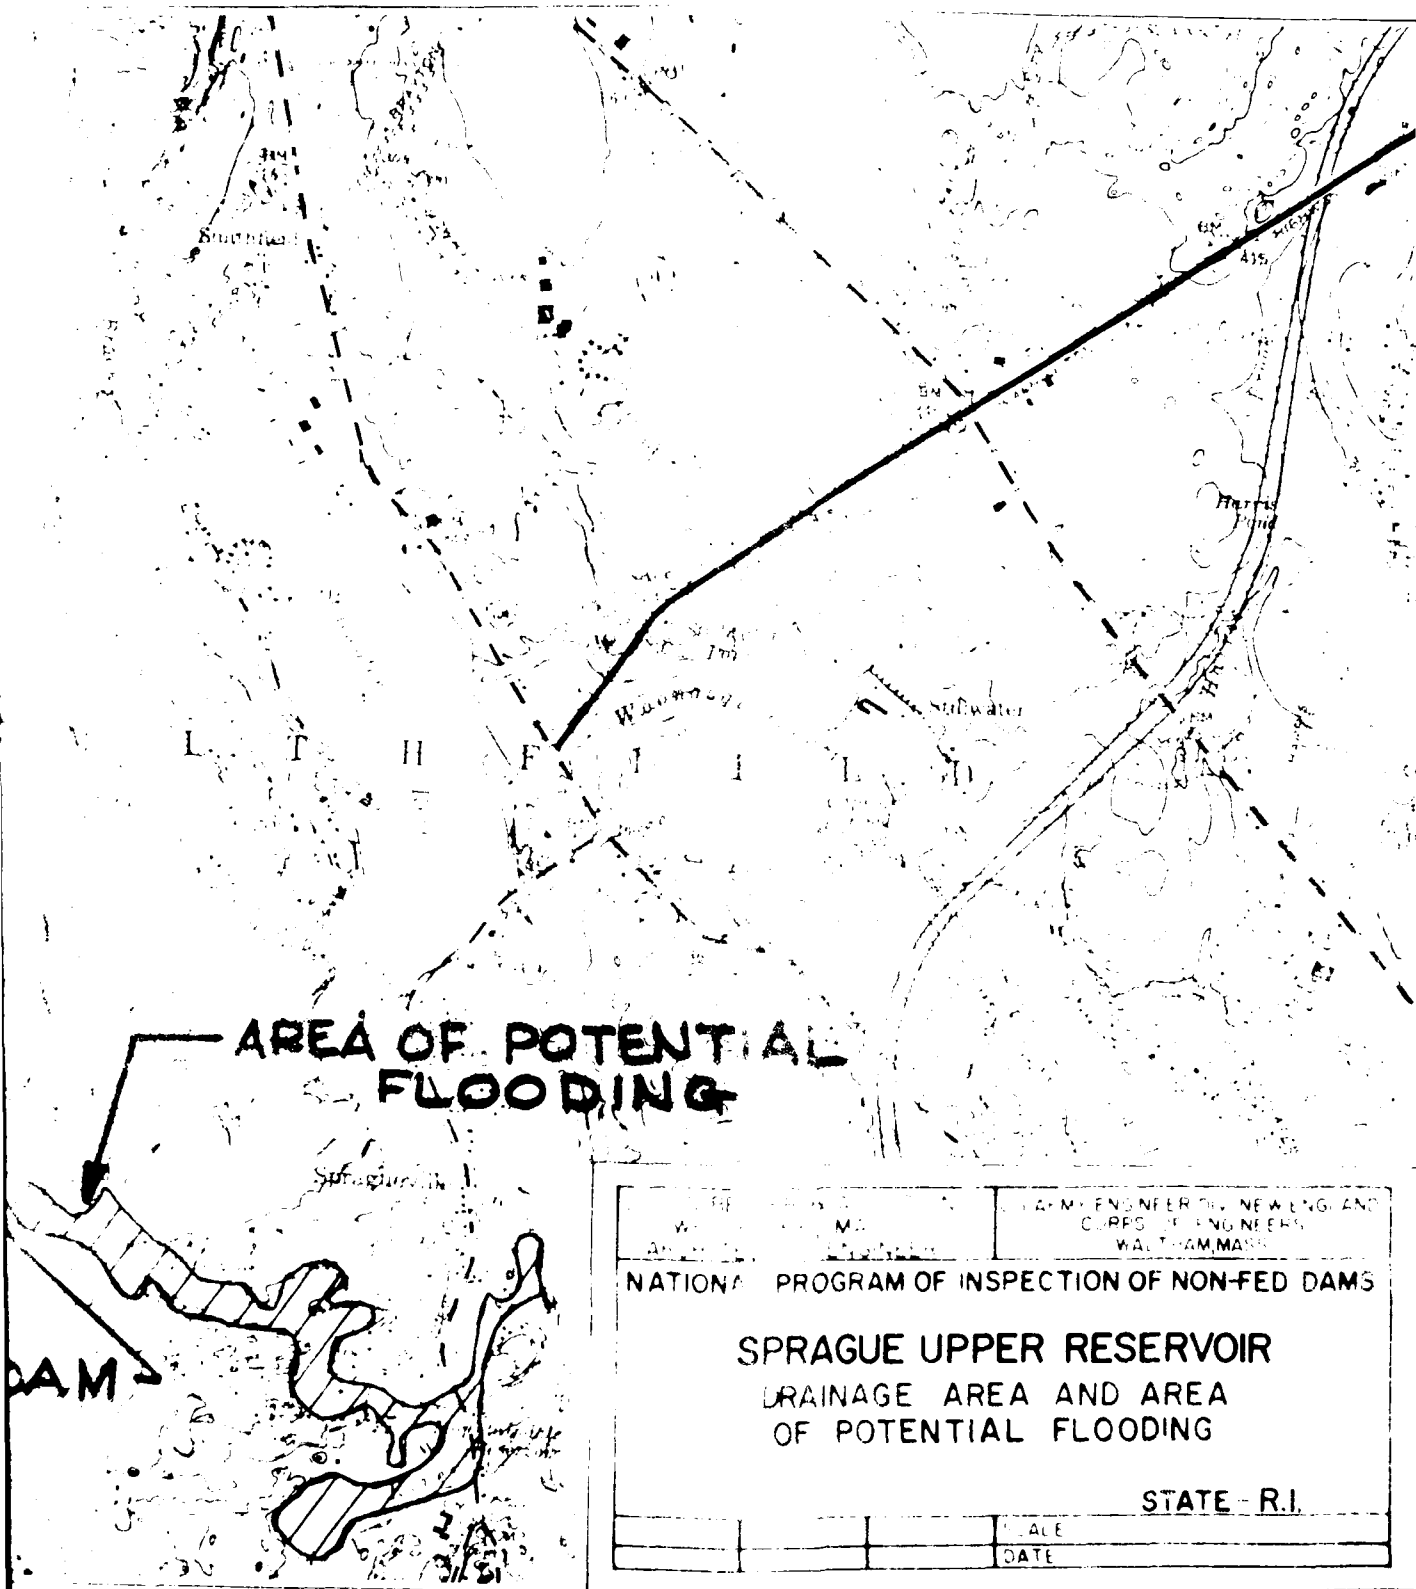
Figure 4, Sheet D 18

In summary about 8 homes, 2 commercial establishments, and 2 roadways, one of which is a state highway (Route 116) are within the area of potential flooding. Mountaindale Road near Stillwater Reservoir also might sustain damage as a result of a breach failure of Sprague Upper Reservoir. See Appendix D. Figure 4, Sheet D-18 which shows the area of potential flooding.
