CONNECTICUT RIVER BASIN  
WHITINGHAM

LAKE SADAWGA  
VT00012

PHASE I INSPECTION REPORT  
NATIONAL DAM INSPECTION PROGRAM

AUGUST 1978

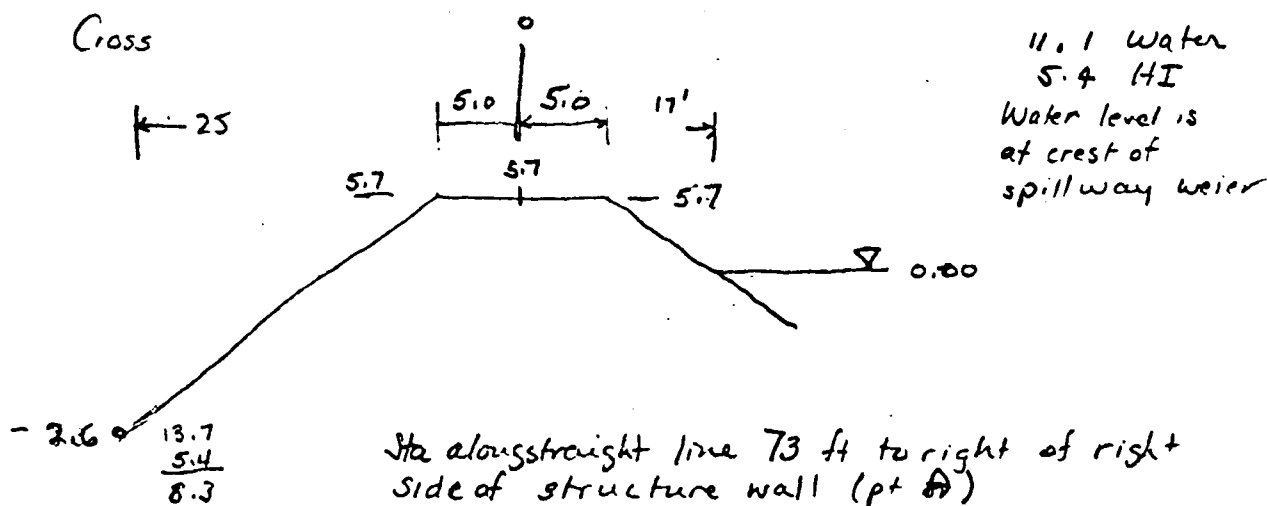
Erosion upstream to right of structure as shown.

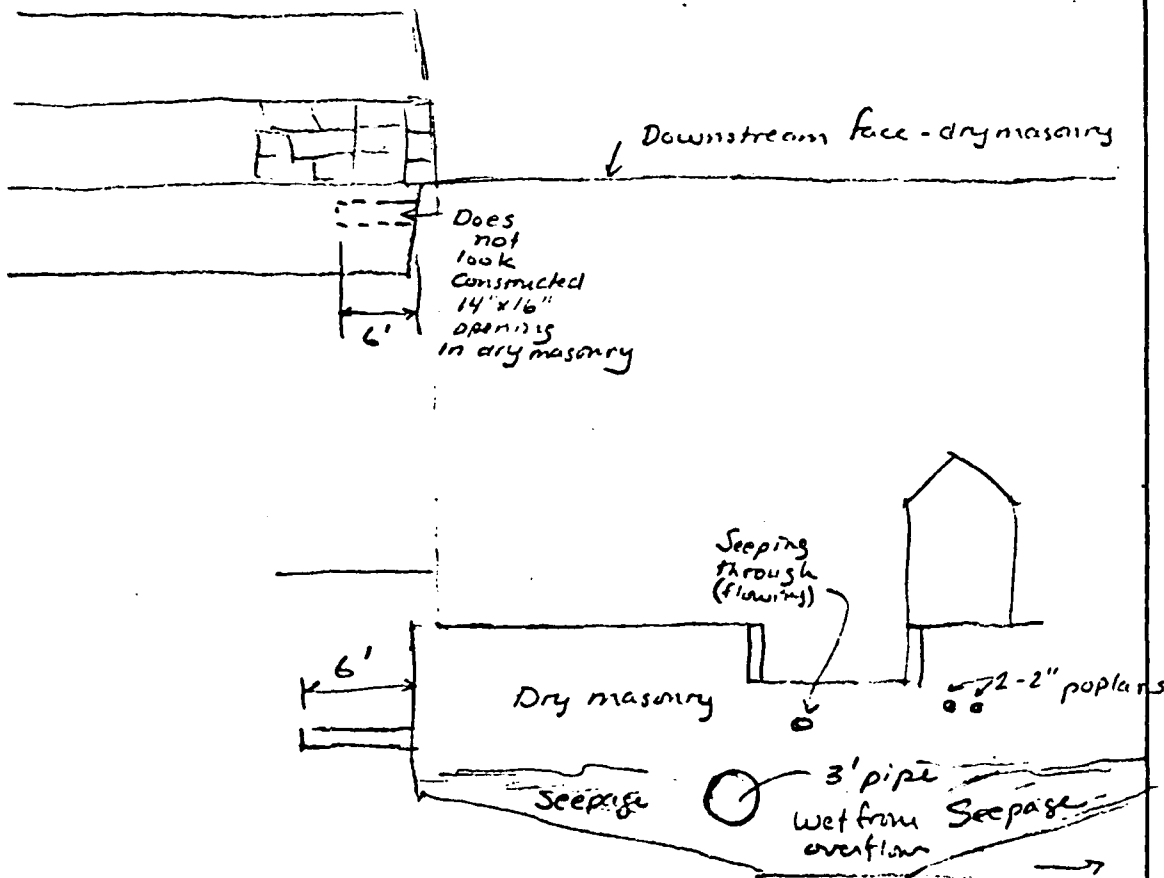
Hole in rt. abutment.

Structure is founded on quartzite or schist bedrock dipping 14° N striking N75E

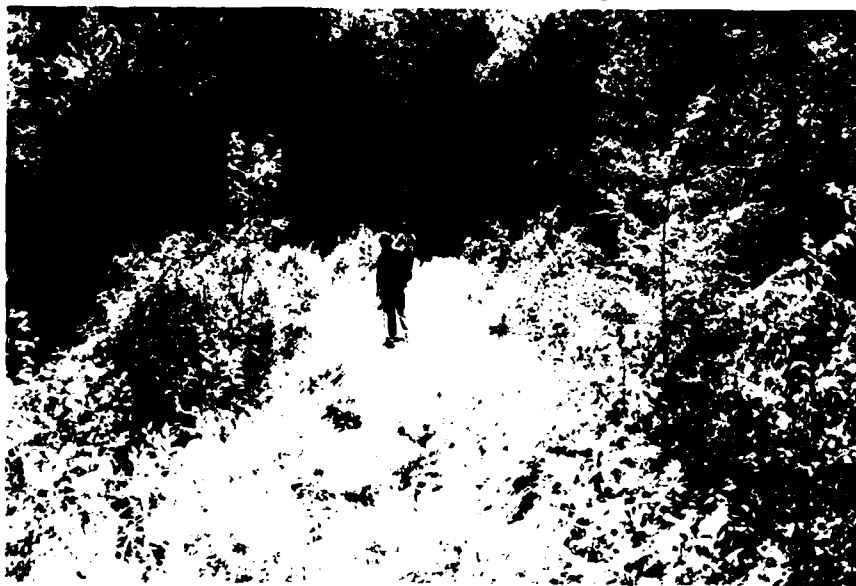
The West Dike has a crest width of only a few feet. In the records it appears that for a "rare storm" (1640 cfs inflow, 11% of PMF) the freeboard will drop to only 2 feet. Under these conditions the West Dike will be in substantial danger of eroding through due to only minor wave action, because the crest is narrow and the slopes are steep.

#4 WEST DIKE

1. Redesign and rebuild the West Dike to make it equivalent to the dam.
2. Monitor settlement of the cracked portion of the control section and redesign this structure as necessary.

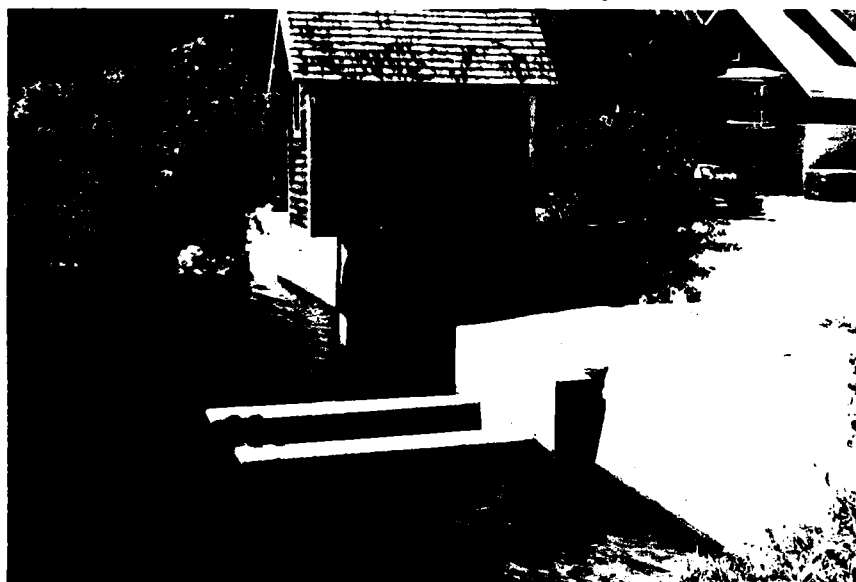
#5 SPILLWAY, DROP-INLET AND GATEHOUSE

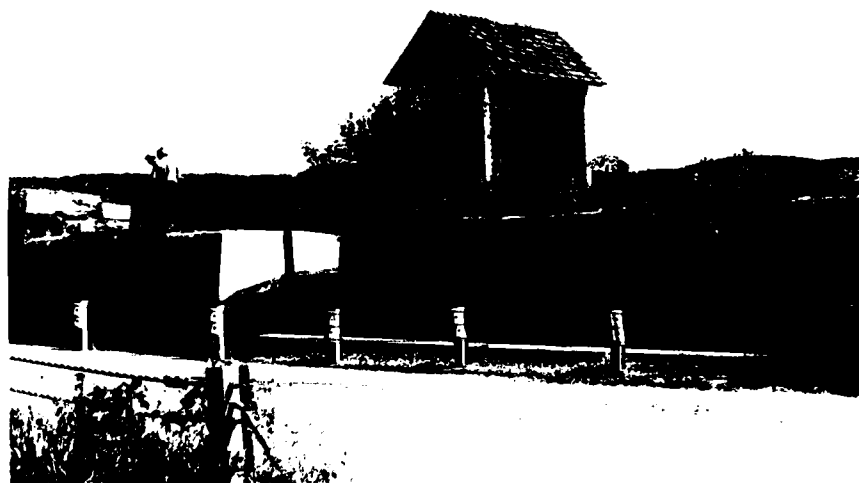
#6 SPILLWAY, GATEHOUSE FROM DOWNSTREAM

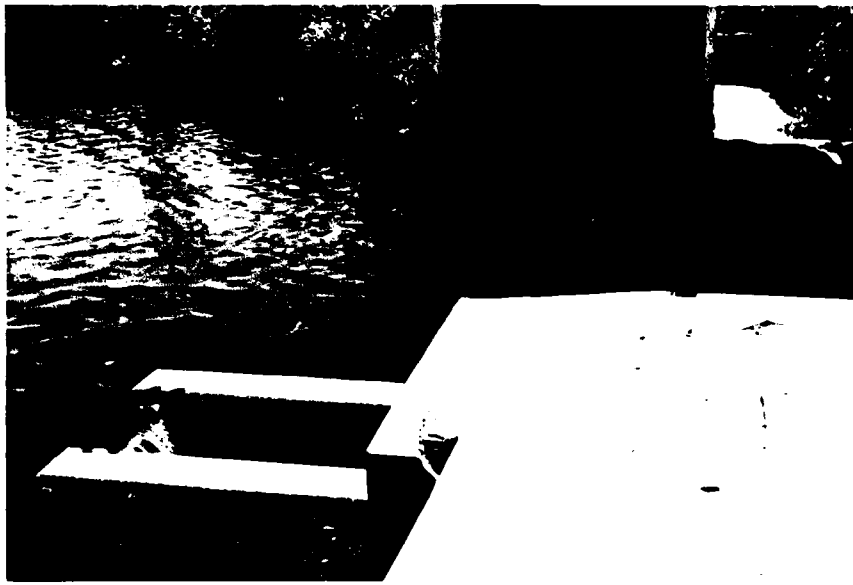
#7 DROP INLET, ALSO NOTE CRACKED CONCRETE

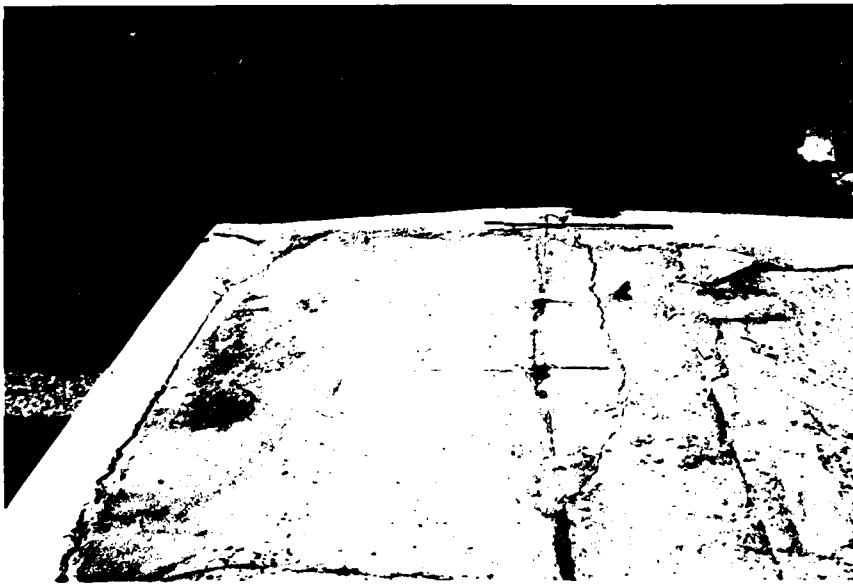
A portion of the concrete cap is in fair condition, since it is severely cracked and shows signs of settlement. It should be monitored to determine whether settlement is occurring. It is also recommended that the condition of the penstock where it penetrates the wall be determined.

The concrete cap shows evidence of deterioration in the form of light scaling and medium surface cracks. A portion of the cap just to the right of the control section (see Photo 8 in Appendix C) approximately 4 feet x 8 feet in plan appears to have settled and cracked. This portion of the cap is located directly over the old 3.9-foot diameter penstock where it penetrates the masonry wall.

#8 VIEW OF CRACKED CONCRETE ON SPILLWAY
