SMITHFIELD, RHODE ISLAND

WATERMAN RESERVOIR DAM

PHASE I INSPECTION REPORT

AUGUST 1978

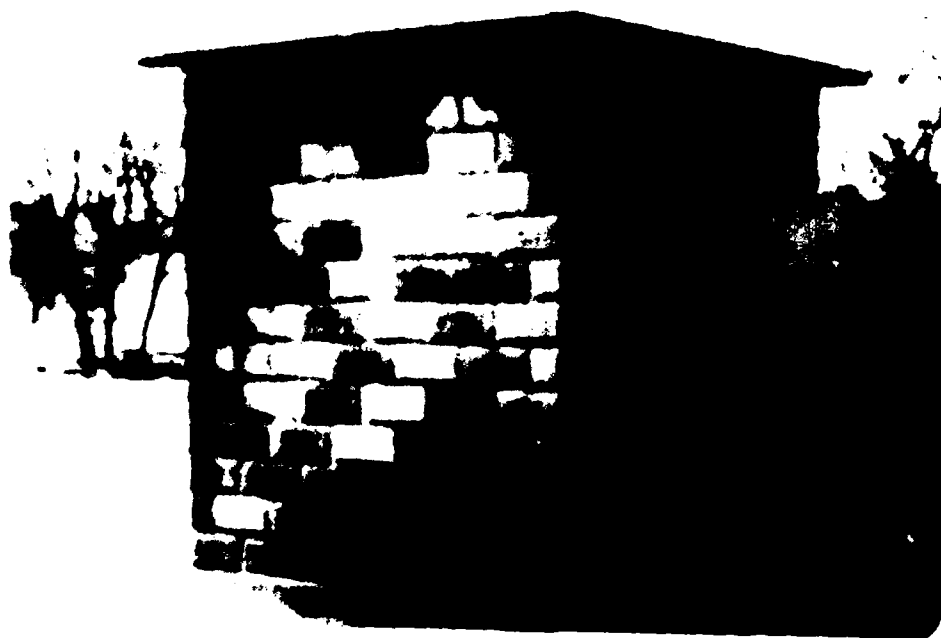
In this area the riprap consists of stones varying from 2 to 8 inches in size with some areas void of all stone. Large sloughed areas exist on either side of the gate house. (Photographs 4 thru 7) These have resulted in the riprap being removed exposing the underlying embankment materials which consist of a bony gravel with maximum sizes to 2-inch diameter. The concrete stairs on the left side of the gate house have dropped approximately 3.5 feet below the top of the gate house foundation because of the sloughing of the slope in this area. (Photographs 7 and 8)

Photograph 4 Main Dam - Looking north at gate house.

(3) Eroded and sloughed areas on the upstream face of the main dam should be repaired.

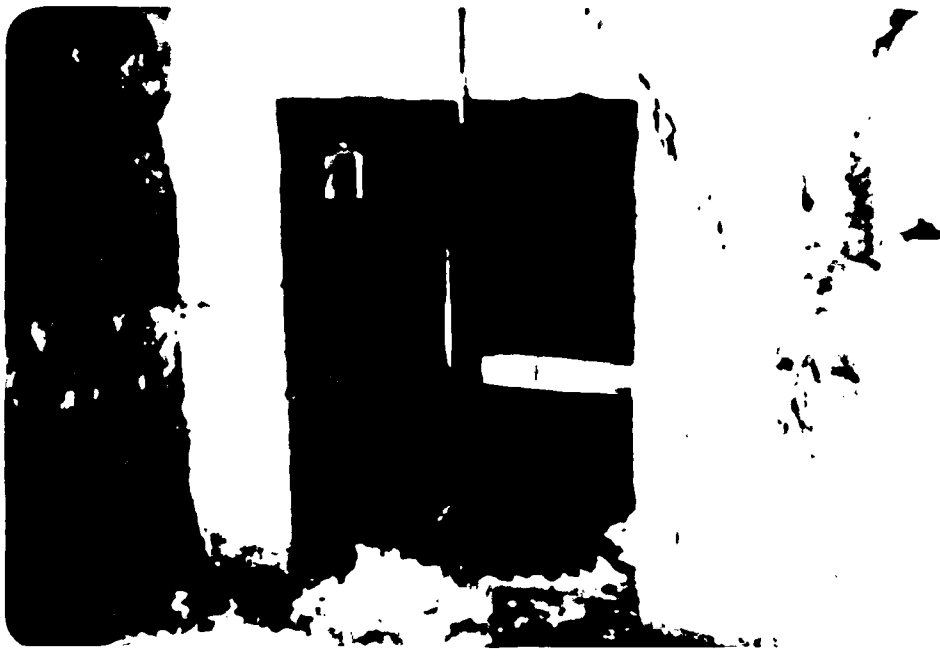
Seepage noted from the masonry wall on the downstream slope, probably had been caused by recent rains, snow melt and ground thaw. Seepage was also noted from the north wing wall of the outlet channel after the gate was closed. (Photograph 9) The seepage appeared to contain sawdust. (Photographs 10 and 11) At the time this seepage was noted, heavy rain was falling.

Photograph 9 Main Dam - Outlet conduit from the
north wing wall. Note: Wooden stop
log structure in conduit.

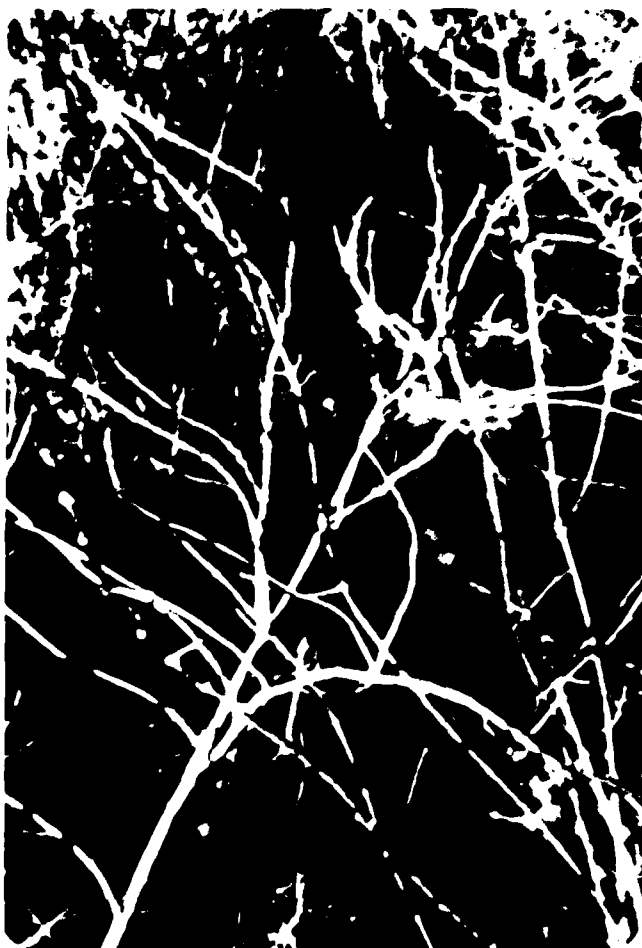
Photograph 22 Spillway: Westerly view from east wing wall.
