GRAND LAKE DAM
ME 00180

PENOBSCOT RIVER BASIN
GRAND LAKE MATAGAMON

PHASE 1 INSPECTION REPORT
NATIONAL DAM INSPECTION PROGRAM

SUBJECT: Grand Lake Dam

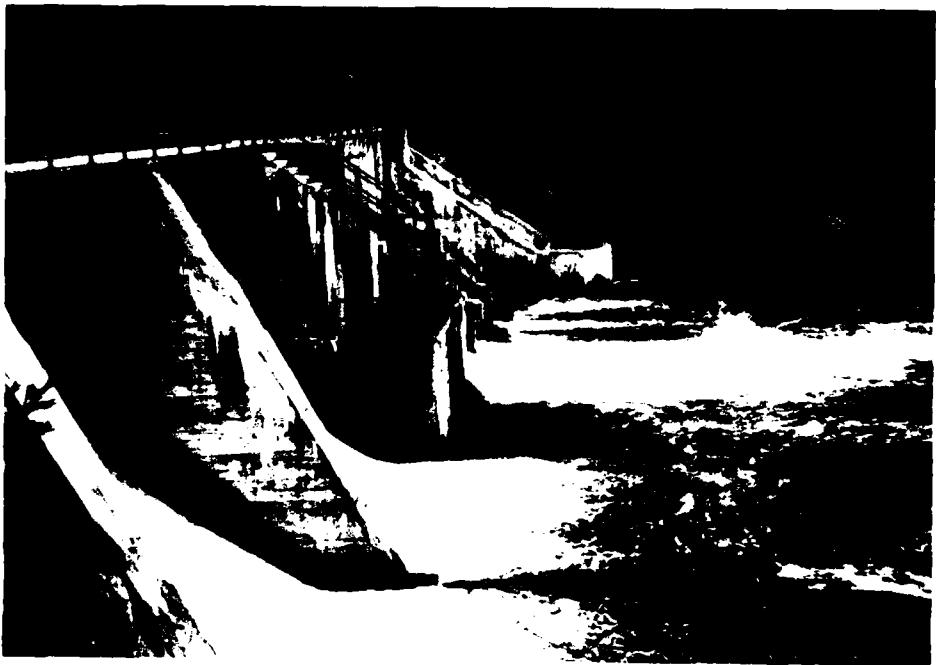
Fig. 1 Downstream view of dam from right bank. Note fish ladder at left embankment
