WESTMINSTER RESERVOIR DAM
MA 00639

**PHASE I INSPECTION REPORT
NATIONAL DAM INSPECTION PROGRAM**

DEPARTMENT OF THE ARMY
NEW ENGLAND DIVISION, CORPS OF ENGINEERS
WALTHAM, MASS. 02154

JUNE 1980

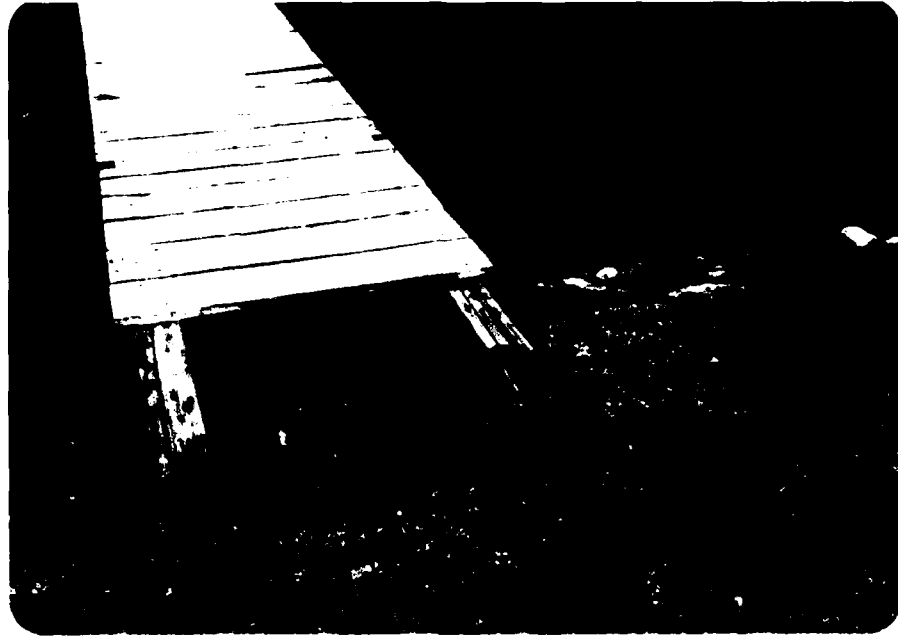
NO. 5 VIEW OF ACCESS BRIDGE & EROSION OF SLOPE

Moderate erosion was noted on the upstream slope of the dam adjacent to the gatehouse footbridge. (See Photo No. 5).

A few pieces of riprap have been dislodged from the upstream face of the embankment but it is generally in good condition. Several planks are missing from the gatehouse access bridge (see Photo No. 3 and No. 5).

- a. Operating and Maintenance Procedures. It is recommended that the Owner accomplish the following:
 - (1) To prevent continued erosion, fill in and re-seed eroded areas on the upstream face of the earth embankment portions of the dam.

- (4) Place earthfill and re-seed eroded areas on the upstream slope.
 - (5) Remove all debris and loose stone in the floor of the spillway discharge channel.
