CONNECTICUT RIVER BASIN
CANAAN, NEW HAMPSHIRE

GOOSE POND DAM
NH 00118

PHASE I INSPECTION REPORT
NATIONAL DAM INSPECTION PROGRAM

MAY 1979

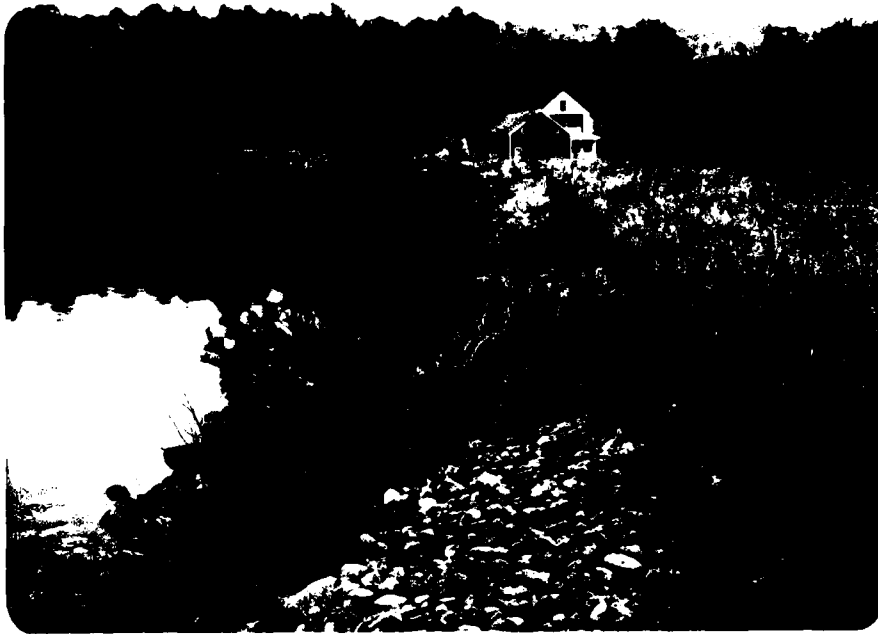
Vegetation, consisting of grass and weeds, was noted on the upstream slopes and on the top of the dam. Small bushes were observed on the downstream slope.

1. Goose Pond Dam, Looking East. Showing Vegetation on the Upstream Side of Core Wall.

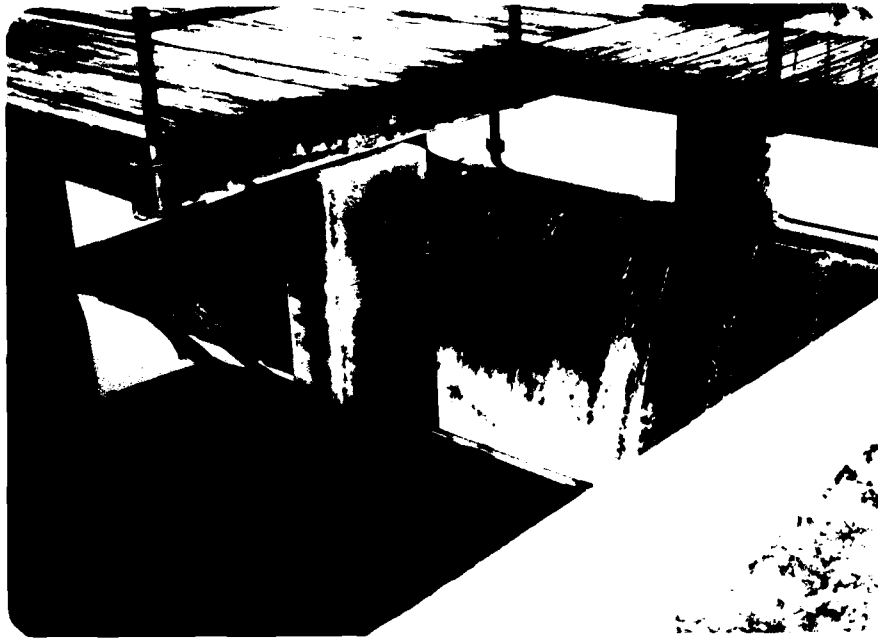
The crest of the non-overflow section is 11 feet above the crest of the spillway. At the time of inspection, water was observed flowing over the flashboards on the spillway crest. The hydraulic design of the spillway is good.

3. Spillway Crest with Flashboards in Place, Looking Northwest.

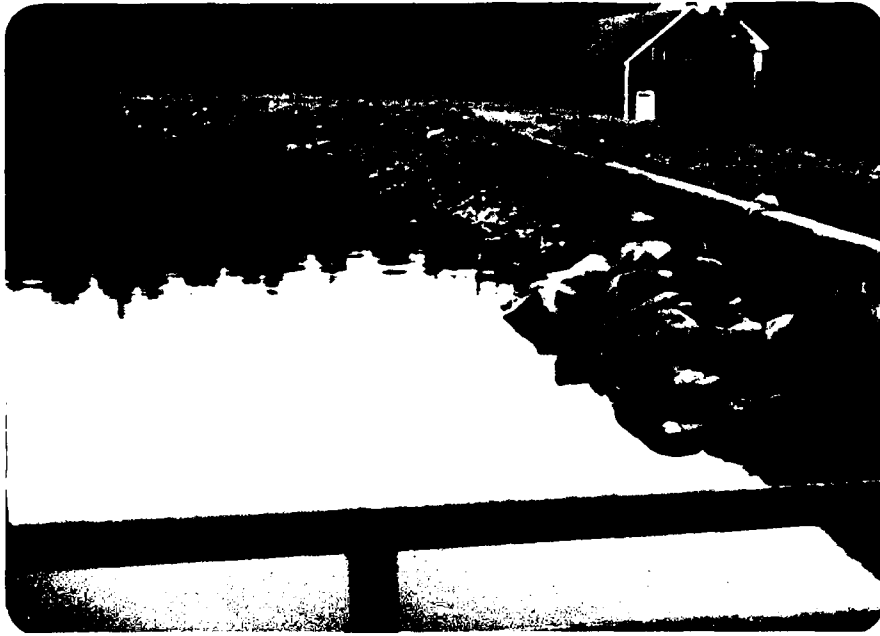
The riprap slope protection on the upstream slope is in poor to fair condition. A section of the slope protection, approximately between 66 feet and 105 feet east of the spillway, has been washed away.

11. East Dike, Showing Rip-Rap and Concrete Core Wall Near the Intake Structure.

1. The slope protection on the upstream slope east of the spillway should be re-established.
2. The exposed concrete surface of the core wall should be repaired.
