GRAFTON POND DAM

NH 00119

PHASE I INSPECTION REPORT
NATIONAL DAM INSPECTION PROGRAM

NOVEMBER 1978

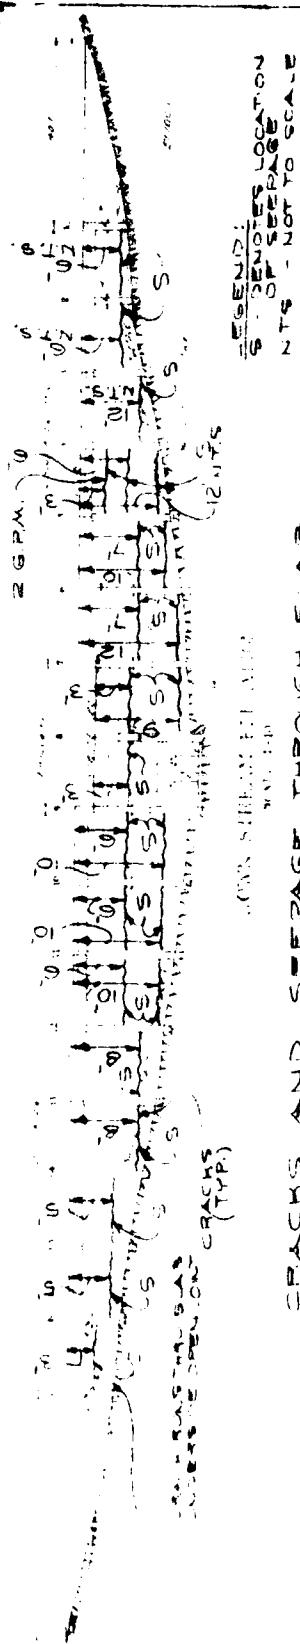
GENERAL PLAN AND ELEVATION
ASBURNEN DAM
GRANTON POND - MASCONOMA RIVER

CRACKS AND SEEPAGE THROUGH SLABS
