ANDOVER RIVER BASIN
WEARE, NEW HAMPSHIRE

**WEARE RESERVOIR DAM
NH 00114**

**PHASE I INSPECTION REPORT
NATIONAL DAM INSPECTION PROGRAM**

AUGUST 1978

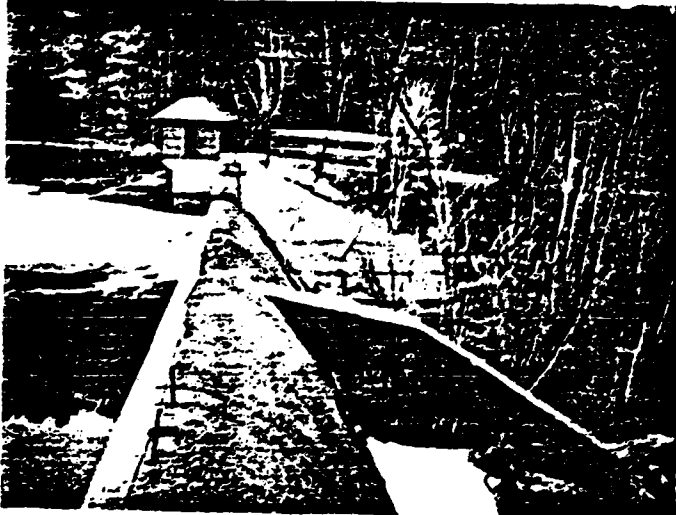
A

CRACK >

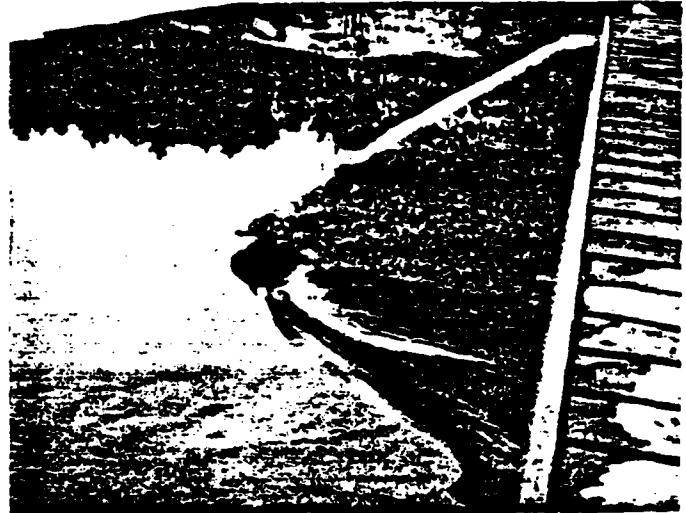
B

WATER FLOWING UNDER
CONCRETE

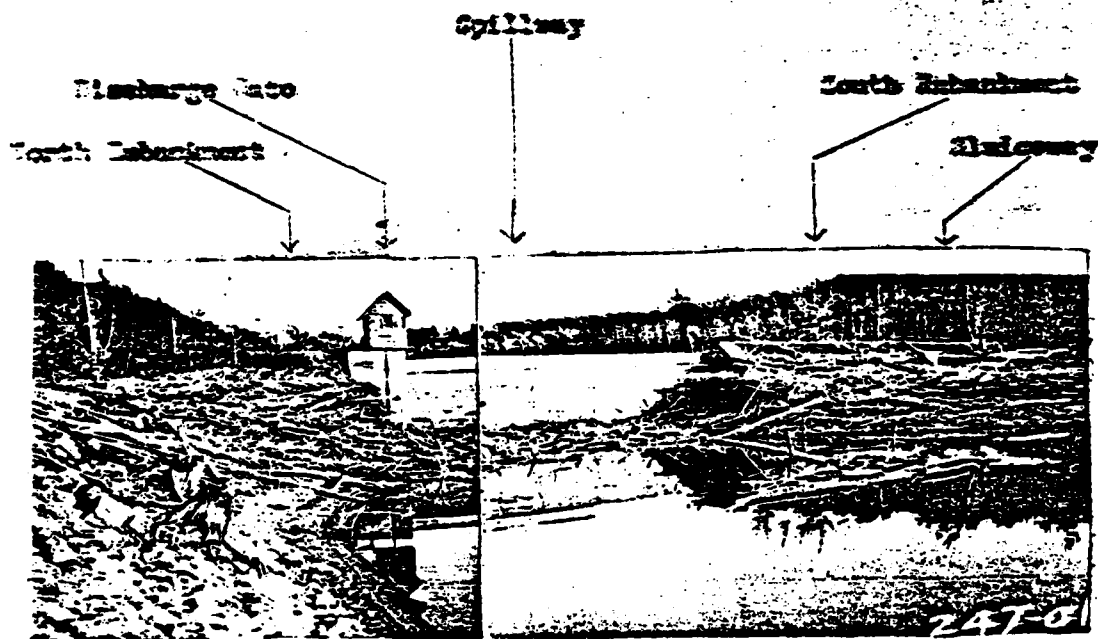
FIGURE 2. DAM BEFORE WASHOUT
LOOKING DOWNSTREAM
