MERRIMACK RIVER BASIN
CAMPTON, NEW HAMPSHIRE

CAMPTON POND DAM
N.H. 00130

PHASE I INSPECTION REPORT
NATIONAL DAM INSPECTION PROGRAM

JUNE 1979

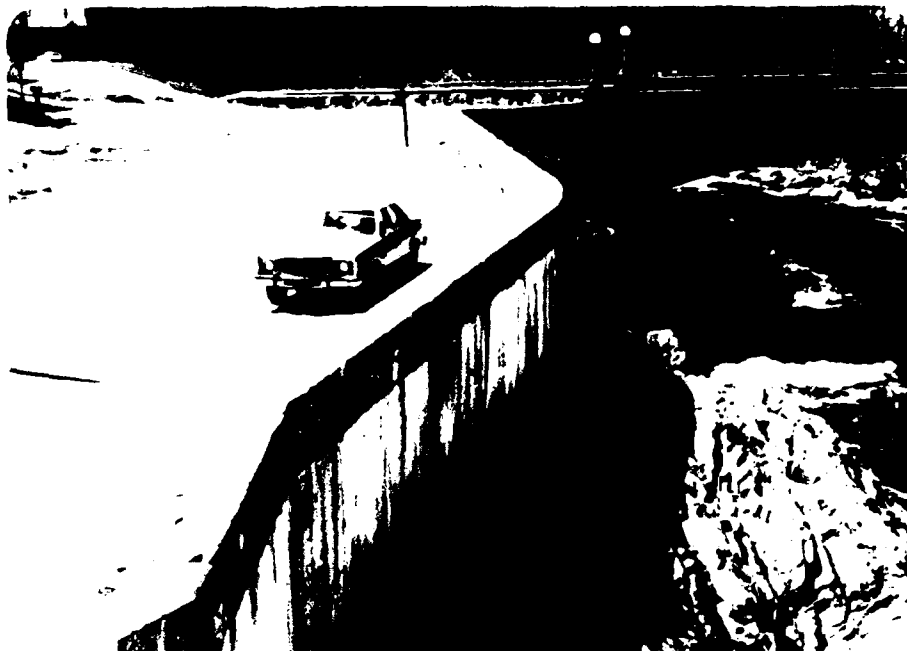
Both left and right sides of the downstream channel include concrete and masonry retaining walls which support paved roadways. Photo 5 illustrates the left downstream retaining wall as viewed from the gate structures. As the photo indicates, bedrock provides foundations for the wall. The rock strikes almost perpendicular to the dam and dips approximately 70° toward the stream (west). The angularity of the rock surfaces indicates stable foundation material. Photo 4 illustrates the right downstream retaining wall. As the photo indicates, the wall also rests on bedrock. The masonry section of the wall rests on a concrete foundation poured on rock. The rock strikes almost perpendicular to the dam and dips approximately 85° toward the stream (east). Considerable spalling is occurring at both the concrete footing and the concrete-rock interface, but should not impair its stability. Similarly, some minor spalling of concrete is also evident around the construction joints in the concrete section of the wall near the dam. Some small local depressions in the ground surface behind the wall indicate some consolidation of the backfill probably has occurred. No openings in the wall were observed that could have produced loss of backfill through the wall. There is no apparent tilting of the wall.

#5. VIEW OF LEFT SIDE DOWNSTREAM RETAINING WALL

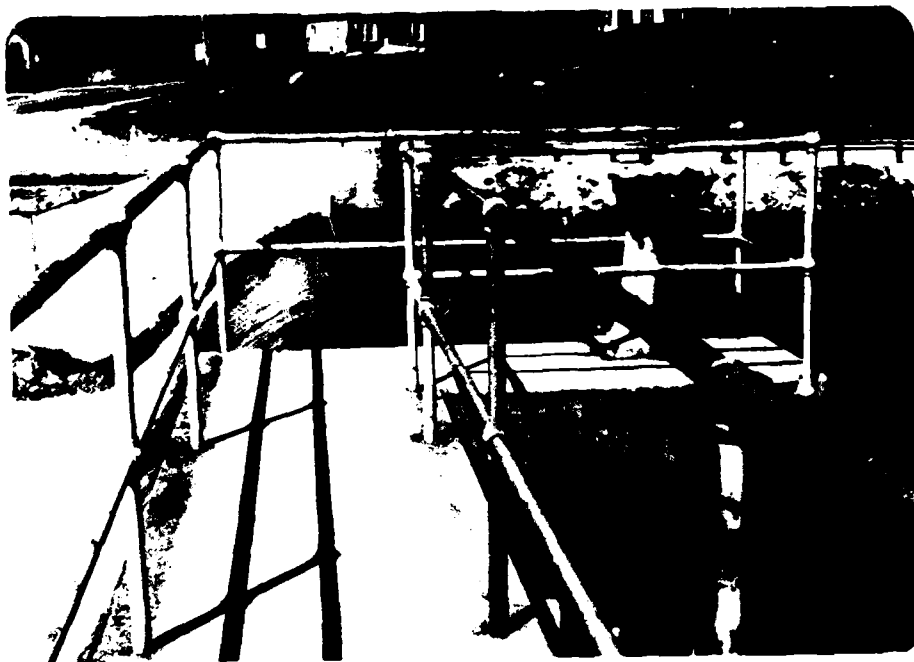
Photo 7 illustrates the condition of the outlet gate control superstructure. Water flowing over the dam precluded inspection of the outlet pipe, but all exposed concrete appears in good condition.

#7. VIEW OF OUTLET GATE OPERATOR AND PLATFORM
