MERRIMACK RIVER BASIN  
ALTON, NEW HAMPSHIRE

ALTON POWER DAM  
NH 00011

PHASE I INSPECTION REPORT  
NATIONAL DAM INSPECTION PROGRAM

JANUARY 1980

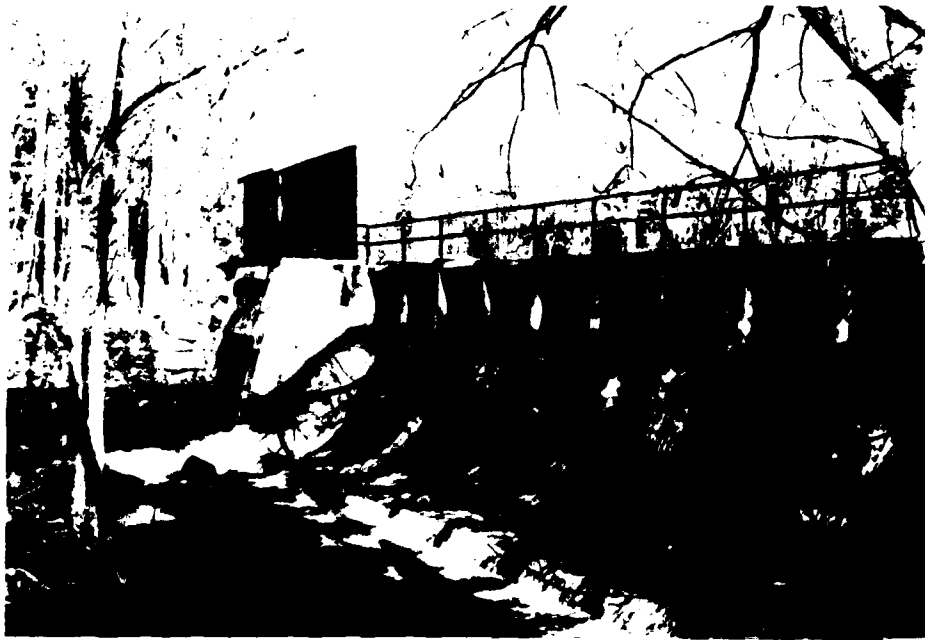
b. Dam. The concrete spillway of Alton Power Dam appeared to be in good condition. However, flow over the structure precluded its close examination, Photo No. 2. The alignment of the visual portions of the spillway and the footbridge over the spillway did not indicate evidence of major lateral movement or unusual settlement, Photo No. 3. The concrete training walls at either end of the spillway appeared to be sound with no major deficiencies observed.

2. Overview of spillway and downstream channel

3. Perform an inspection of the spillway during a period of low flow to assess its structural condition.
4. Perform an investigation to determine the required work to insure the operability of the outlet works and make the penstock supports structurally adequate. An alternative to the rehabilitation of the penstock supports would be to remove the penstock as it now exists. A small portion could be cantilevered from the gate house wall to serve as the outlet works discharge pipe.

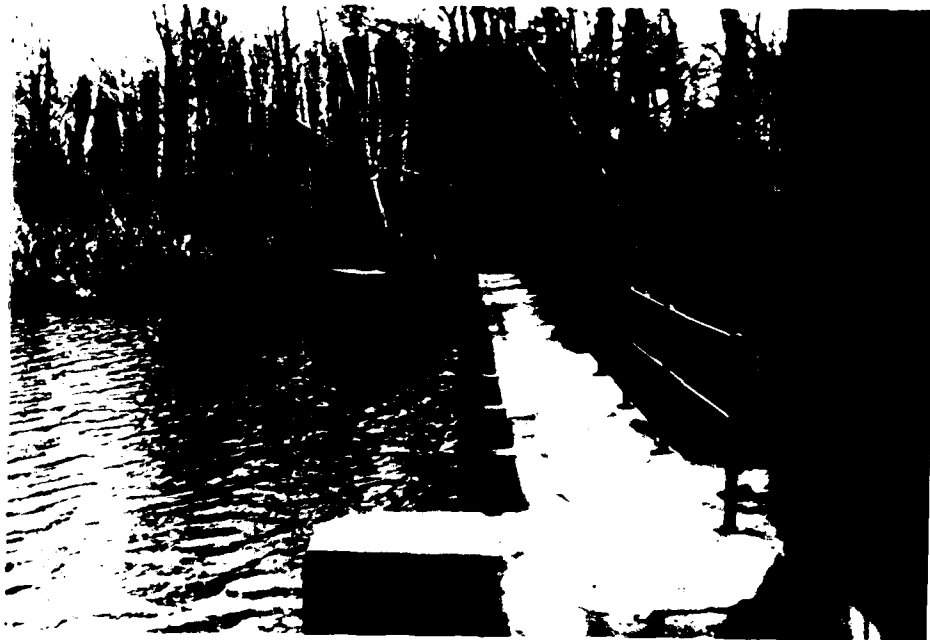
3. Alignment of dam from right abutment

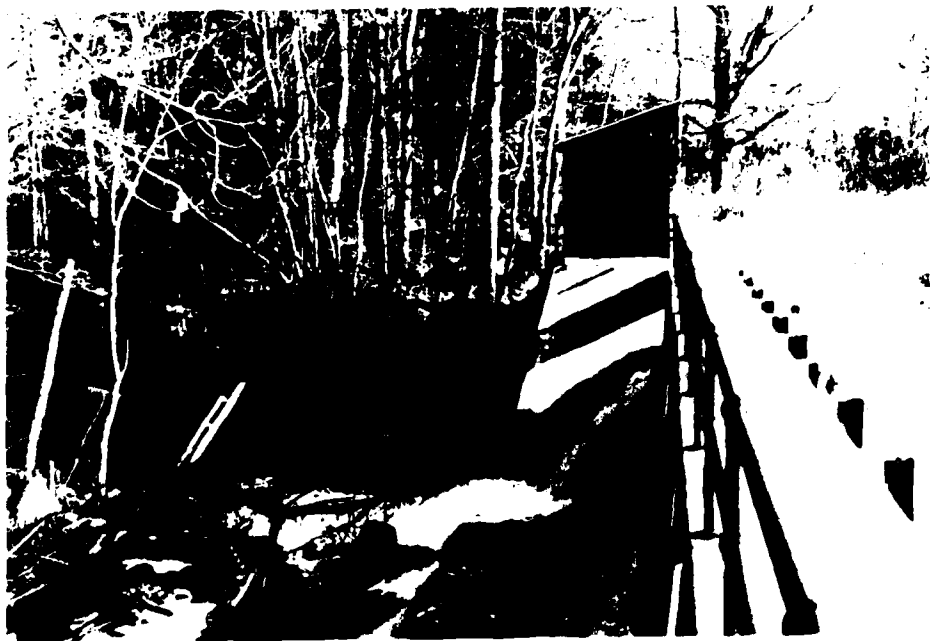
5. Right side of dam from footbridge

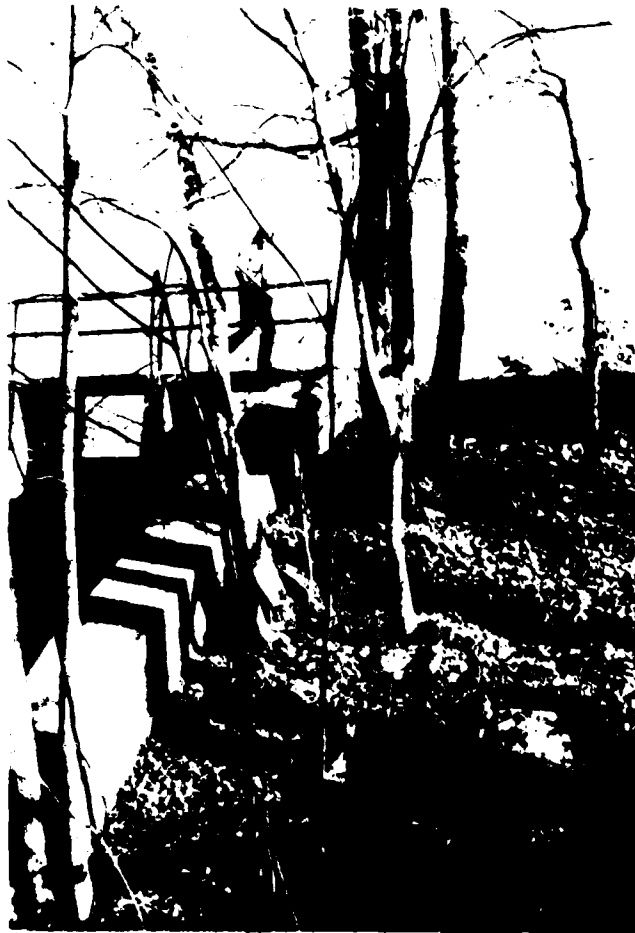
saplings and a number of trees up to 8 in. in diameter. Along the upper portion of the left downstream slope are several large oaks, birch and small maple trees. A difference in grade was observed between the top downstream surface of the left training wall and the adjacent embankment, Photo No. 6. The embankment might have been constructed this way or the difference may be caused by natural settlement of the embankment due to insufficient compaction effort during its construction. Some minor erosion was also apparent along the downstream side and adjacent to the left training wall.

6. Left embankment adjacent to left training wall, downstream

1. Repair the spalled areas of concrete on the outlet works head walls and the cracks in the concrete, at the downstream face of the outlet works.
2. Repair the timber stoplog supports.
3. Cut and remove the trees and brush located on the crest and slopes of the left embankment. If the stumps are left in place or removed, with voids

filled, should be determined in conjunction with the seepage investigation recommended above. In either case, a selective procedure of tree removal should be used.

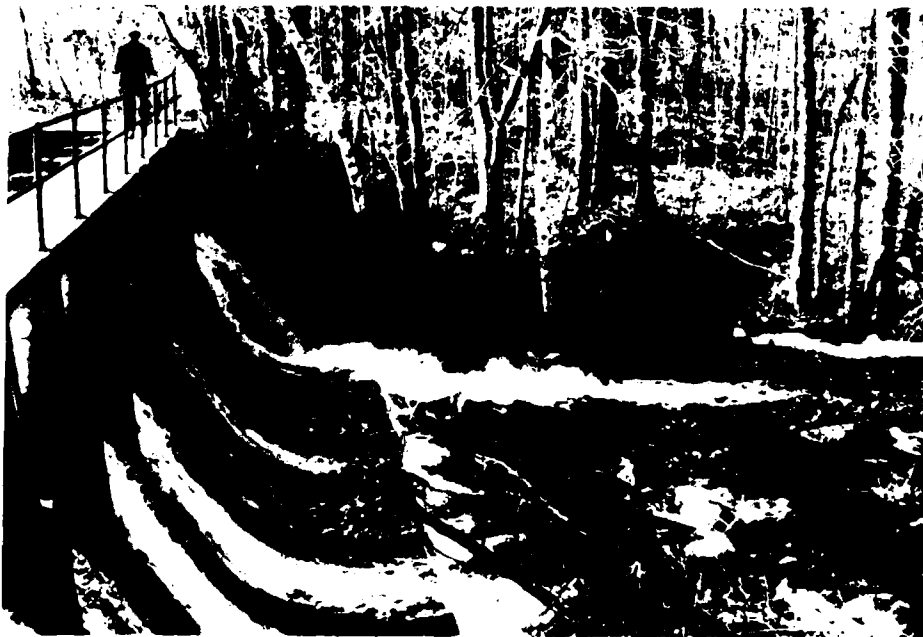
There was considerable seepage at the base of the old dry-laid stone wall located along the left side of the downstream channel, Photo No. 7. Seepage was also evident from 3 to 6 in. above the water level in the area left and downstream of the spillway left training wall, Photo No. 8. The water was clear. According to Mr. Franklin Alden, the seepage condition has been present for at least 20 years, although prior inspection reports, Appendix B, do not mention seepage.

7. Old stone masonry wall, left training wall and embankment, downstream

1. A detailed hydraulic/hydrologic investigation to determine the need and means for increasing the spillway capacity.
2. Perform an investigation to determine the nature of the observed seepage, its effect on the stability of the left embankment and possible means of providing cut-off. As part of this investigation, a small wooden weir, or some other means, should be installed to measure the quantity of seepage occurring in the area of the old dry-laid stone wall. Variations in seepage flow could then be correlated with rainfall, snowmelt and reservoir level.

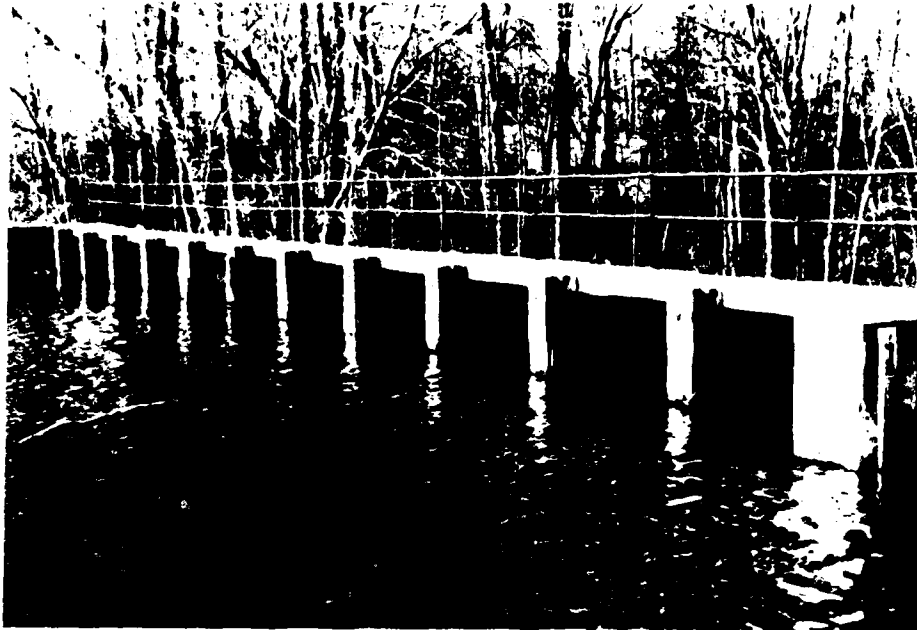
The condition of the individual stoplogs was obscured by the flow of water. However, the Dam Operator stated during the site examination that the stoplogs had been replaced on 22 April 1979. The wooden restraints forming the tracks in which the stoplogs are placed were deteriorated in the vicinity of the water line and did not appear to be in good condition, Photo No. 9. The support at the centerline of the spillway, located between bays 6 and 7, was partially rotted and damaged to such a degree as to place its serviceability in question.

9. Deteriorated stoplog supports along upstream side of spillway

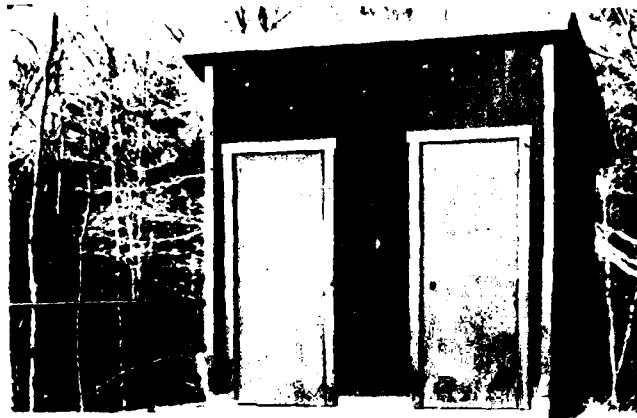
The gate lift mechanism, Photo No. 12, is enclosed by a wooden gate house which is also used to store spare stoplogs. Overall, the gate house was found to be in good condition as shown in Photo No. 13. However, the outlet works gate lift mechanism, when tried, could not be operated during the site examination. The Dam Operator reported that the gate was last opened sometime in 1972. The debris rack, originally located in front of the intake, has been removed at some unknown time.

13. Right headwall, gate house and outlet works intake, upstream
