NATIONAL PROGRAM FOR INSPECTION OF NON-FEDERAL DAMS  
ERROL DAM (NH 001811) (U) CORPS OF ENGINEERS WALTHAM MA  
NEW ENGLAND DIV MAY 79

ANDROSCOGGIN RIVER BASIN  
ERROL, NEW HAMPSHIRE

ERROL DAM  
NH 00161

PHASE I INSPECTION REPORT  
NATIONAL DAM INSPECTION PROGRAM

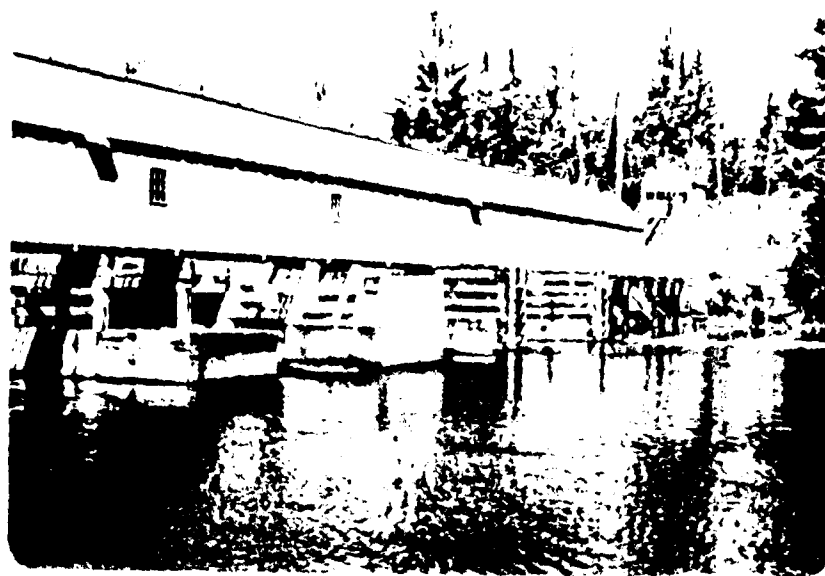
1. West half of dam on the upstream side.

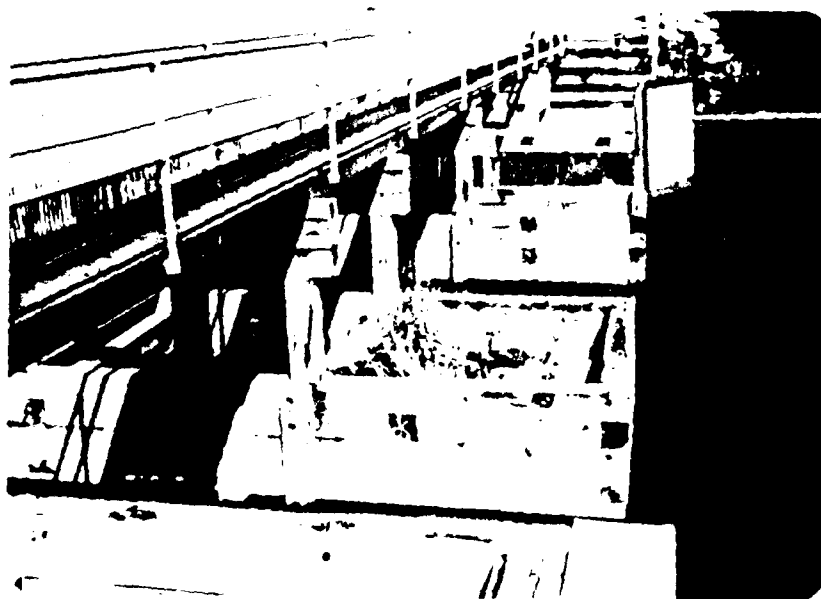
2. Concrete and wooden parts on the upstream side.
