MASSACHUSETTS COASTAL BASIN
COHASSET, MASSACHUSETTS

AARON RIVER DAM
MA 01280

PHASE I INSPECTION REPORT
NATIONAL DAM INSPECTION PROGRAM

SEPTEMBER 1980

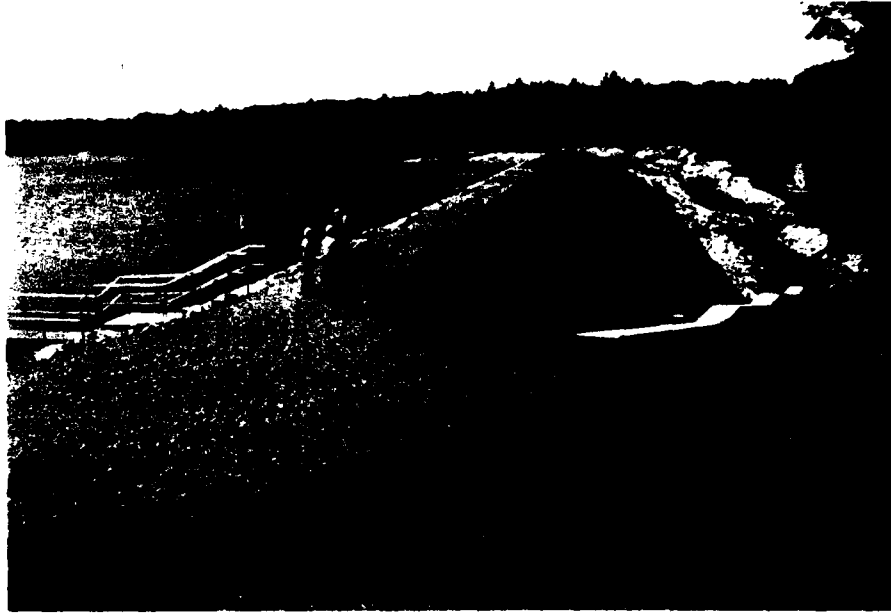
1. OVERVIEW OF DAM FROM RIGHT ABUTMENT.

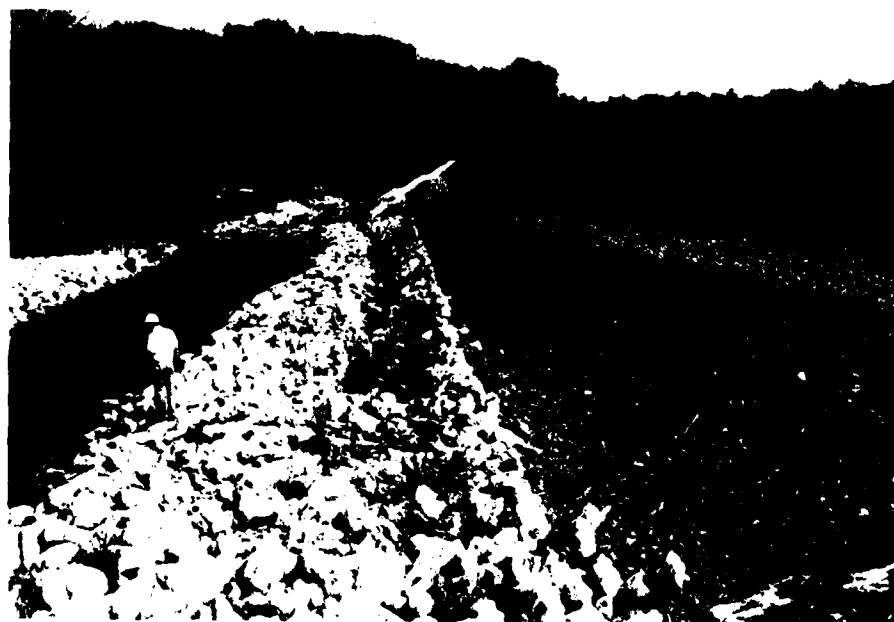
3. DOWNSTREAM FACE OF DAM LOOKING TOWARDS RIGHT ABUTMENT.

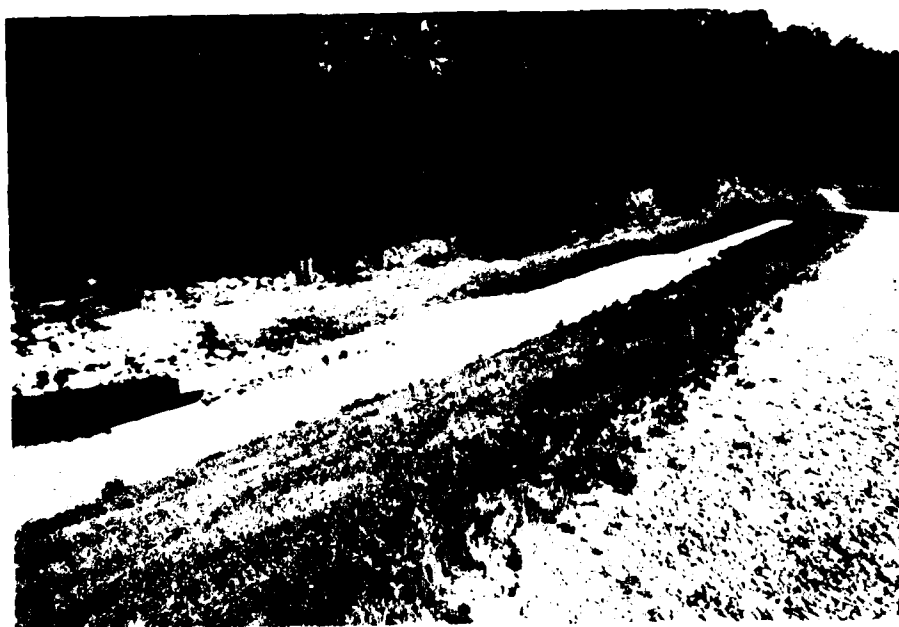
11. VIEW OF FISH LADDER FROM CREST OF DAM.

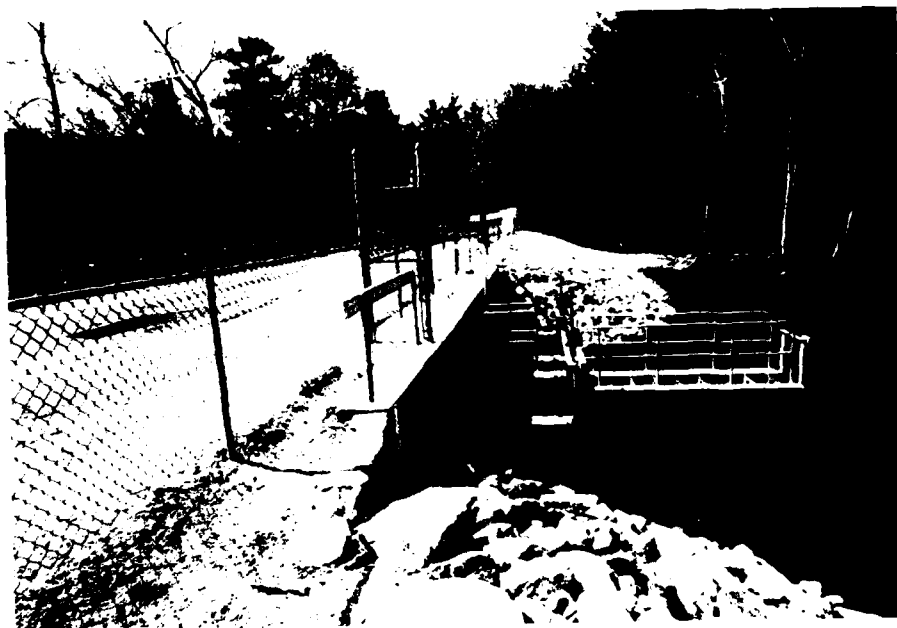
14. BOUND BROOK CONTROL STRUCTURE LOCATED AT BEECHWOOD STREET, APPROXIMATELY 1.2 MILES DOWNSTREAM OF THE DAM.
