MERRIMACK RIVER BASIN
NASHUA, NEW HAMPSHIRE

SUPPLY POND DAM

NH 00123

PHASE I INSPECTION REPORT
NATIONAL DAM INSPECTION PROGRAM

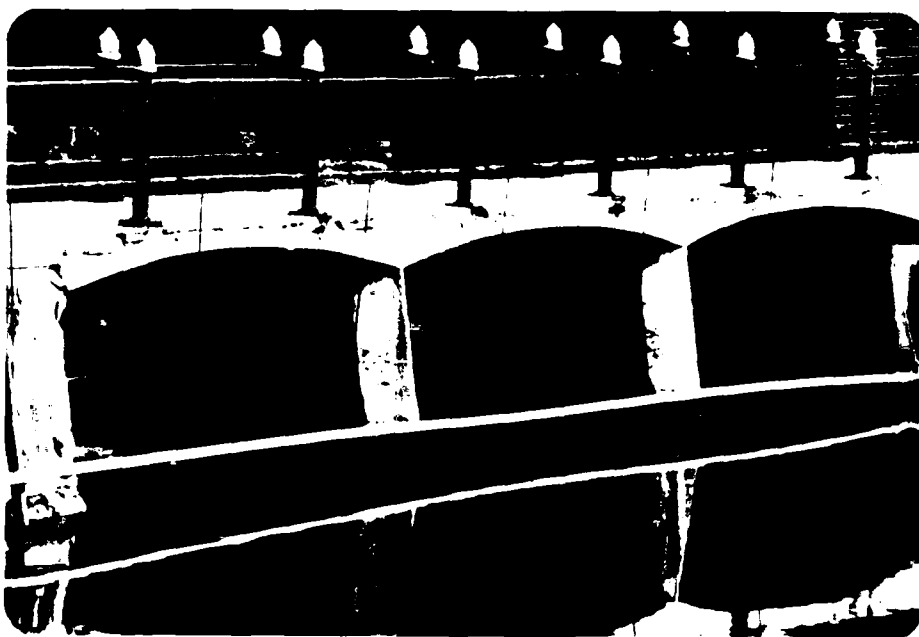
The three span service bridge structure deck exhibits minor surface spalling and a transverse crack. The spalling can be attributed to excessive surface trowelling of concrete and the random cracks can be attributed to expansion of the concrete deck. There is also considerable random surface cracking and efflorescence on the underside and at the fascias of this service bridge.

4. View of concrete deterioration on spillway
piers and service bridge
