CONNECTICUT RIVER BASIN
HANOVER, NEW HAMPSHIRE

HANOVER CENTER RESERVOIR DAM
NH 00051

PHASE I INSPECTION REPORT
NATIONAL DAM INSPECTION PROGRAM

APRIL 1979

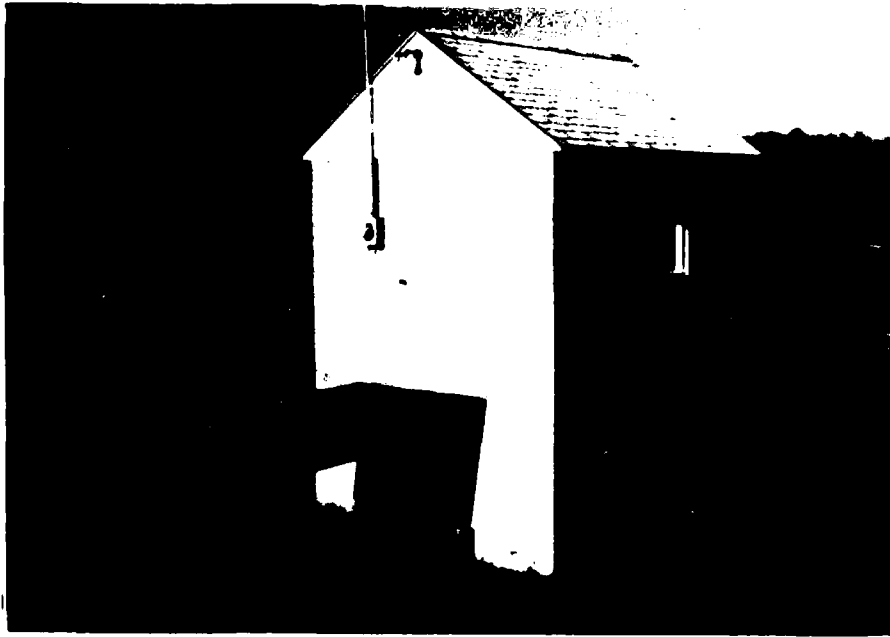
(2) Water Supply Valve Structure. A 10-foot square concrete structure that supports the valvehouse (See Appendix C - Figure 6) is located approximately 80 feet from the north end of the dam on the upstream face. The valves control flow into the Town of Hanover water supply system. The concrete structure was observed to be in good condition.

Figure 6 - Looking at gatehouse which contains valve for controlling discharge into water supply line and fish pond.
