LOCHMERE DAM

NH 00015

PHASE I INSPECTION REPORT
NATIONAL DAM INSPECTION PROGRAM

NOVEMBER 1978

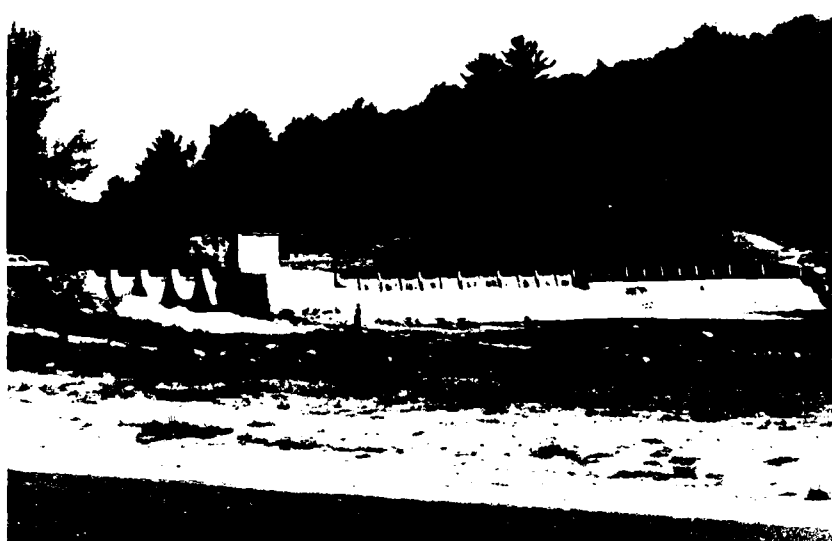
Overview from right side downstream

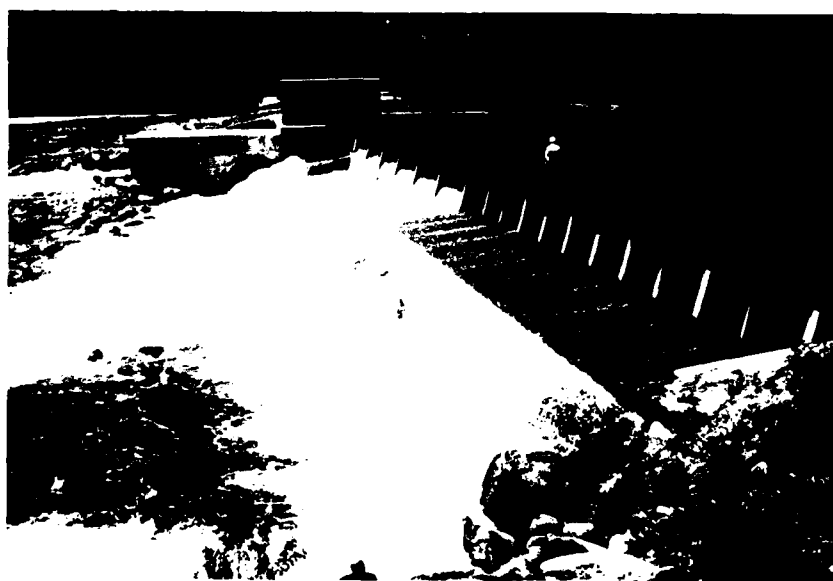
Overview from left abutment

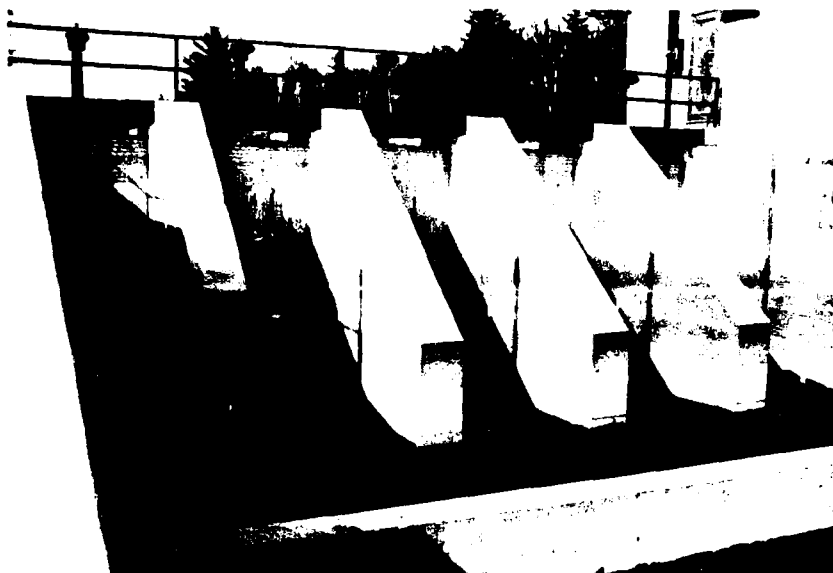
1. View from downstream of right side gate structure

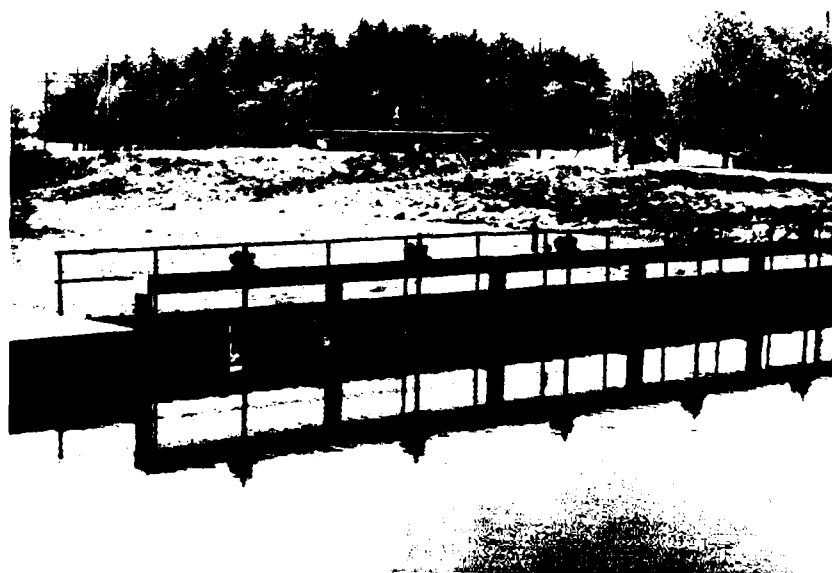
It was found that the hand crank with its keyway and the power drive shaft with its keyway were not compatible for hand crank operation. Thus, none of the gates at either structure were operated on a purely manual basis using the hand crank.

At the time of inspection, the structural supporting members and the operating gate mechanisms were in good condition. All gates were individually raised and lowered utilizing the portable electrical operator and all operated satisfactorily. None of the gates were operated utilizing the hand crank due to the incompatibility of the keyway on the hand crank and the keyway of the shaft on the bench stand.

2. View from upstream of operating mechanisms for left side waste gates

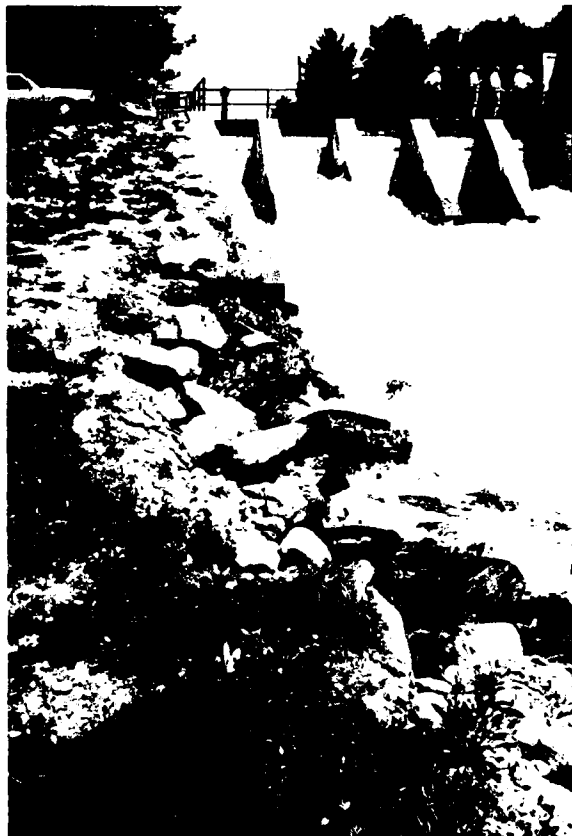
3. View from downstream of repairs to eroded area near toe of right side outlet channel
