MERRIMACK RIVER BASIN  
WEST WILTON, NEW HAMPSHIRE

WARD DAM

PHASE I INSPECTION REPORT  
NATIONAL DAM INSPECTION PROGRAM

DECEMBER 1980

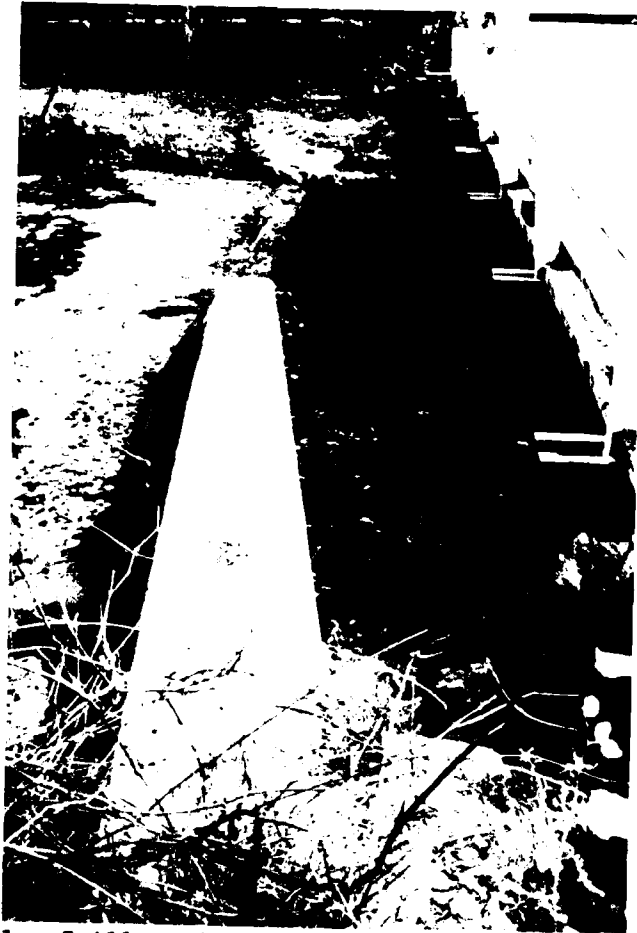
1. Spillway Crest From Right Abutement
