PISCATAQUA RIVER BASIN
WAKEFIELD, NEW HAMPSHIRE

GREAT EAST LAKE DAM

NH 00111

PHASE I INSPECTION REPORT NATIONAL DAM INSPECTION PROGRAM

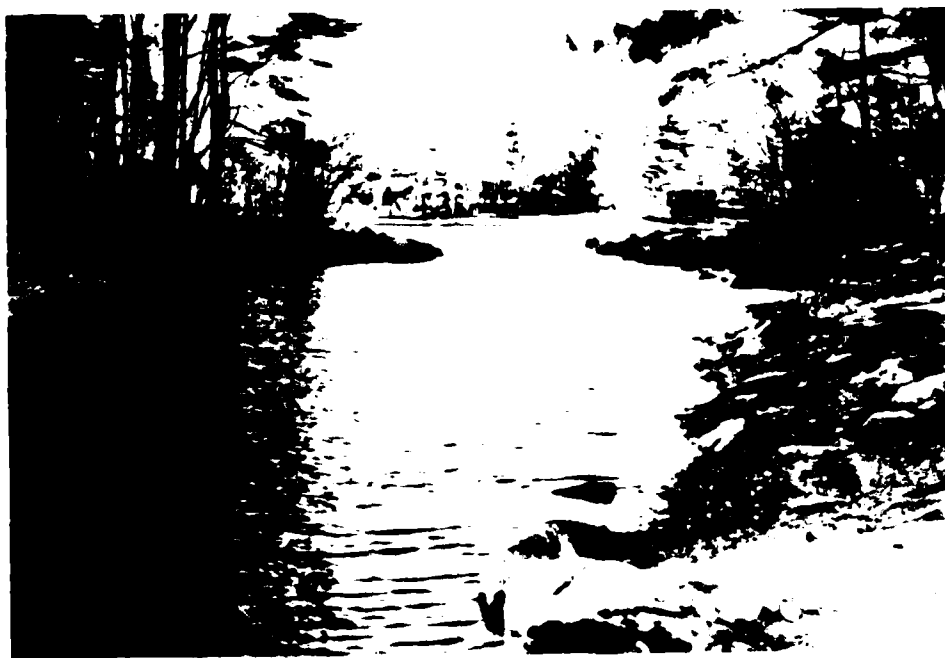
PHOTO NO. 1 - View of approach channel and reservoir.

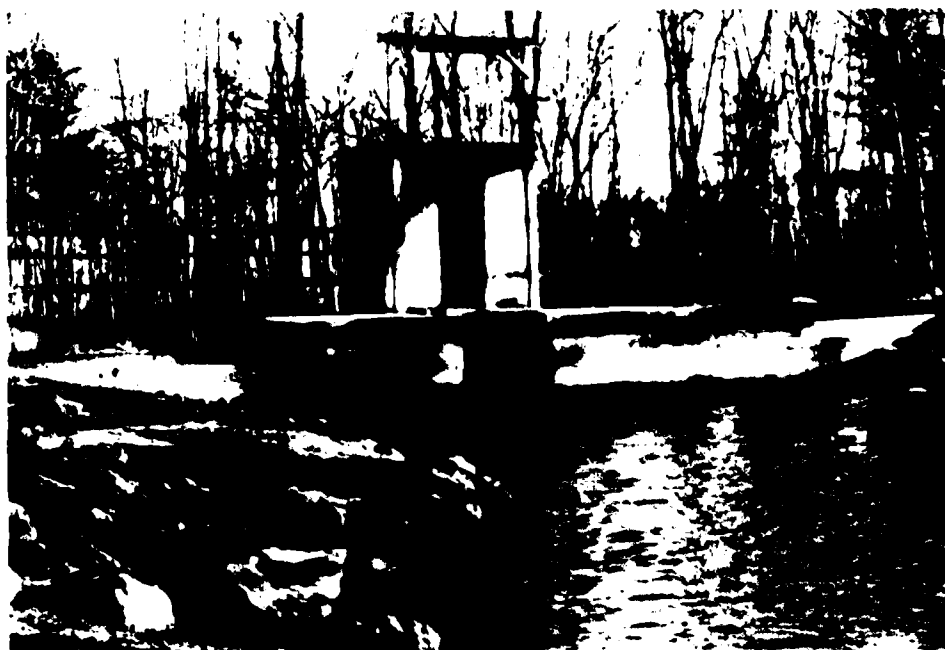
The spillway structure consists of two 20-foot wide, flat slab sections, with one on either side of the outlet works structure. Each spillway slab has flash boards installed on the upstream face, as shown in Photos 2, and 3. The concrete spillway slabs were placed over a dry-masonry foundation and, in some areas, were probably founded on bedrock. The concrete surface of the spillway structure is in good condition.

PHOTO NO. 2 - View of approach channel and upstream side of dam.

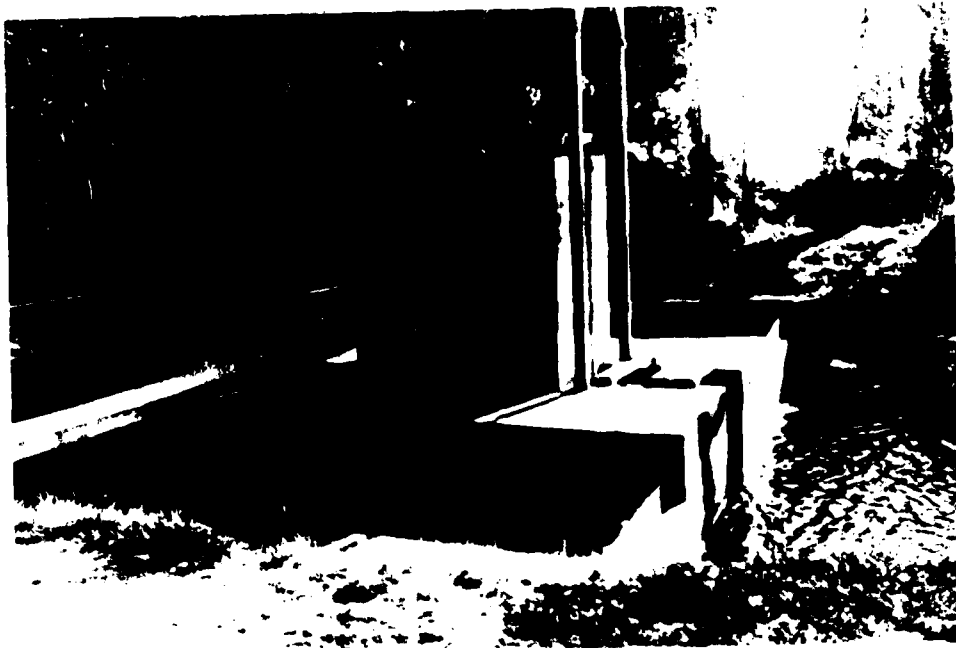
The service deck over the left spillway section and outlet works consists of a concrete deck, tube railing and concrete supports. The deck and the supports are in very good condition as shown in Photo 4.

PHOTO NO. 4 - View of dam from left abutment (upstream side).

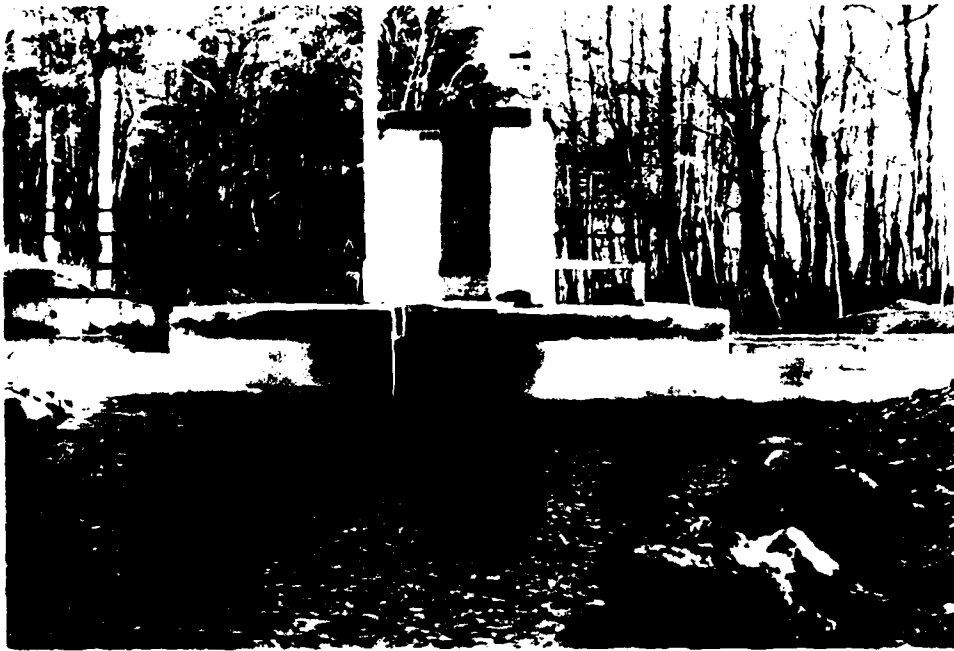
PHOTO NO. 5 - View of upstream side of the dam.

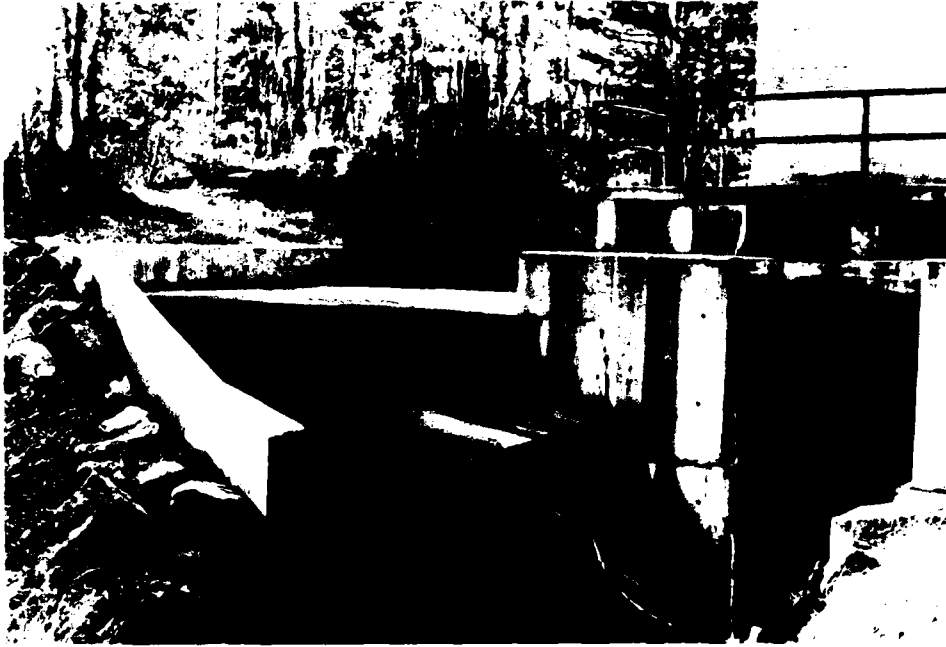
PHOTO NO. 7 - View of right section of spillway.

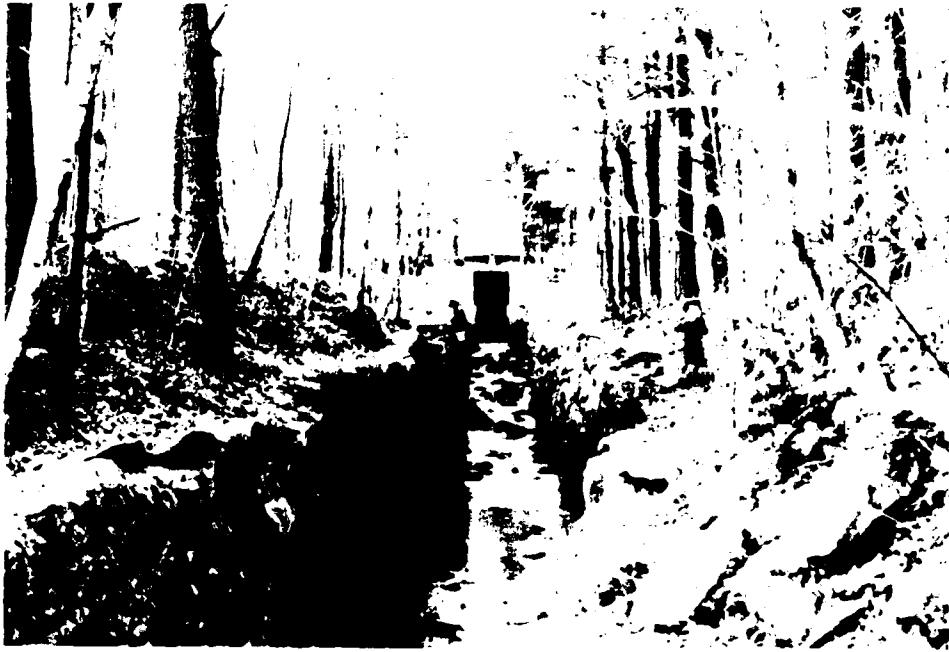
The vertical, dry-masonry walls on the sides of the discharge channel, which have bulged locally and deviate slightly from a straight alignment, will continue to deteriorate with time. They should be inspected periodically and be repaired, as needed, as part of the routine maintenance program.

Minor bulging and misalignment of the vertical, dry-masonry walls on the sides of the discharge channel downstream of the dam indicate that the stability of those walls is deteriorating with time, and that they will need to be repaired from time to time as part of the routine maintenance program.

PHOTO NO. 11 - View of discharge channel, looking upstream.

(a) Inspect the condition of the vertical, dry-masonry walls on the sides of the discharge channel from the dam to Canal Road at least once a year and make repairs when needed.

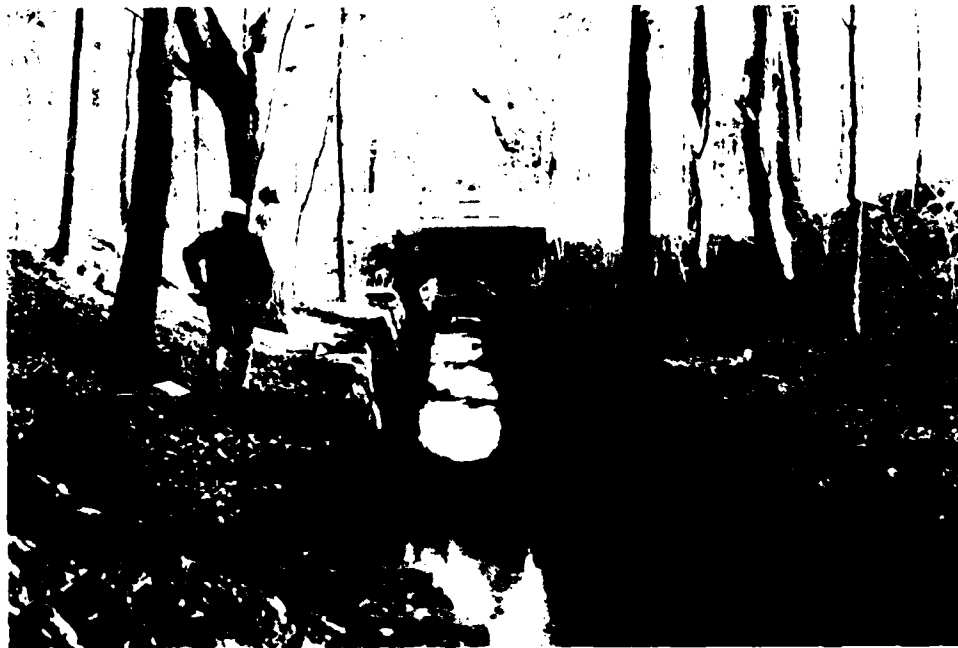
PHOTO NO. 12 - View of discharge channel,
looking downstream.

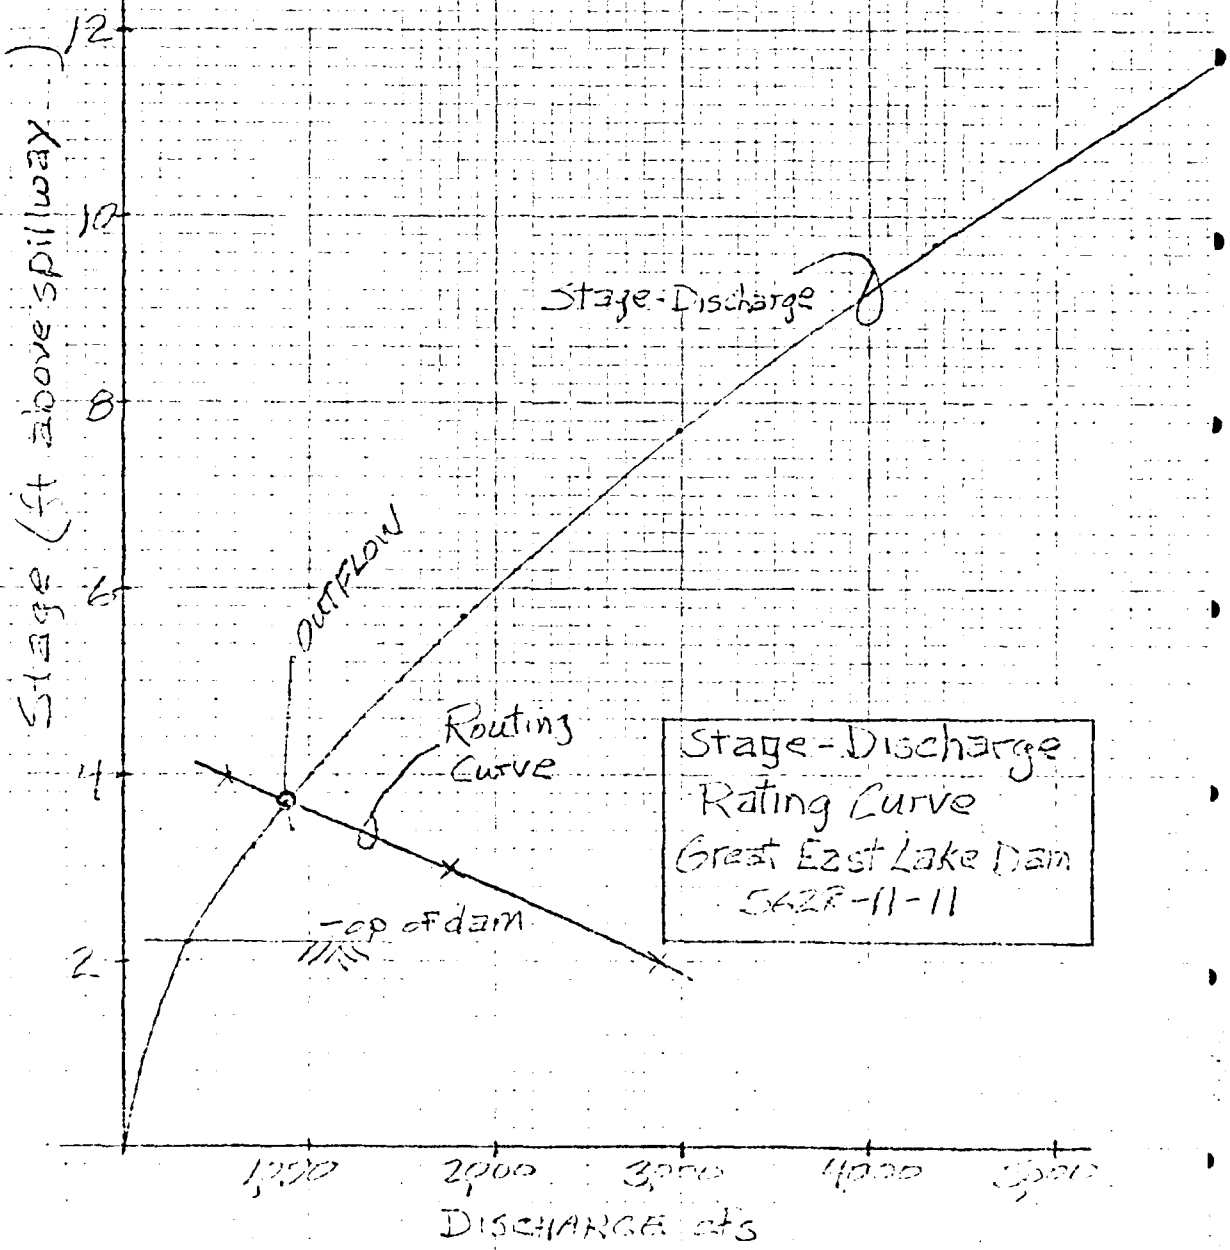
Stage-Discharge
 Rating Curve
 Great East Lake Dam
 5628-11-11

1. Reservoir Storage will reduce the SDF at the outlet from 5200 cfs to 900 cfs or by 83%.
2. The spillway and storage capacity can safely pass 39% of the test flood.
3. At the test discharge of 900 cfs the dam crest will be overtopped by 1.5 ft.

It is recommended that the owner engage a qualified engineer to evaluate further the potential for overtopping and the inadequacy of the spillway.
