MERRIMACK RIVER
BENNINGTON, NEW HAMPSHIRE

MONADNOCK POWER STATION DAM
NH 00249

PHASE I INSPECTION REPORT
NATIONAL DAM INSPECTION PROGRAM

FEBRUARY 1979

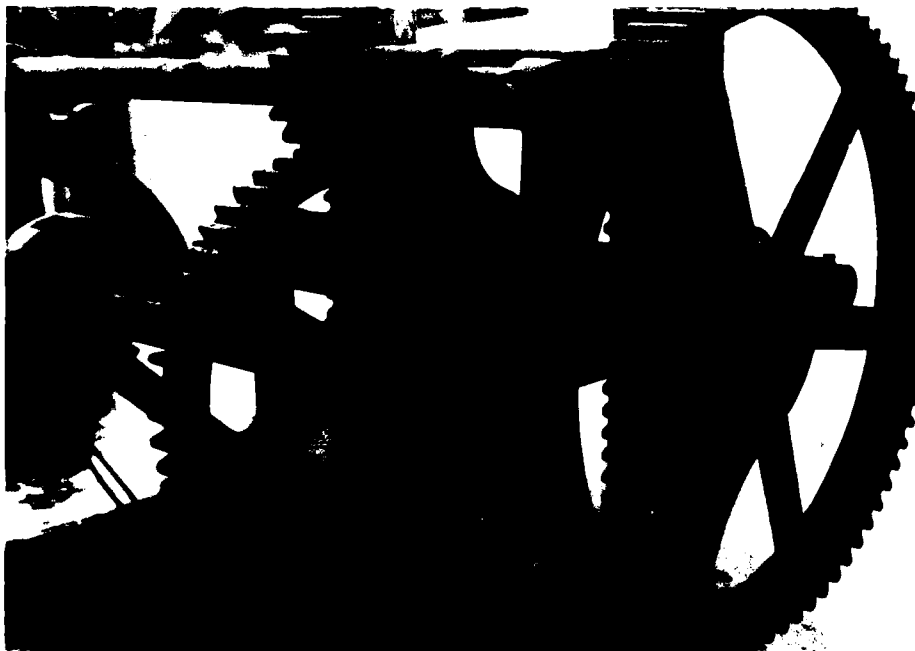
c. Appurtenant Structures. The dam gate structure is located on the upstream face of the powerhouse and is constructed integral with the powerhouse. (See Appendix C - Figure 5.) The exposed portions of the concrete gate structure have several areas of spalling and deterioration. (See Appendix C - Figure 6.) The leading edge of the concrete deck has spalled and the concrete has eroded exposing the reinforcing steel. Efflorescence was also observed on the upstream vertical face of the gate structure. The visible portion of the wooden gates and manual gate operating mechanism were observed to be in good condition. One hand crank was broken. (See Appendix C - Figure 7.)

Figure 7 - Looking at the broken hand wheel operating mechanism.
