MERRIMACK RIVER BASIN
BENNINGTON, NEW HAMPSHIRE

PAPER MILL DAM
NH 00251

PHASE I INSPECTION REPORT
NATIONAL DAM INSPECTION PROGRAM

FEBRUARY 1979

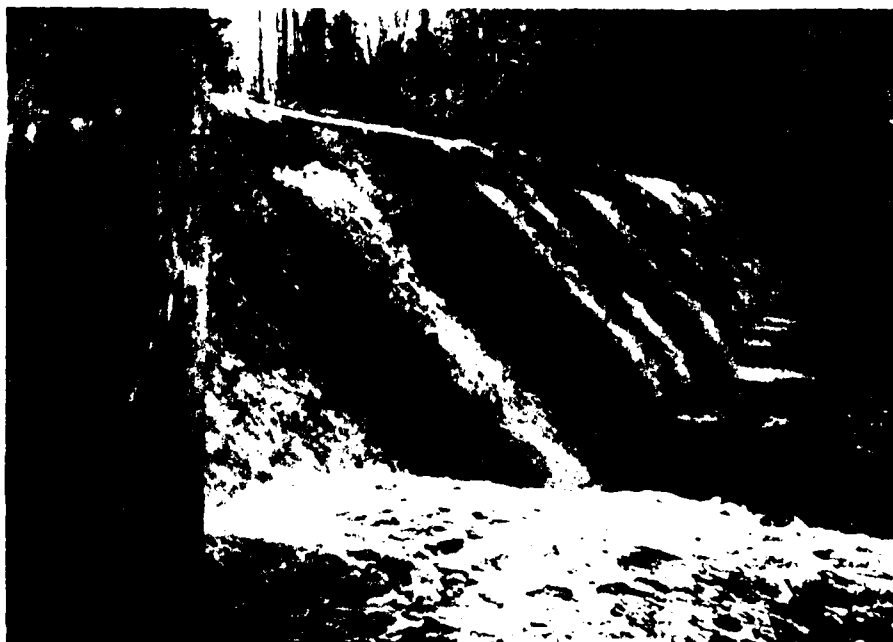
Figure 2 - Looking south along the upstream face of the spillway. Note the erosion at the crest.

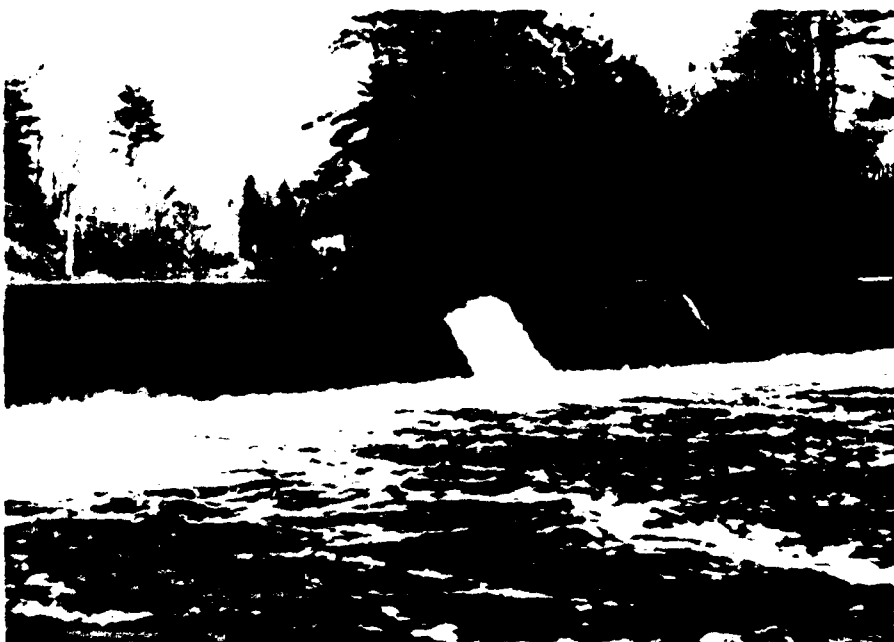
On a return visit to the dam on April 19, 1979 it was observed that a piece of the dam crest (approximately 2 cubic feet) had apparently spalled away near the center of the dam. The depression caused by the spalling is reflected in the water surface passing over the crest. (See Appendix C - Figure 15.)

Figure 15 - View of the eroded section of the dam crest.
