MERRIMACK RIVER BASIN
BRISTOL, NEW HAMPSHIRE

INTERNATIONAL PACKINGS CORPORATION
UPPER DAM
NH-00315

PHASE I INSPECTION REPORT
NATIONAL DAM INSPECTION PROGRAM

APRIL 1979

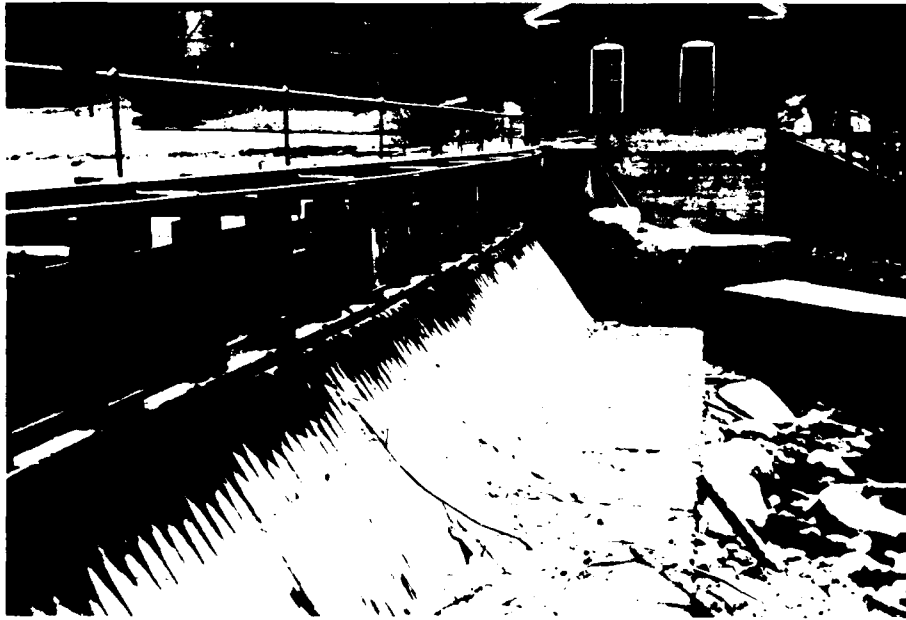
1

- (e) The timber deck and the downstream face of the spillway were found to be in poor condition (see photograph 1). Many of the planks are broken and badly worn. The downstream cribwork has lost a substantial amount of its stone fill, particularly near the east end. Most of the timber crib members appear to be in reasonably good condition, although some cracked logs were noted (see photograph 2).

- (f) The stop log support columns, steel support beam and cable appear to be in good condition (see photograph 1). It was noted, however, that the support beam is bowed about 6 to 8 inches downstream.

VIEW OF SPILLWAY STRUCTURE SHOWING CONDITION OF TAIL
APRON; POWER HOUSE IN BACKGROUND

- (1) Repair spalled concrete throughout the structure.
- (2) Refill the cribwork with stone where loss has occurred.
- (3) Replace deteriorated timber, particularly the deteriorated planking and plywood on both the upstream and downstream faces of the structure.
- (4) Curtail the leakage that is taking place through the ceiling of the powerhouse tailrace.
- (5) Cut trees and brush on embankment sections of the dam and remove root systems and rehabilitate embankment.
- (6) Repair eroded portions of the discharge channel below the controlled outlet and the embankment upstream of that structure.
- (7) Repair areas of localized settlement between the masonry walls along the easterly embankment and monitor this area for any future settlement.
- (8) Repair or replace stop log lift hooks as needed.

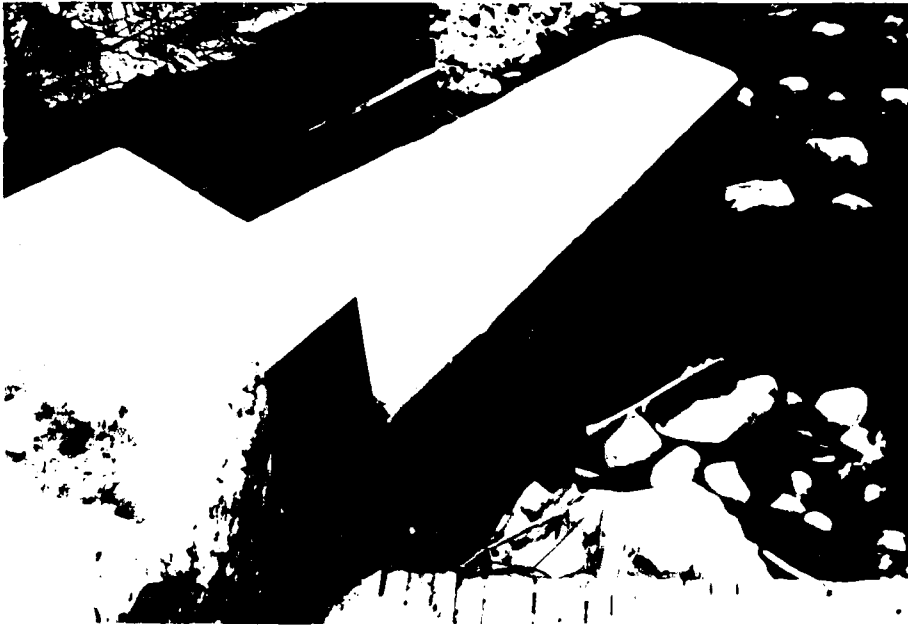
3

- (d) The wingwall between the spillway and the tailrace has settled and a crack has developed near the upstream end (see photograph 3). Undermining of the downstream end appears to be the cause of this distress.

CONCRETE WING WALL ADJACENT TO TAIL RACE; NOTE
CRACKING

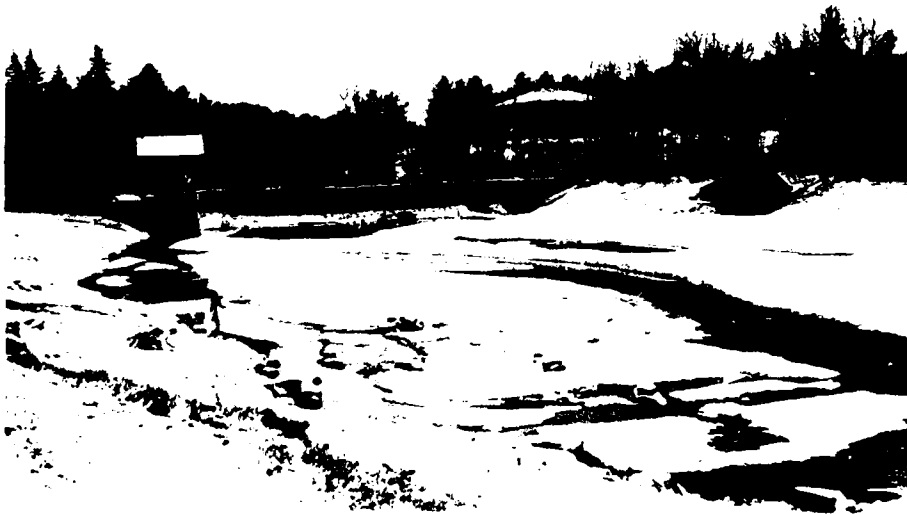
6

VIEW OF UPSTREAM FACE OF DAM. INLET TO CONTROL
OUTLET STRUCTURE IS AT RIGHT.

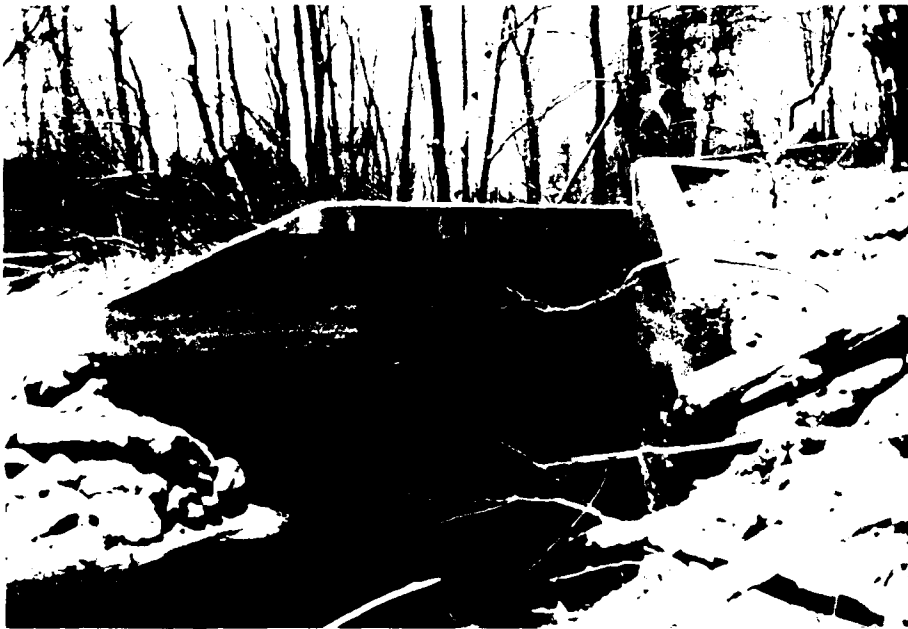
A controlled outlet with stop log bays is located in the westerly embankment of the dam (see photographs 6, 7 and 8). This discharges to an earth channel below the embankment. This structure is in fair condition, but the hoisting equipment for the stop logs is deteriorated and unusable so that the stop logs must be manually removed. Severe deterioration of the concrete on the outlet side of the structure was observed.

INLET TO CONTROL OUTLET STRUCTURE

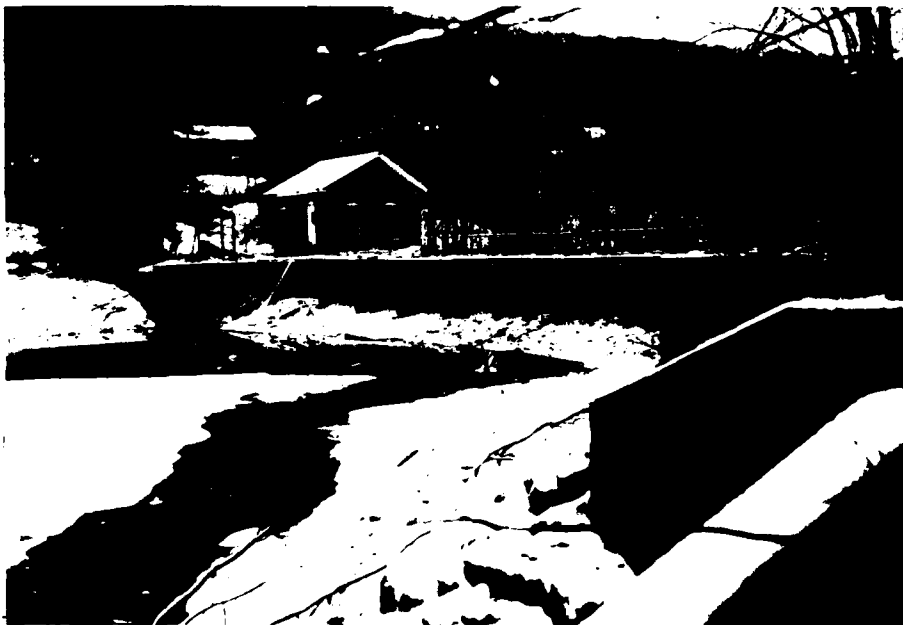
10

of freeboard was noted between the top of the stop logs and the embankment sections (see photograph 10). Evidence of overtopping of the embankment was observed.

VIEW OF UPSTREAM FACE OF DAM FROM CONTROL OUTLET.
HIGHWAY CAN BE SEEN IN BACKGROUND AT LEFT; NOTE
LACK OF FREEBOARD OVER TOP OF DAM.

It is recommended that further evaluation of the underseepage and limited freeboard be made by qualified engineers, and that recommendations for mitigation of these conditions be formulated and implemented. It is also recommended that a qualified engineer evaluate the possibility of modifying the existing spillway to allow for automatic release of stop logs if overtopping of the dam occurred.

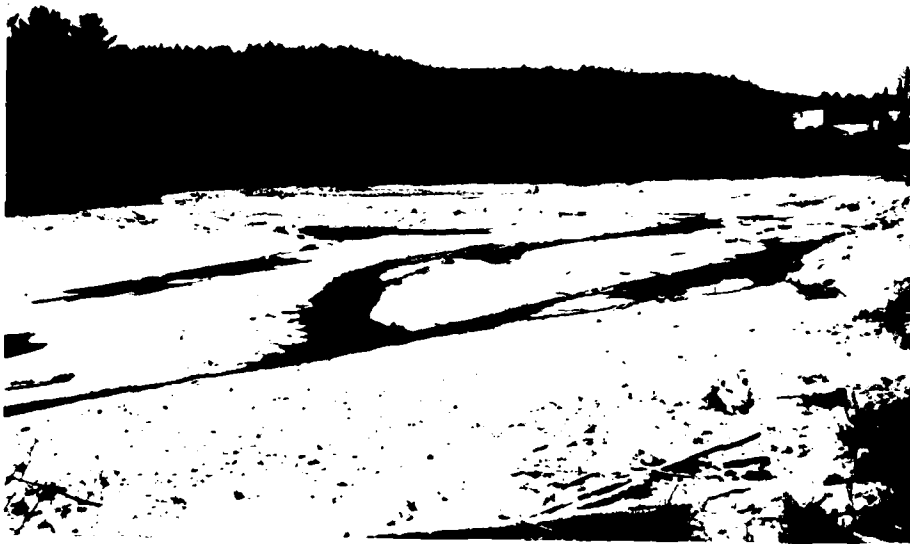
11

VIEW UPSTREAM FROM NEAR POWER HOUSE; RESERVOIR IS AT
LOW WATER DUE TO CONTROL OF FLOW FROM NEWFOUND LAKE
