HEAD WORKS DAM -
OSSIPPEE LAKE
NH 00328

BERRY BAY DAM -
OSSIPPEE LAKE
NH 00329

PHASE I INSPECTION REPORT
NATIONAL DAM INSPECTION PROGRAM

NOVEMBER 1978

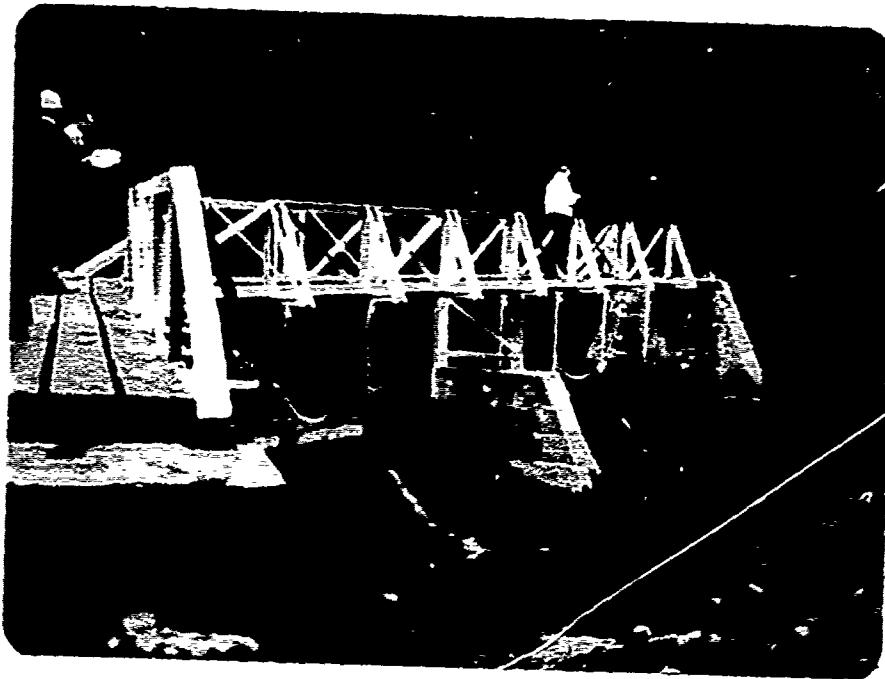
Berry Bay Dam - Overview from right abutment

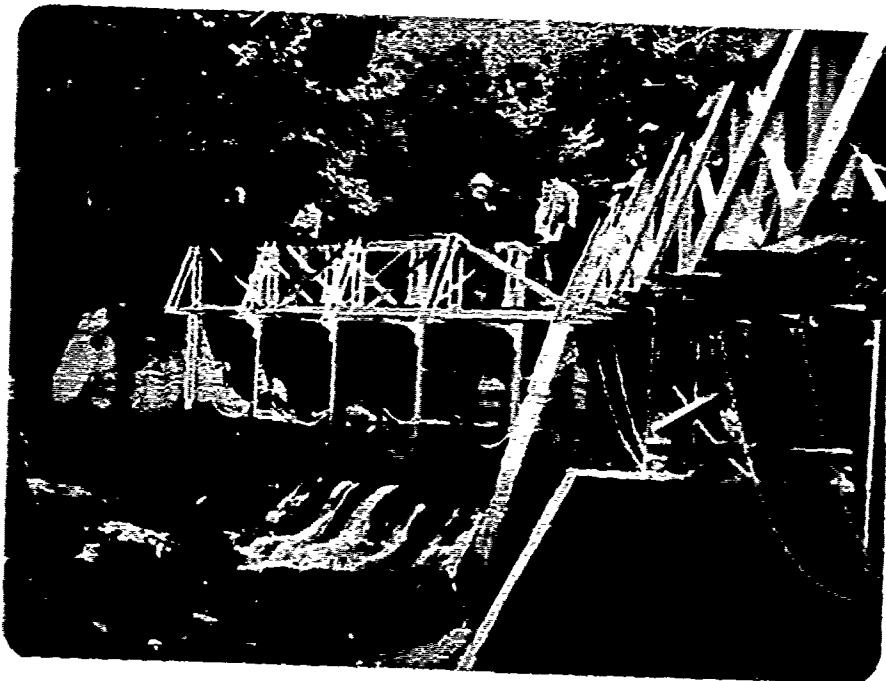
Berry Bay Dam - Overview from left abutment

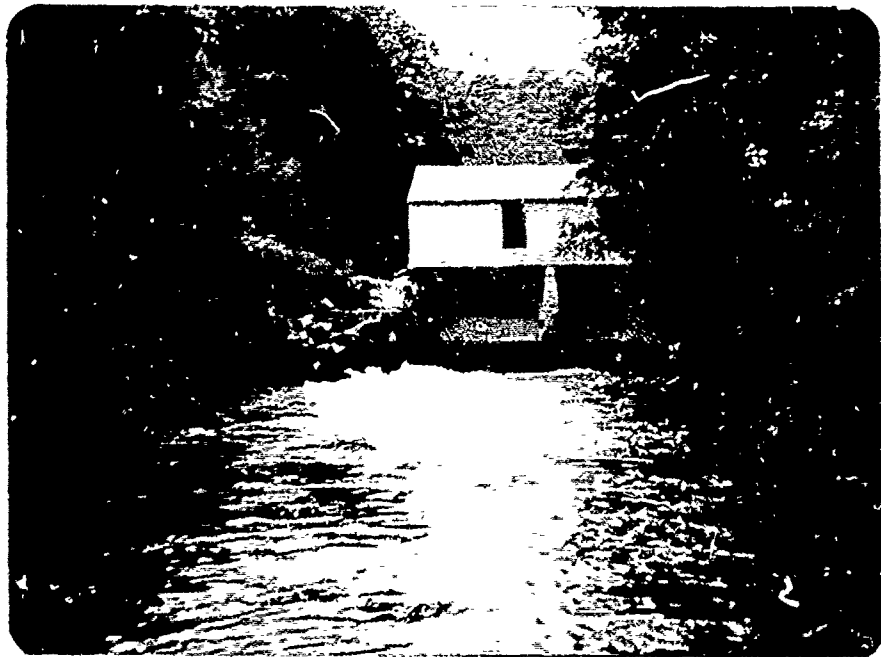
Head Works Dam - Overview from
downstream
