CONNECTICUT RIVER BASIN
SPRINGFIELD, NEW HAMPSHIRE

BOG BROOK DAM

PHASE I INSPECTION REPORT
NATIONAL DAM INSPECTION PROGRAM

JULY 1980

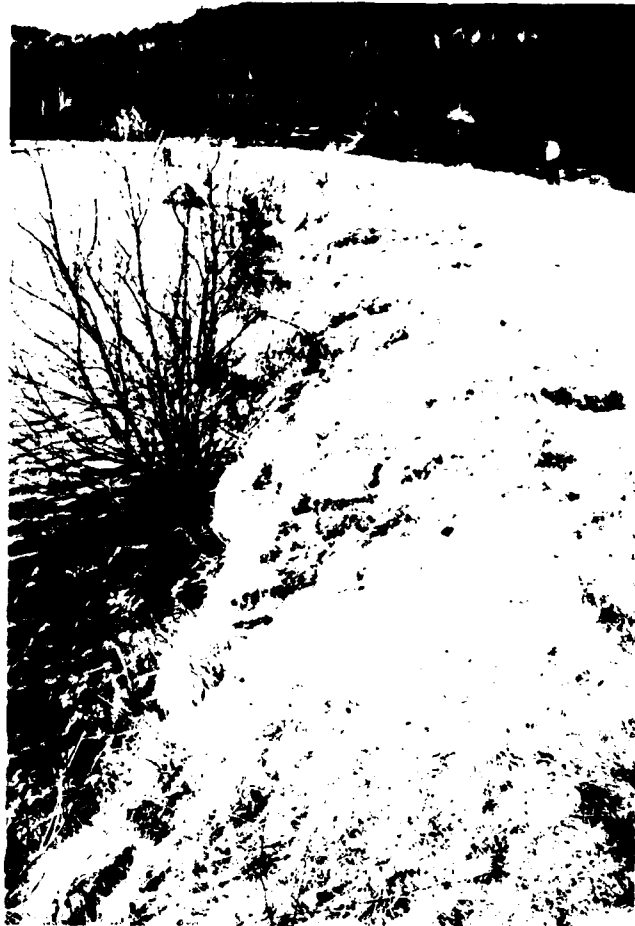
1. View of Upstream Slope Showing Sloughing and Brush Growth

It is recommended that the services of a qualified registered professional engineer be retained to investigate the condition of the upstream slope and make recommendations for the regrading of the slope and the placement of slope protection such as riprap. The owner should implement the findings of the engineering study.

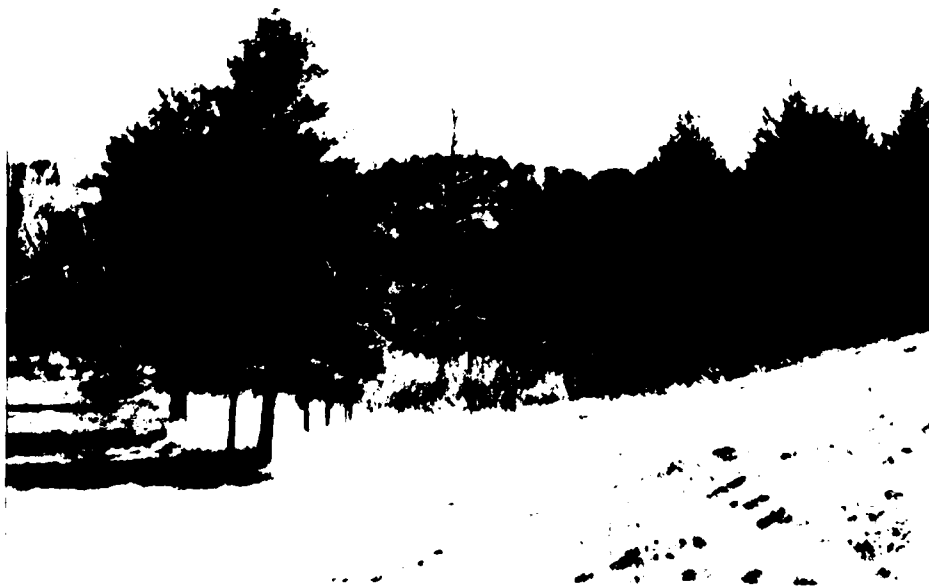
2. View of Downstream Slope Showing Wet Area at Right Toe

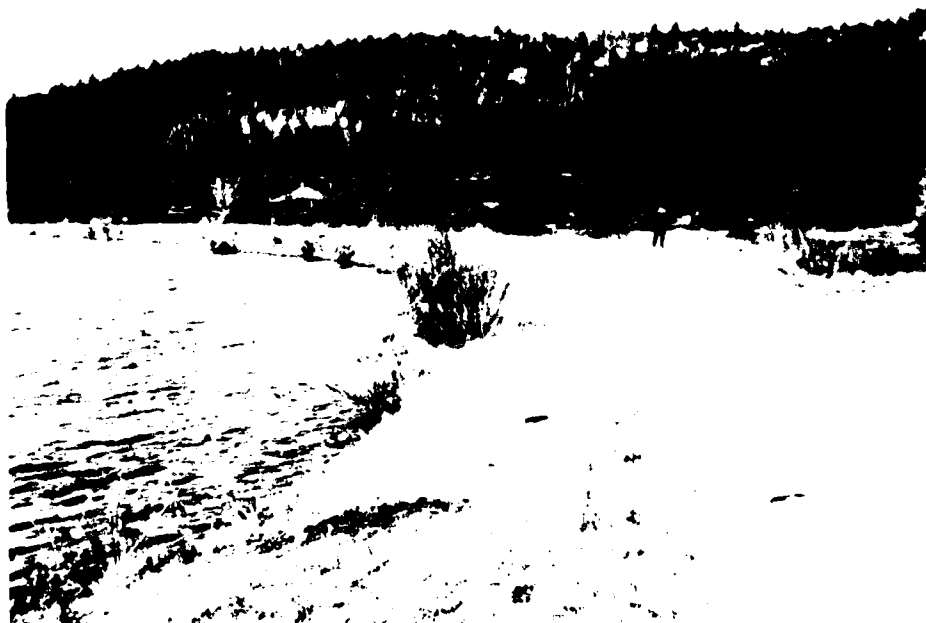
4. View from Right Abutment Showing Emergency Spillway channel

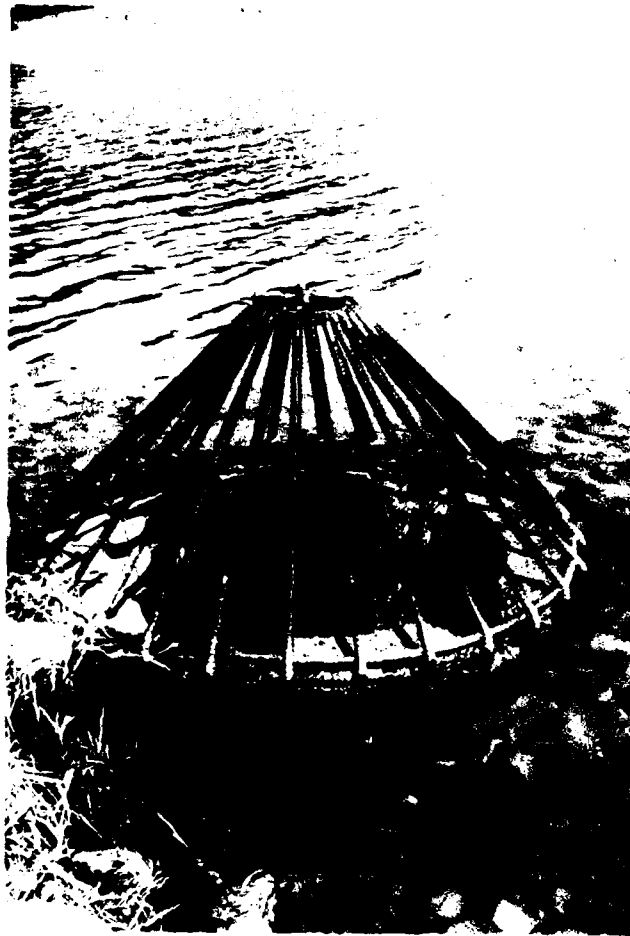
7. Principal Spillway Inlet

The spillway structure appears to be in good condition. The trash rack is clear of debris. The rim of the inlet has three slots, measuring approximately 6 inches deep, cut into it. These show signs of erosion.
