WHITE'S POND DAM

NH 00106

PHASE I INSPECTION REPORT
NATIONAL DAM INSPECTION PROGRAM

AUGUST 1978

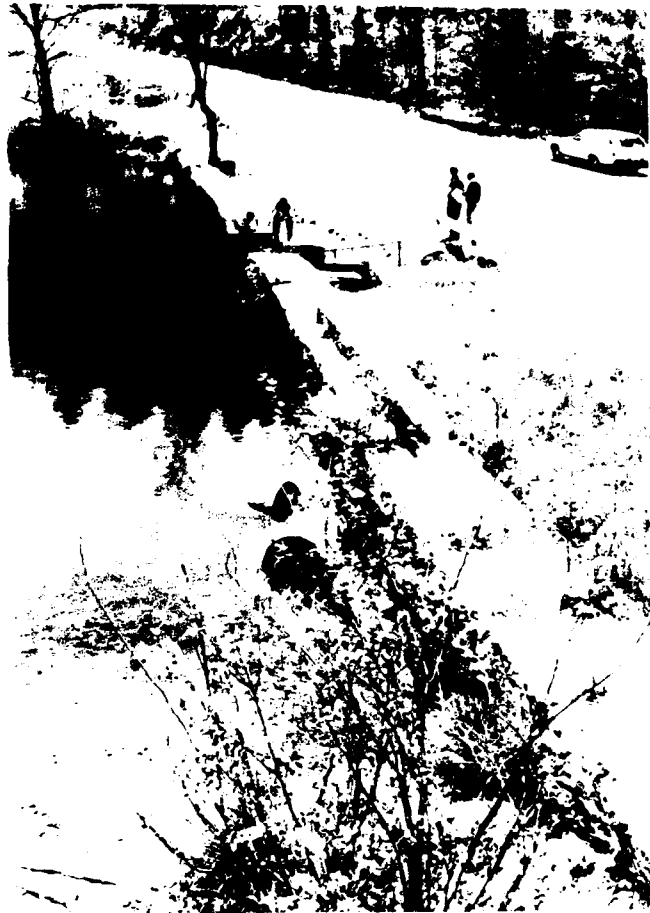
Overview from right abutment

The double courses of granite, with capstone, which form the dam proper were somewhat unequal in alignment, consistent with early construction techniques (Fig. 3 and Overview Photos). However, displacement pond-ward is evident probably caused by former trees, since removed. One tree, a probable contributor to the movement, still remains. Since the outlet of the dam is located opposite the sag point of Rt. 107 with no controlled drainage, storm runoffs flow towards the flume section and the outlet headwall. This condition has caused surface scour adjacent to the flume walls (Photo 1) and undermining and loss of ground at the northeast wing wall.

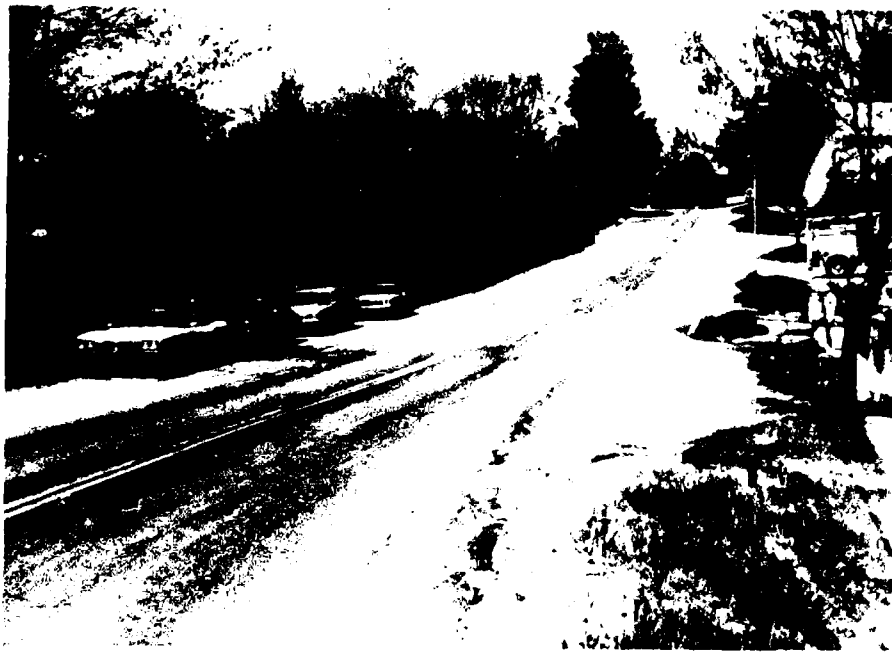
Overview from left abutment

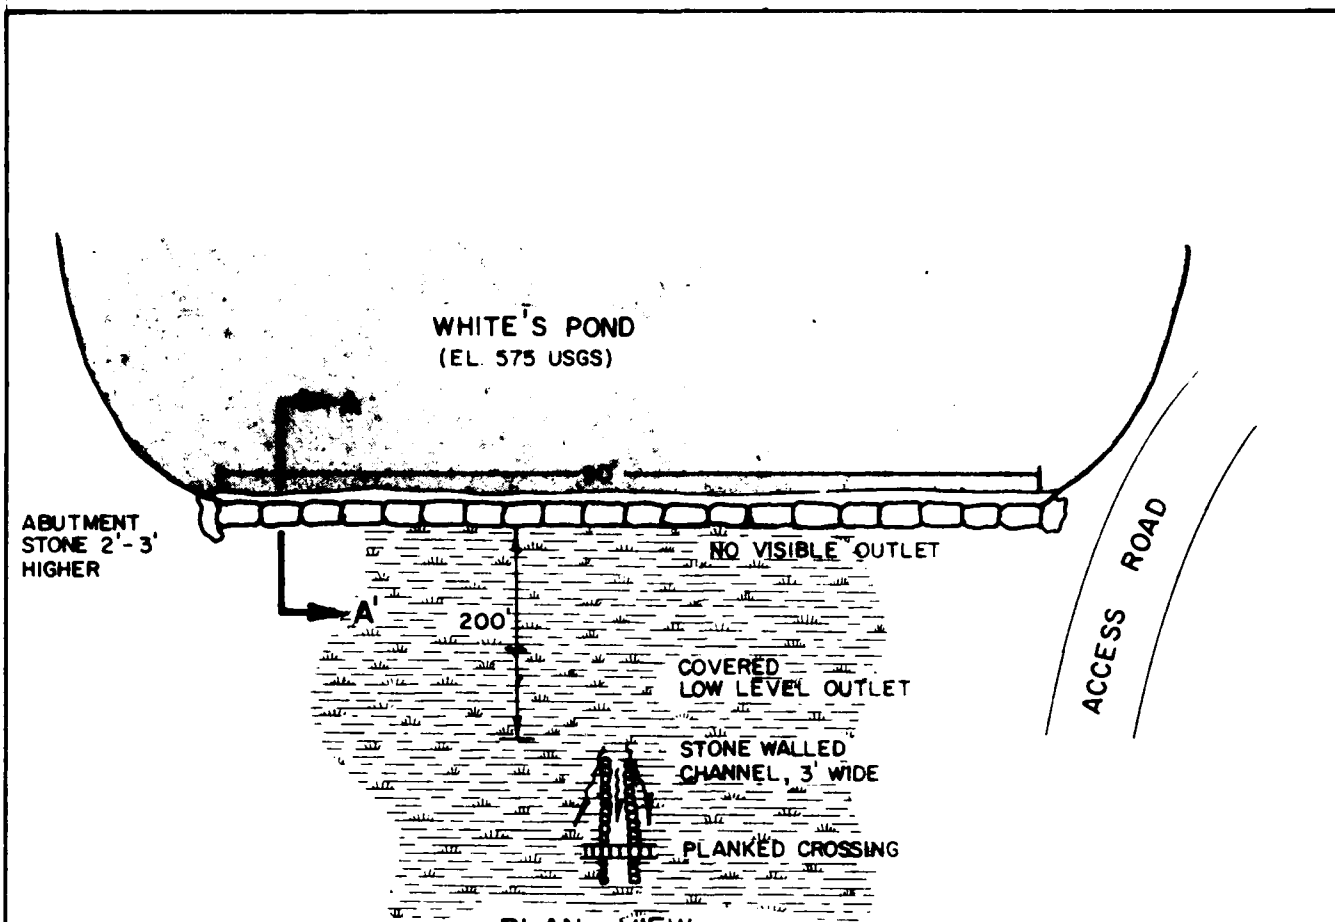
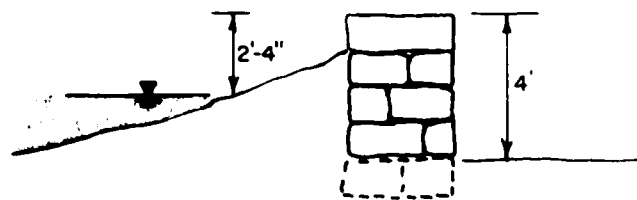
The 90 foot long, 4 foot high closure structure on the northside of the pond is, as is the dam proper, constructed of double-wall granite blocks with capstone (Figure 6). It has recently been remortared in several locations, and is in fair condition.
