MERRIMACK RIVER BASIN  
WOODSTOCK, NEW HAMPSHIRE

MIRROR LAKE DAM  
N.H. 00317

PHASE I INSPECTION REPORT  
NATIONAL DAM INSPECTION PROGRAM

AUGUST 1980

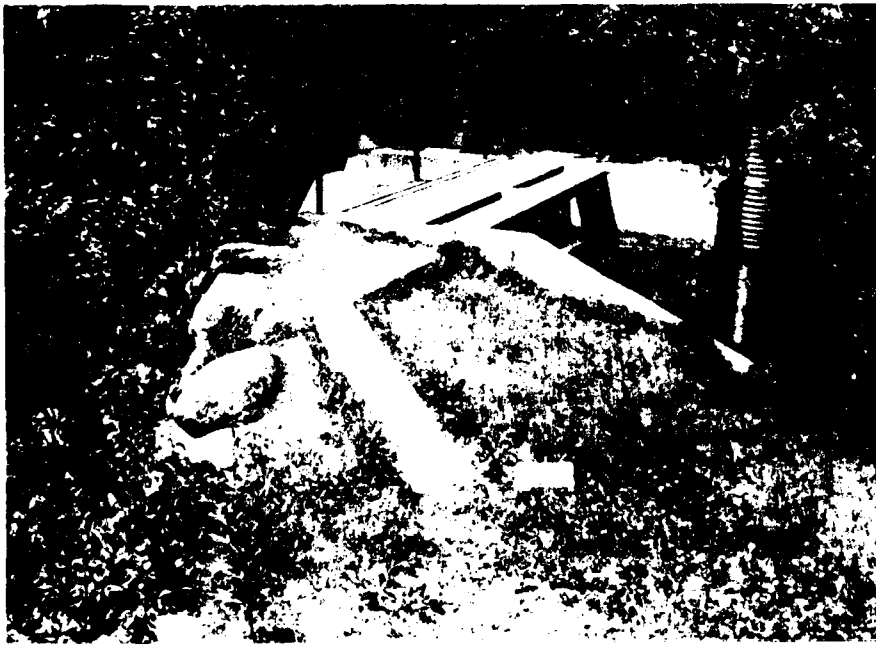
Photo 10 - View from the east earth embankment looking west at the concrete spillway structure housing 2 stoplog spillway bays. Note concrete core-wall.

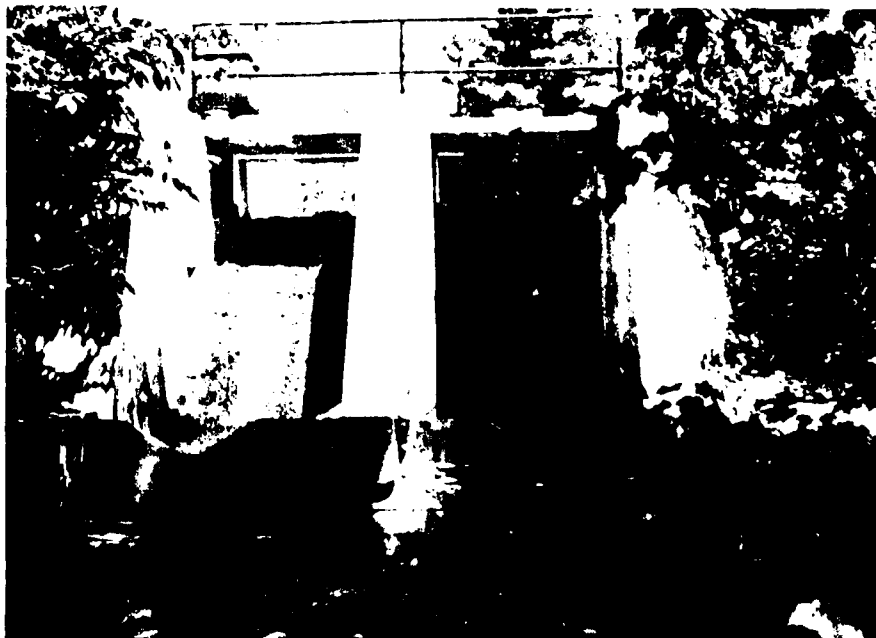
The bays are separated by a 1.5-foot-wide concrete buttress and are covered by an 11.5'W x 5'L concrete walkway. (See Appendix C - Photo 11.) The general condition of the concrete throughout the entire spillway structure was observed to be good. No spalling, cracks, or unusual seepage was apparent. The only rust that was observed was on the embedded concrete sections and on the surface of the V-notch metal plate weirs. (See Appendix C - Photos 11 and 12.)

Photo 11 - View of the 2 concrete stoplog spillway bays from the downstream channel.

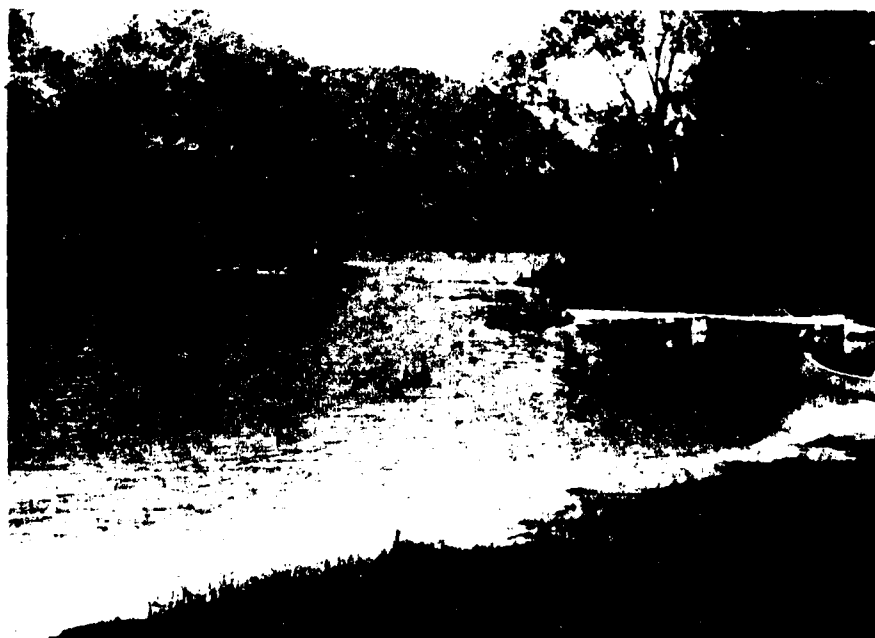
Some erosion has occurred on the upstream slope near the west embankment where there is no vegetation, apparently due to trespassing. Near the east embankment the upstream slope consists of a sandy beach, bare of vegetation, where canoes are beached. On the crest of the dam is a footpath which is bare of vegetation. Erosion caused by overflowing water resulting from rainfall or overtopping of the dam could cause the dam to breach if adequate erosion protection is not provided.

July 9, 1980  
 Photo 13 - View of upstream channel from east earth embankment. Note canoe beaching area in foreground and channel constriction in background.
