MERRIMACK RIVER BASIN  
WILTON, NEW HAMPSHIRE

SOUHEGAN RIVER WATERSHED  
DAM NO. 10A

PHASE I INSPECTION REPORT  
NATIONAL DAM INSPECTION PROGRAM

AUGUST 1979

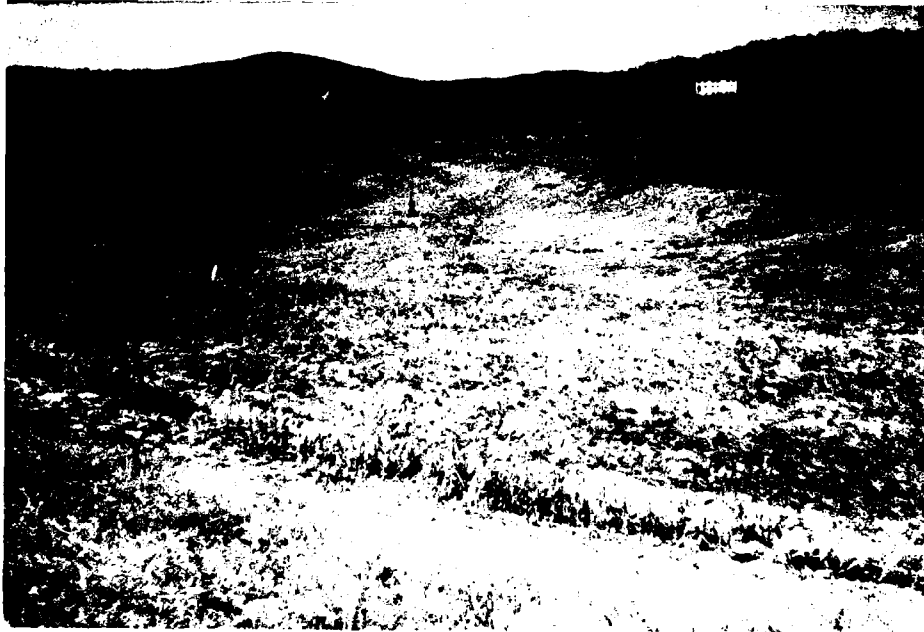
Overview from right abutment

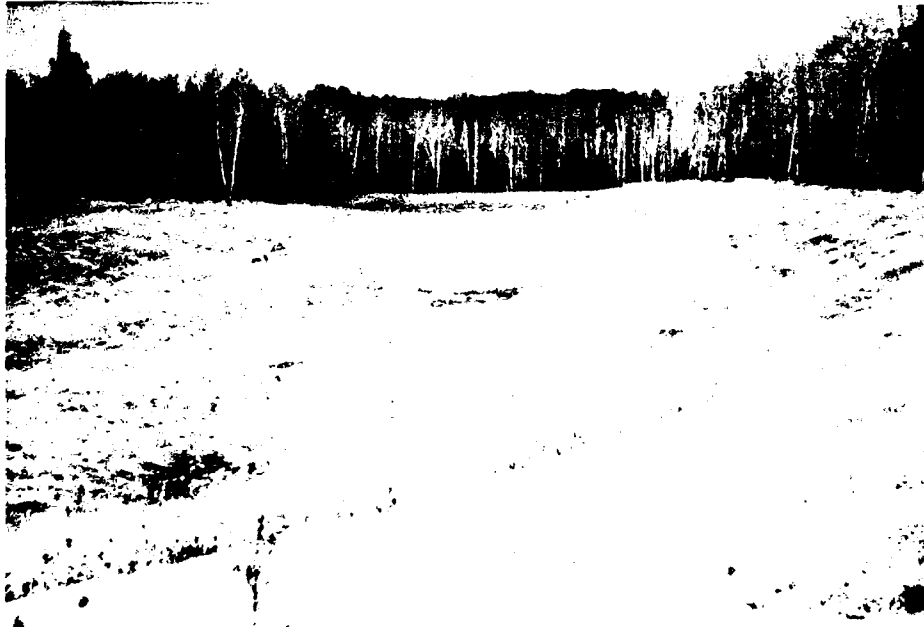
The emergency spillways are in good condition. There are wet spots in the channel but these are caused by natural groundwater or ponded runoff.

2. View of right emergency spillway channel  
looking downstream

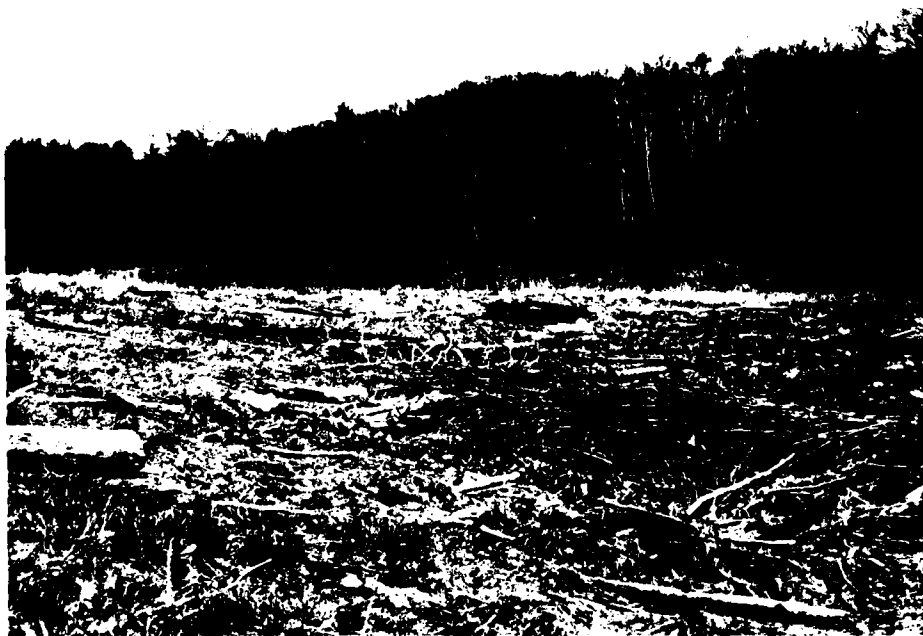
Some debris was found on the upstream slope of the embankment and tire ruts 4 to 6 inches deep in the crest of the embankment.

4. View of right upstream slope showing debris on the approach to the right emergency spillway

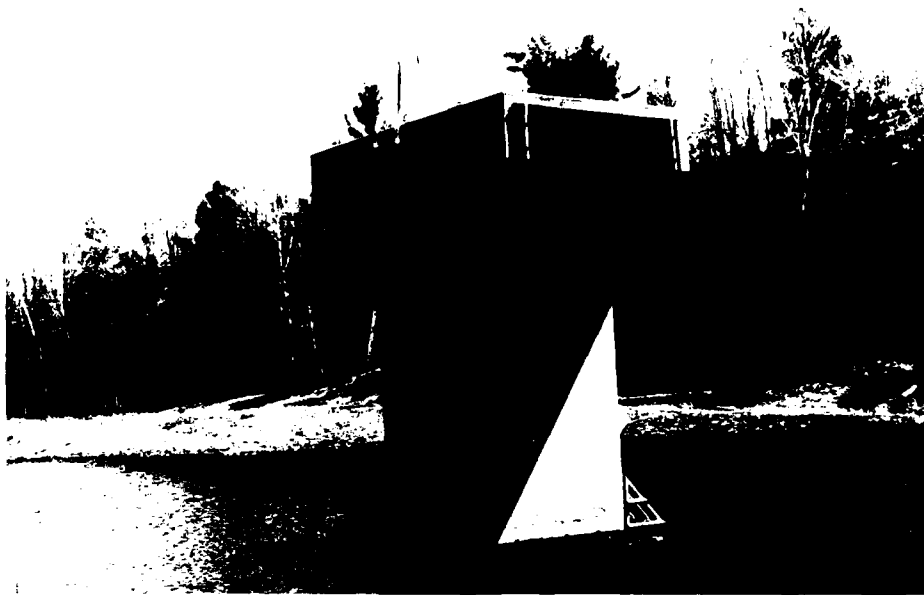
This structure was observed from the embankment since access to the structure was not possible. The exterior service ladder could not be reached at normal pool elevation (see photos).

The sluice gate bench stand is in good condition. The hand wheel has been removed from the site to prevent unauthorized use. The low stage trash racks are in good condition. The high stage trash racks show minor corrosion of the end hardware supporting the racks.

5. View of drop inlet structure showing ladder and high stage trash racks

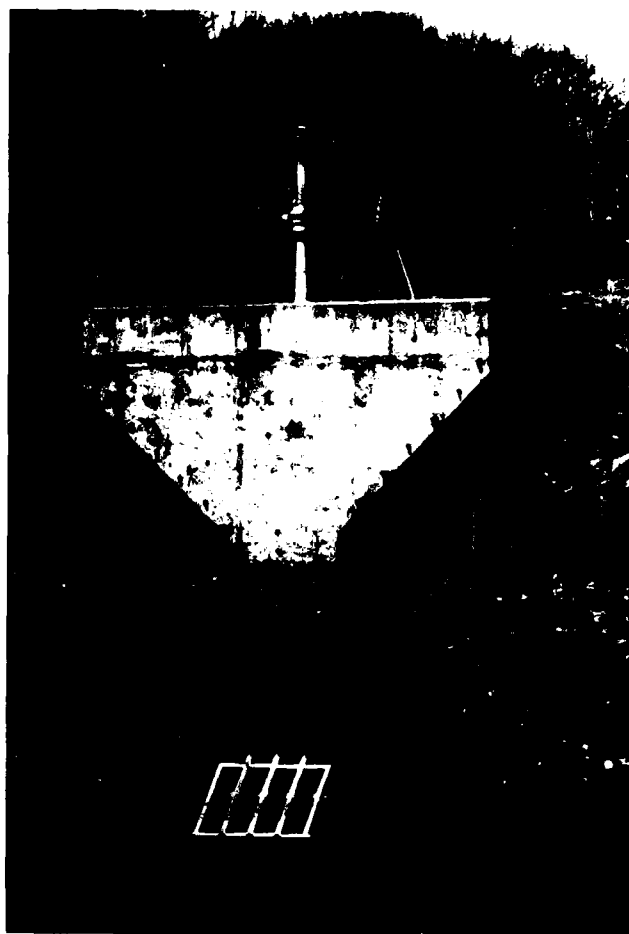
6. View of drop inlet structure showing low stage trash racks
