NATIONAL PROGRAM FOR INSPECTION OF NON-FEDERAL DAMS  
SOUHEGAN RIVER WATERS. (U) CORPS OF ENGINEERS WALTHAM  
MA NEW ENGLAND DIV AUG 79

REPORT DOCUMENTATION PAGE		READ INSTRUCTIONS BEFORE COMPLETING FORM
1. REPORT NUMBER NH 00263	2. GOVT ACCESSION NO.	3. RECIPIENT'S CATALOG NUMBER
4. TITLE (and Subtitle) Souhegan River Watershed Dam No. 15 NATIONAL PROGRAM FOR INSPECTION OF NON-FEDERAL DAMS		5. TYPE OF REPORT & PERIOD COVERED INSPECTION REPORT

Inclosed is a copy of the Souhegan River Watershed Dam No. 15 Phase I Inspection Report, which was prepared under the National Program for Inspection of Non-Federal Dams. This report is presented for your use and is based upon a visual inspection, a review of the past performance and a brief hydrological study of the dam. A brief assessment is included at the beginning of the report. I have approved the report and support the findings and recommendations described in Section 7 and ask that you keep me informed of the actions taken to implement them. This follow-up action is a vitally important part of this program.

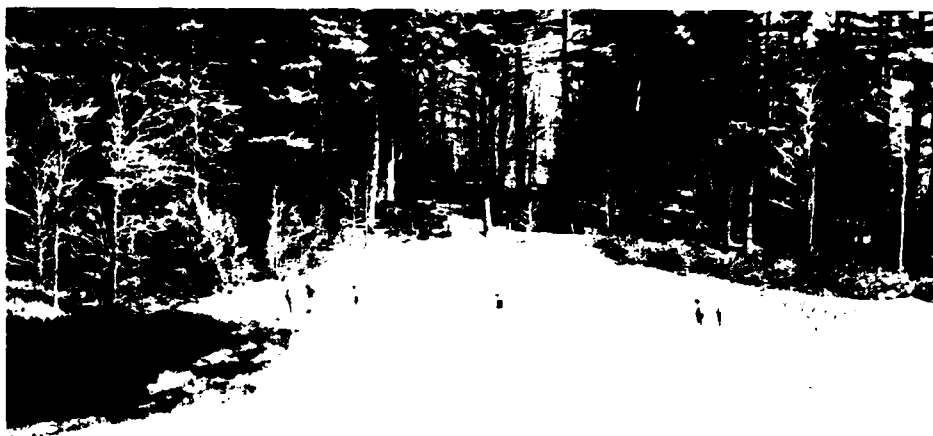
Overview from right abutment

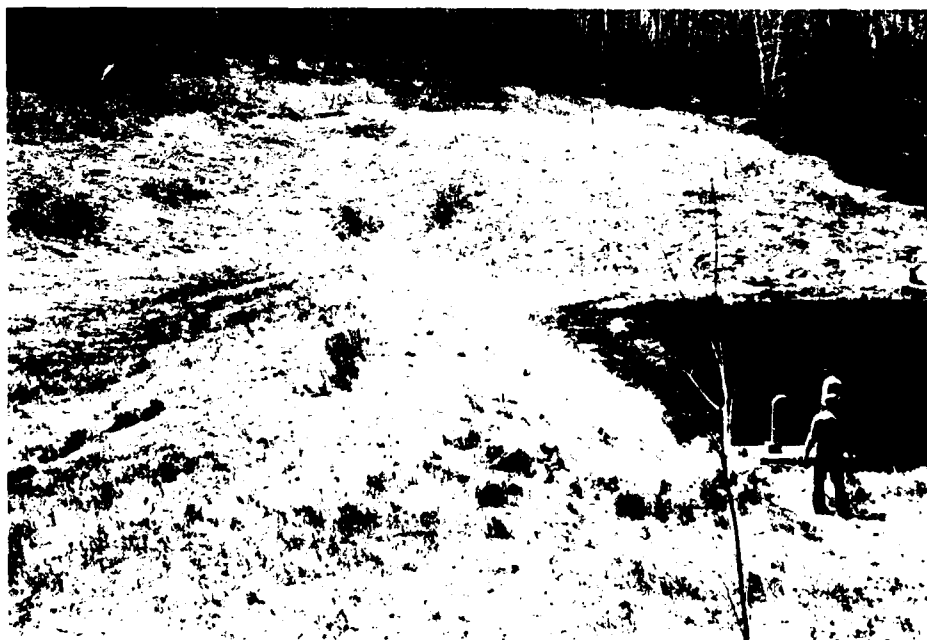
Overview from left abutment

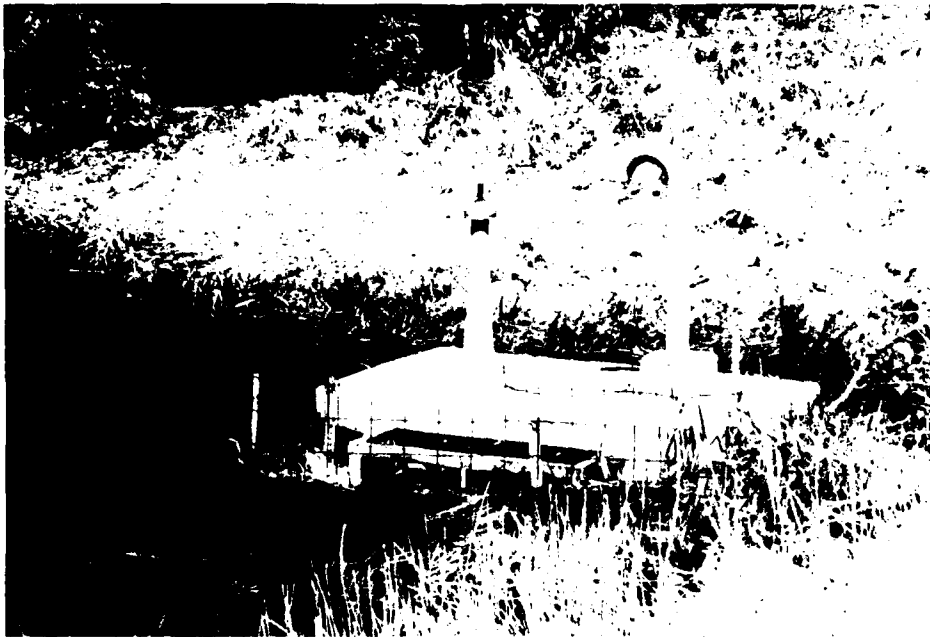
The structure is in good condition with no evidence of spalling, cracking, or efflorescence. The sluice gate bench stand is in good condition. The hand wheel has been removed from the site to prevent unauthorized use.

1. View of drop inlet structure from right downstream side

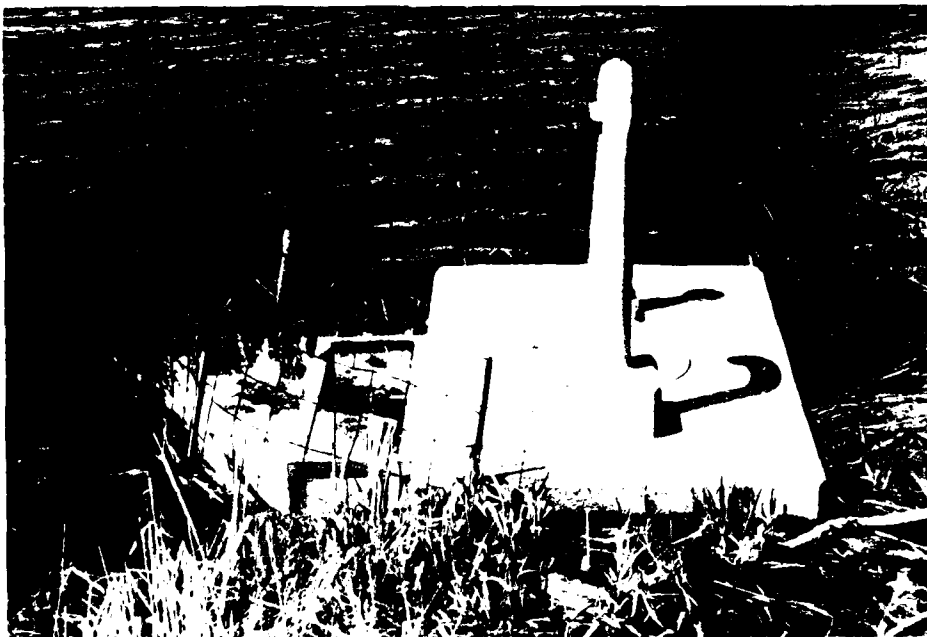
The dam and its appurtenances are generally in good condition. The only potential problem observed during the visual inspection is clogging of the track racks with floating debris.

2. View of drop inlet structure showing debris clogging the trash racks

- a) Mowing of embankment slopes.
- b) Clearing debris from the trash racks of the drop inlet structure and from the slopes of the embankment.
- c) Backfilling any animal burrows, tire ruts or erosion gullies which may be found.

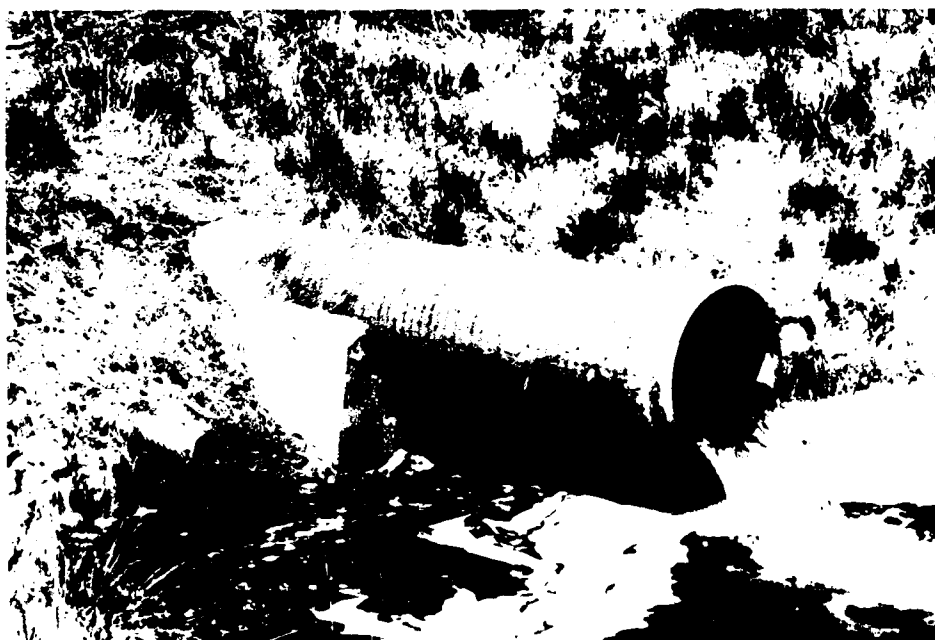
The embankment is in good condition with no evidence of sloughing, erosion, or settlement. The toe drains were functioning with the left toe drain discharging approximately 2 gallons per minute and the right toe drain discharging approximately 4 gallons per minute. The discharge is clear.

4. View of outlet pipe and right toe drain outlet
