OLIVERIAN DAM

NH-00268

PHASE I INSPECTION REPORT  
NATIONAL DAM INSPECTION PROGRAM

MAY 1979

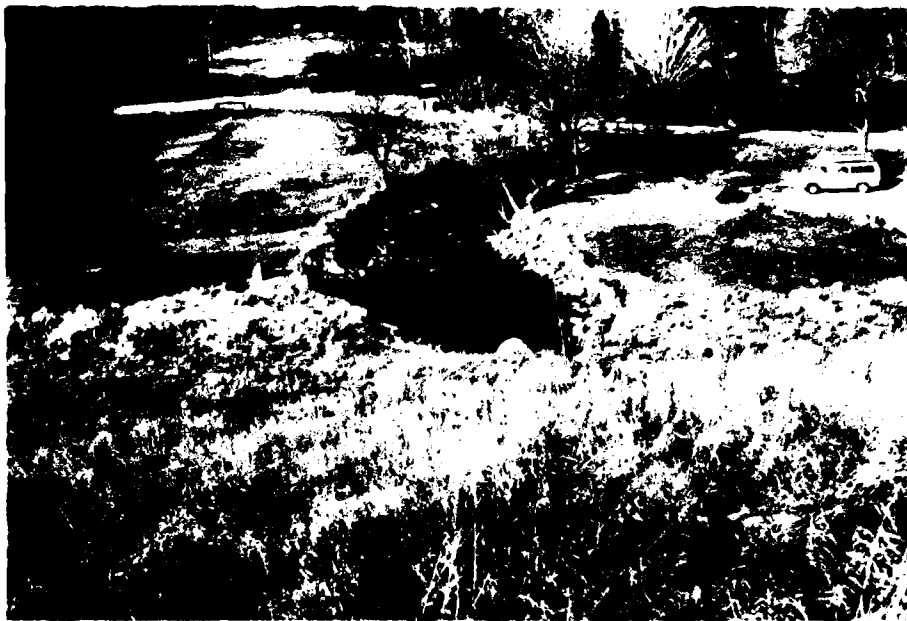
9

VIEW DOWNSTREAM FROM TOP OF DAM
