ASHUELOT POND DAM

NH 00237

PHASE I INSPECTION REPORT NATIONAL DAM INSPECTION PROGRAM

JUNE 1979

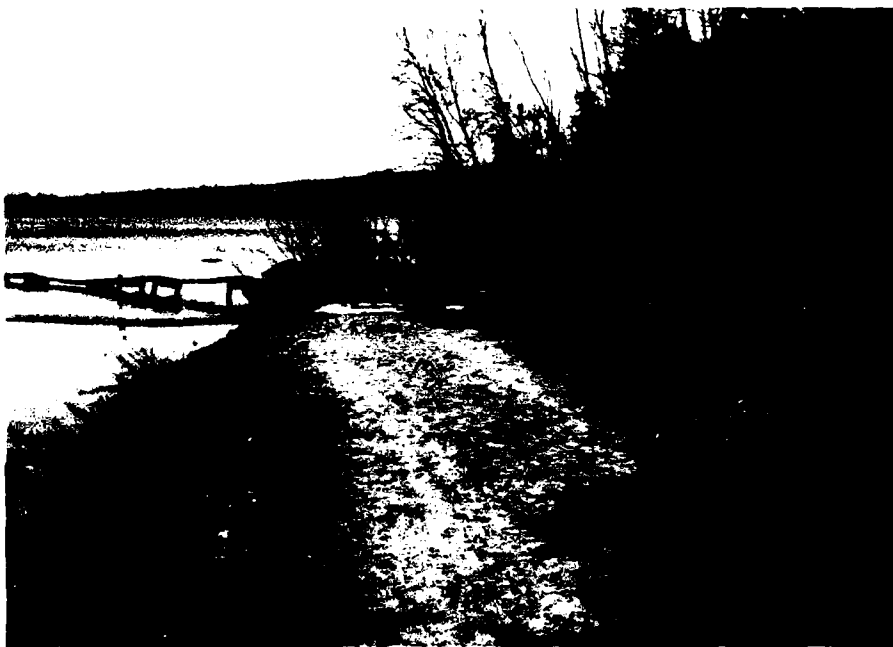
Several areas of the crest are barren, as shown in Photos No. 4 and 5. This erosion has probably been caused by trespassing on the crest. Several trees were observed on the crest, and the roots of trees were observed protruding through the surface of the crest near the left side of the dam, as shown in Photo No. 5.

PHOTO NO. 4 - View of dam crest from right abutment.

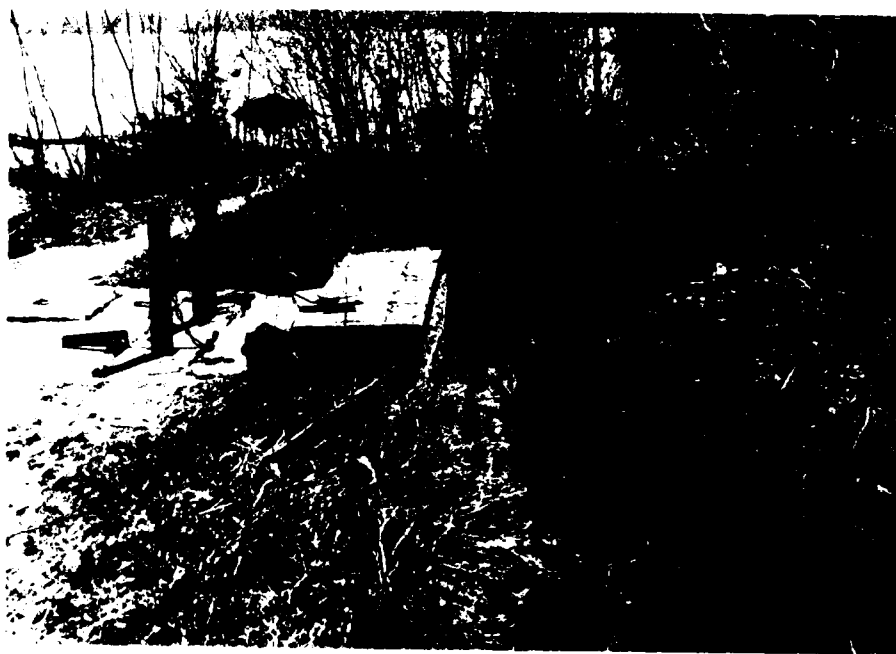
placed uniformly along the river width. The river banks of the spillway section are also reinforced by field stone. Both spillway structures appeared to be in good condition. Field examination appears to indicate that the outlet works structure was constructed as shown in Section B-B, Figure 1, located in Appendix B, see Photos No. 6 and 7.

PHOTO NO. 7 - View of outlet works structure and downstream side of dam.

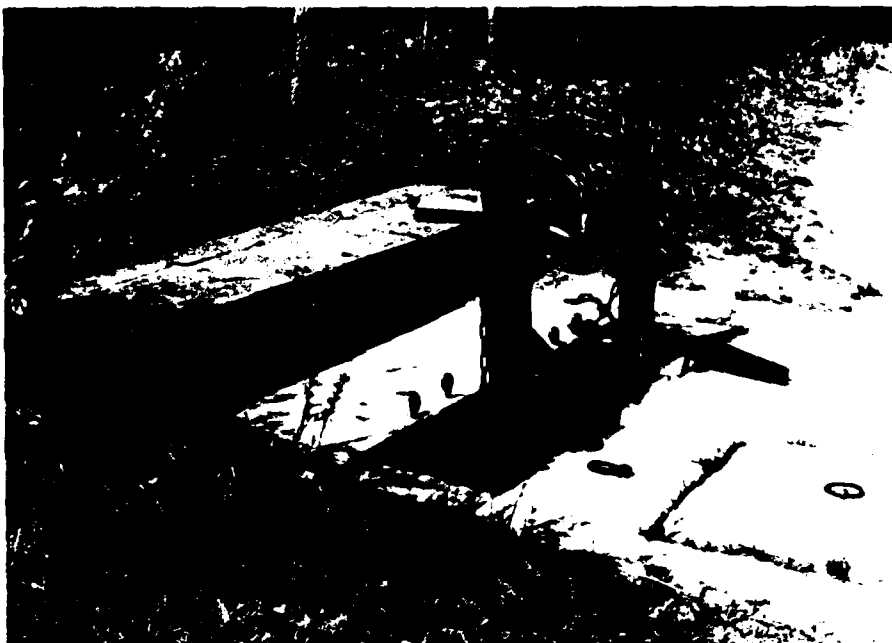
The stoplogs appear to be in good condition. The gates and trash rack were not inspected as they were below water. The gate stems are rusted and the gates were inoperable, see Photo No. 8. The manhole at the outlet works did not allow for vertical access to the stoplogs.

PHOTO NO. 8 - View of gate operating mechanizm.

(e) Repair the outlet works gates such that they can be operated.

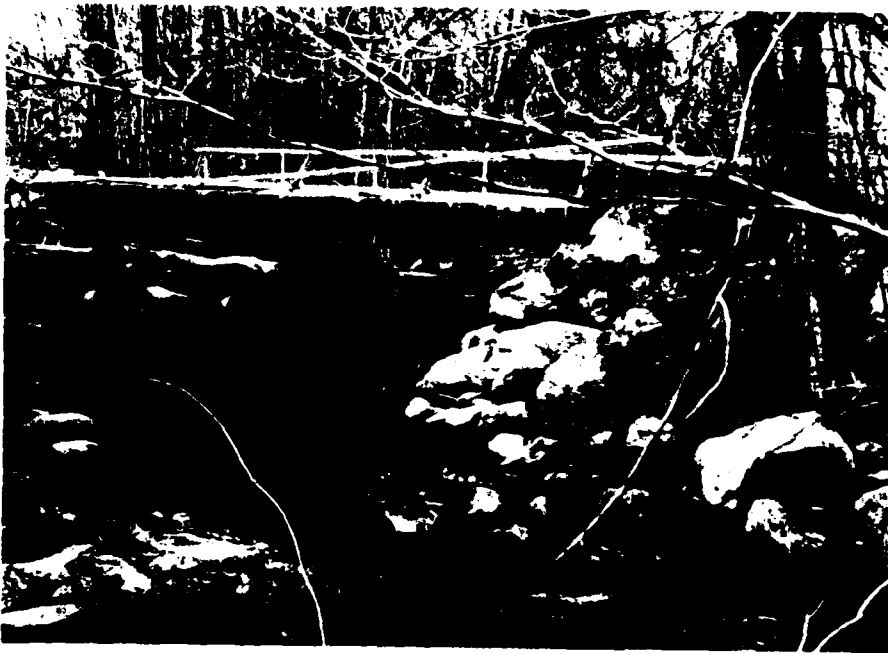
PHOTO NO. 18 - View of bridge over Ashuelot Brook between dam and town of Marlow.

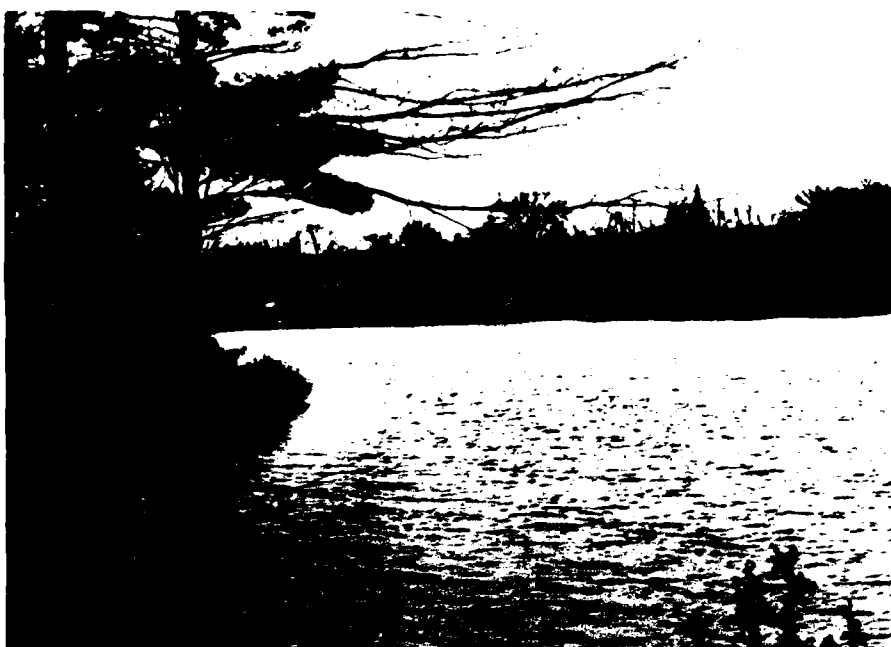
PHOTO NO. 20 - View of Symonds Pond and Route 123 bridge
in Marlow.
