MERRIMACK RIVER BASIN  
NASHUA, NEW HAMPSHIRE

MINE FALLS DAM

PHASE I INSPECTION REPORT  
NATIONAL DAM INSPECTION PROGRAM

MARCH 1979

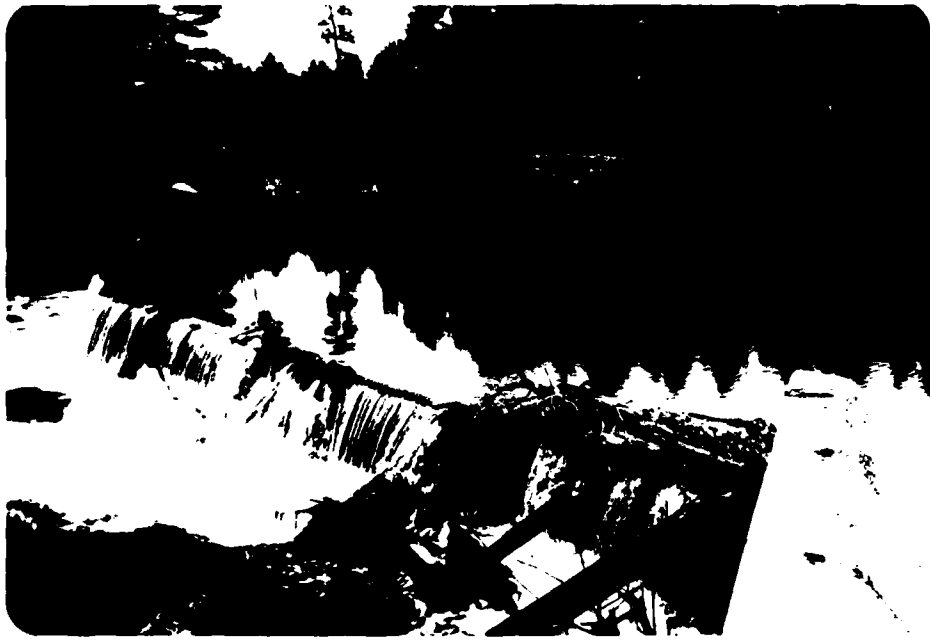
Overview from left abutment

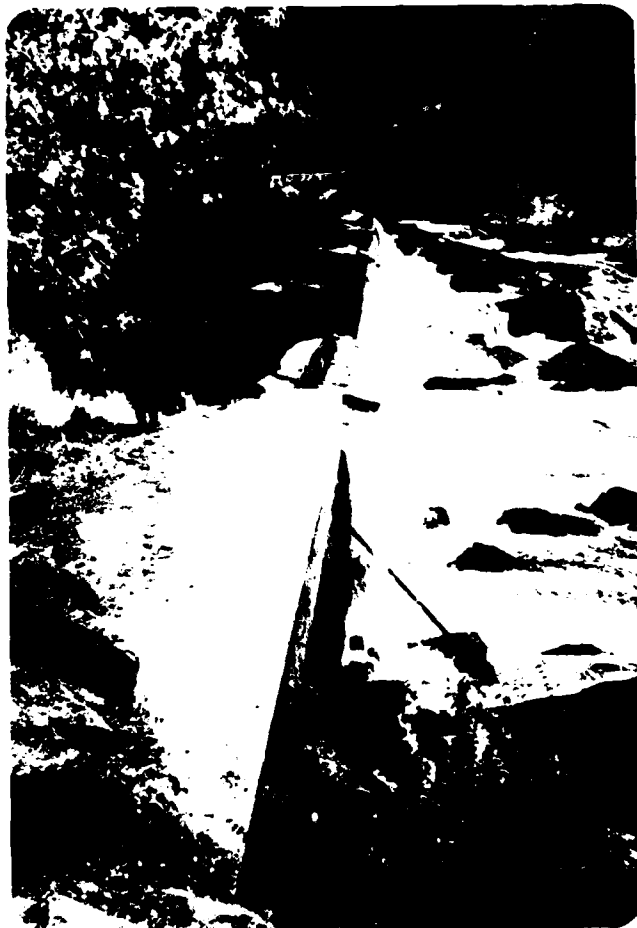
Overview of spillway from right end  
of spillway
