**SUNAPEE LAKE TOWN DAM  
NH 00108**

**PHASE I INSPECTION REPORT  
NATIONAL DAM INSPECTION PROGRAM**

MAY 1979

Identification No.: NH00108  
Name of Dam: Sunapee Lake Town Dam  
Town: Sunapee  
County and State: Sullivan, New Hampshire  
Stream: Sugar River  
Date of Inspection: June 6, 1978

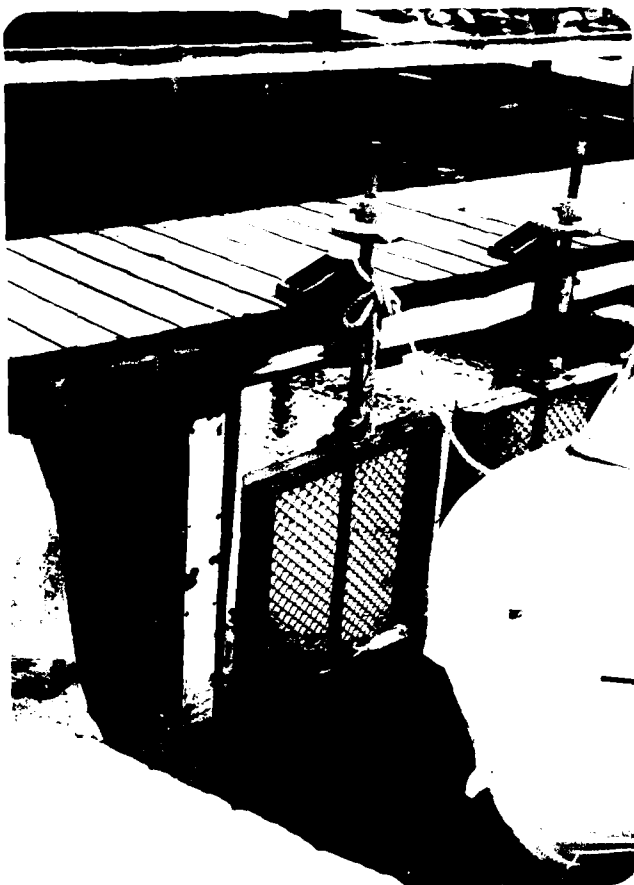
15. Fish Screens at the  
"Upper Lake Dam,"  
Looking Downstream.
