PISCATAQUA RIVER BASIN FARMINGTON, NEW HAMPSHIRE

BERRY BROOK DAM
NH 00313

PHASE I INSPECTION REPORT
NATIONAL DAM INSPECTION PROGRAM

DECEMBER 1979

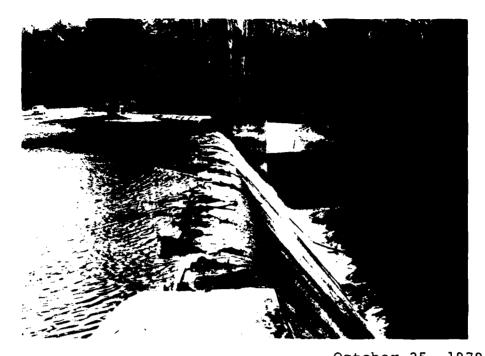
October 25, 1979
Figure 2 - Looking east along spillway crest from west abutment. Note large pine tree growing in earthfill near east abutment.

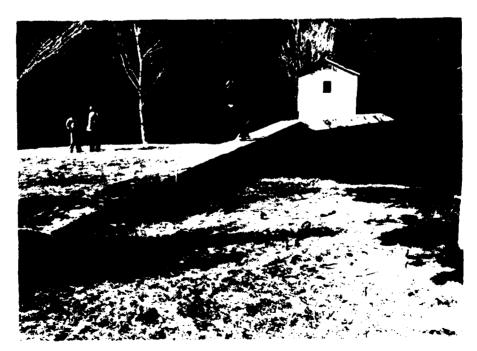
October 25, 1979
Figure 3 - Looking at the east abutment of the dam.

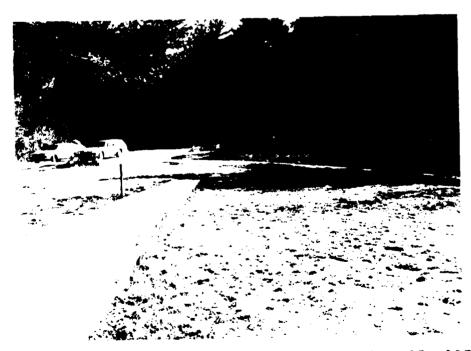
October 25, 1979
Figure 5 - Looking at the east end of the dam. Note gravel roadway.

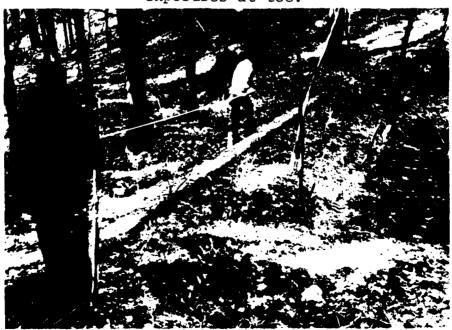
October 25, 1979
Figure 7 - View of the dike located 150 feet west of the west abutment of the dam.
