**BAKER FLOODWATER RESERVOIR  
SITE 8**

**NH 00178**

**PHASE I INSPECTION REPORT  
NATIONAL DAM INSPECTION PROGRAM**

JUNE 1979

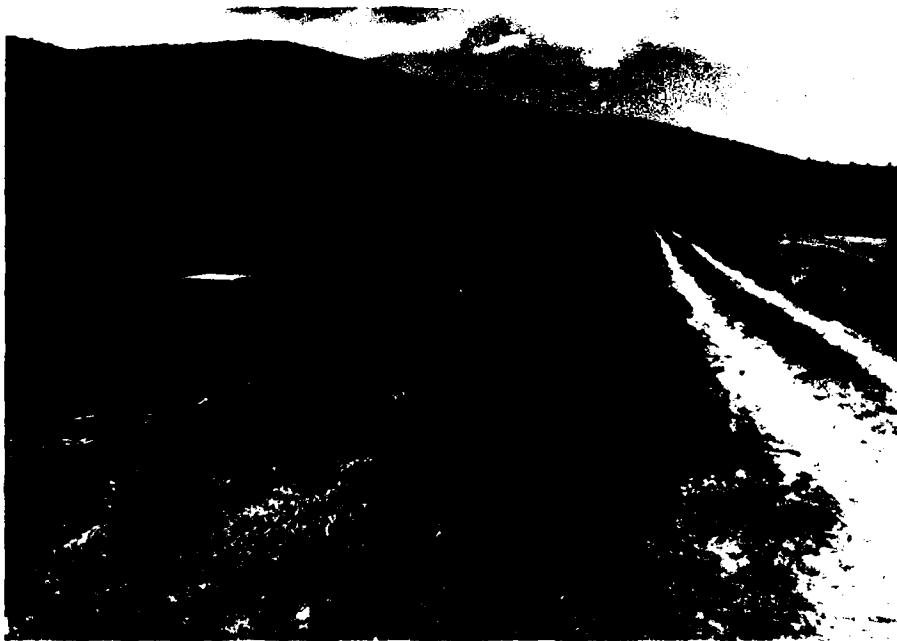
The upstream slope is 2.5 horizontal to 1 vertical. Reservoir storage was such that the entire upstream slope was inspected. The slope is well turfed and in good condition, as shown in Photo No. 3.

PHOTO NO. 3 - View of upstream face of dam from right abutment.

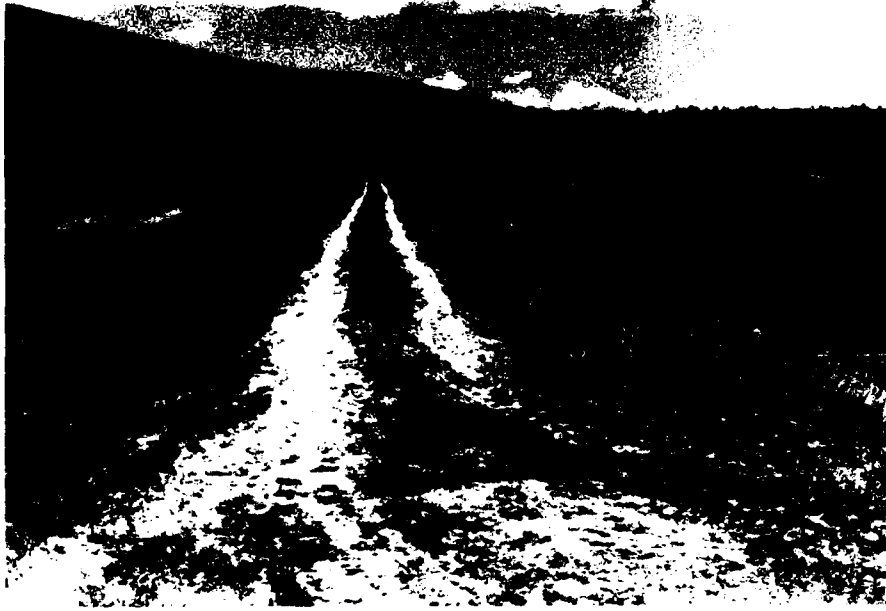
The crest of dam is 14 feet wide and is grass covered with grass with the exception of an unpaved roadway which is shown in Photo No. 5. No significant misalignment of the crest was observed.

PHOTO NO. 5 - View of dam crest from right abutment.

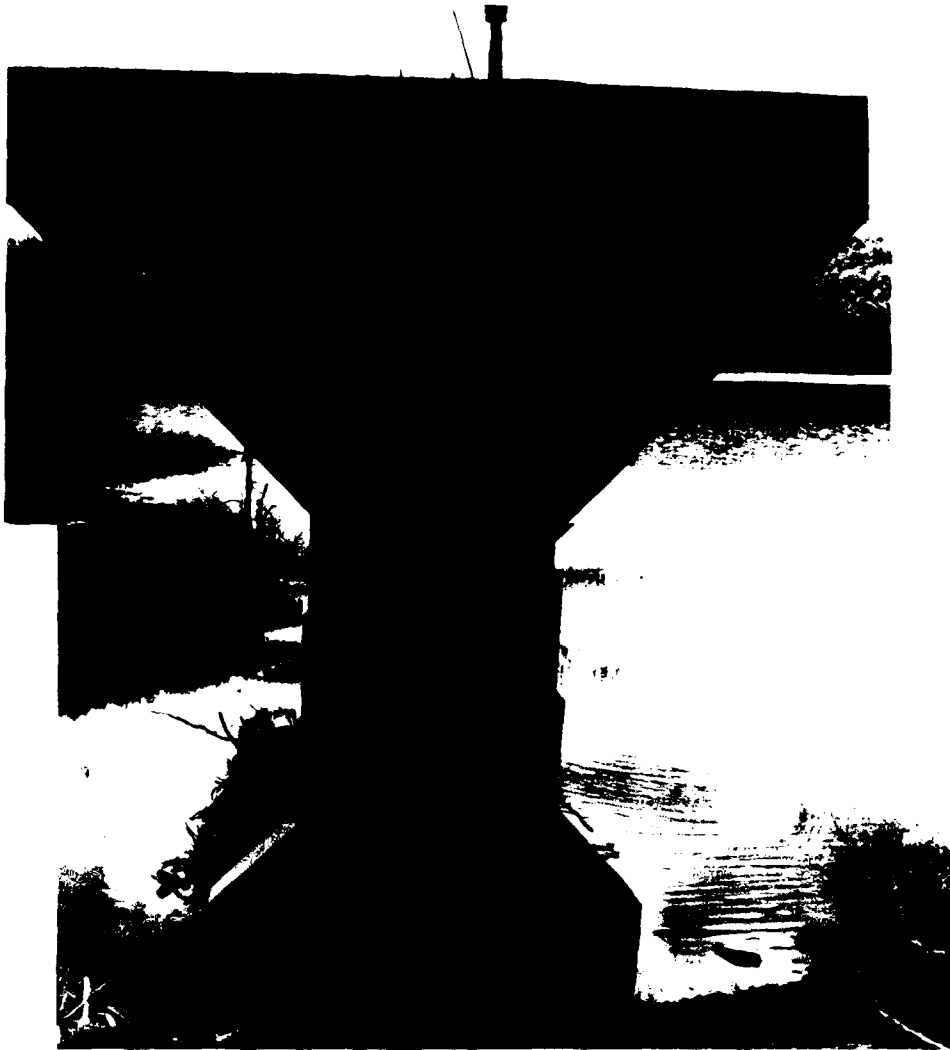
The concrete riser structure (principal spillway) consists of three elements: An overflow control with a low stage inlet and a high stage crest, a vertical transition and a closed discharge conduit. The riser structure is placed in the embankment. Visual inspection revealed that the riser structure appeared to be in good condition, except for water staining, cracks and extensive surface scaling in the form of loss of surface mortar and in some locations loss of coarse aggregate particles.

b. Weir and Training Walls	
General Condition of Concrete	Water staining, cracks and loss of mortar in concrete surface. Photo No. 7
Rust or Staining	None
Spalling	None
Any Visible Reinforcing	None
Any Seepage or Efflorescence	None
Drain Holes

PHOTO NO. 7 - View of riser and covered top high stage inlet from dam.

(b) Repair the deteriorating surface of the concrete on the riser structure.

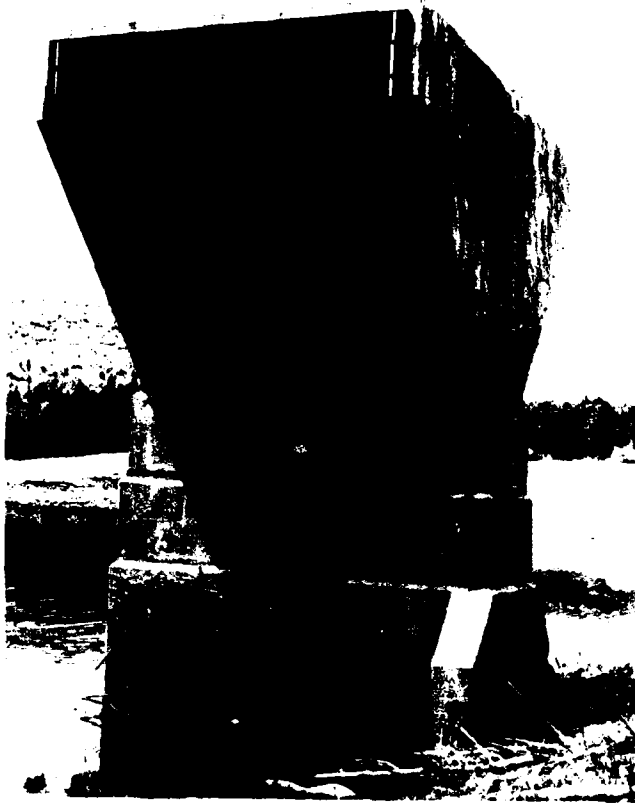
The trash racks at the low and high flow control stages consist of a standard shape angles and grating. Both trash rack assemblies are in good condition. No rust or peeling of the protective coating was noted. The low stage trash rack structure is filled with debris.

PHOTO NO. 10 - View of  
high stage and low  
stage trash racks on  
right side of prin-  
cipal spillway.

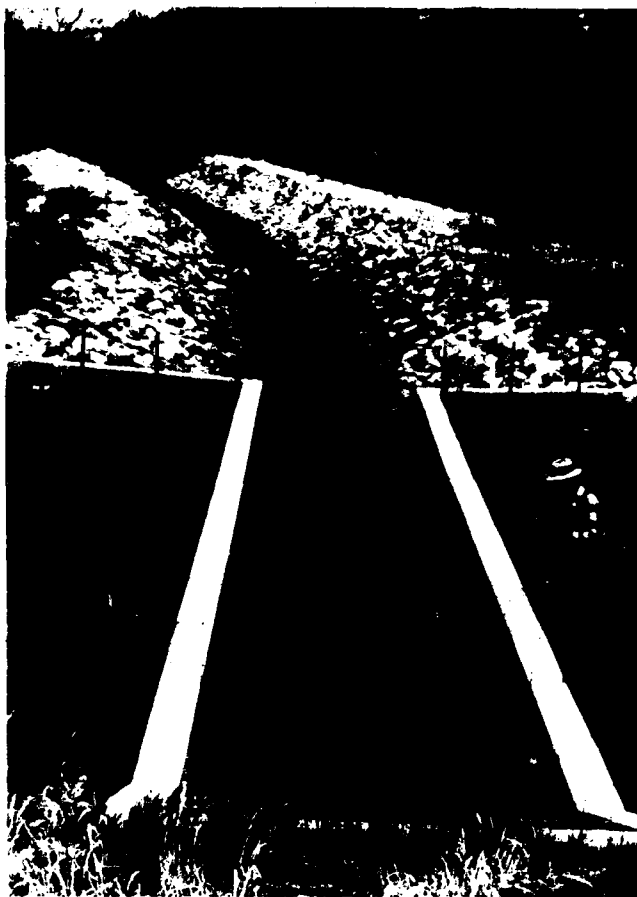
The discharge channel below the stilling basin extends for a distance of 350 feet downstream of the outlet works (Photo No. 12). The channel is lined with rock riprap and is in excellent condition.

Piezometers were installed behind each wingwall in 1973 as part of the investigation to remedy the wall movement. The study was conducted by professional engineers from the New Hampshire State SCS office in conjunction with professional engineers from the regional SCS office in Bromall, Pennsylvania. The above noted modifications are based on recommendations from this study. The report entitled "Report on Investigation of Structural Deficiency - Site 8, Baker River Watershed - Grafton County, New Hampshire," dated March 1976 is available on request from the SCS. The piezometer pipes may be seen in Photo No. 12.

PHOTO NO. 12 - View of  
a portion of SAF  
stilling basin and  
outlet channel.

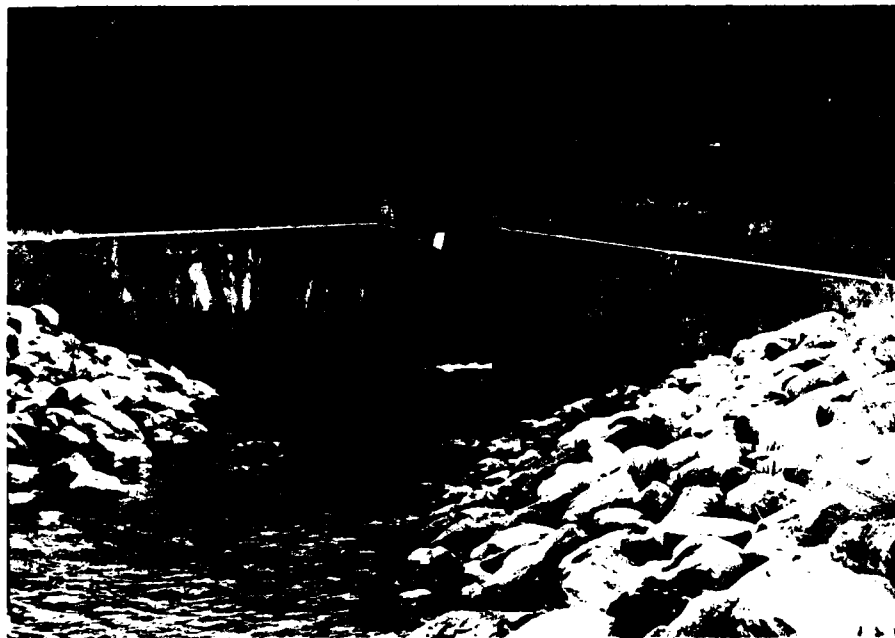
d. Post Construction Changes. The outlet pipes of the foundation drainage system originally passed immediately behind the outlet works training walls and exited through the wingwalls, as shown in Photo No. 13. In 1977, in order to provide better drainage around the SAF outlet, the location of the drain pipes was moved away from the outlet works and carried below the structure to outlet into the discharge channel. The new drain pipe

PHOTO NO. 13 - View of outlet works.
