MERRIMACK RIVER BASIN  
WENTWORTH, NEW HAMPSHIRE

**BAKER FLOODWATER RESERVOIR  
SITE 6**

**NH 00243**

**PHASE I INSPECTION REPORT  
NATIONAL DAM INSPECTION PROGRAM**

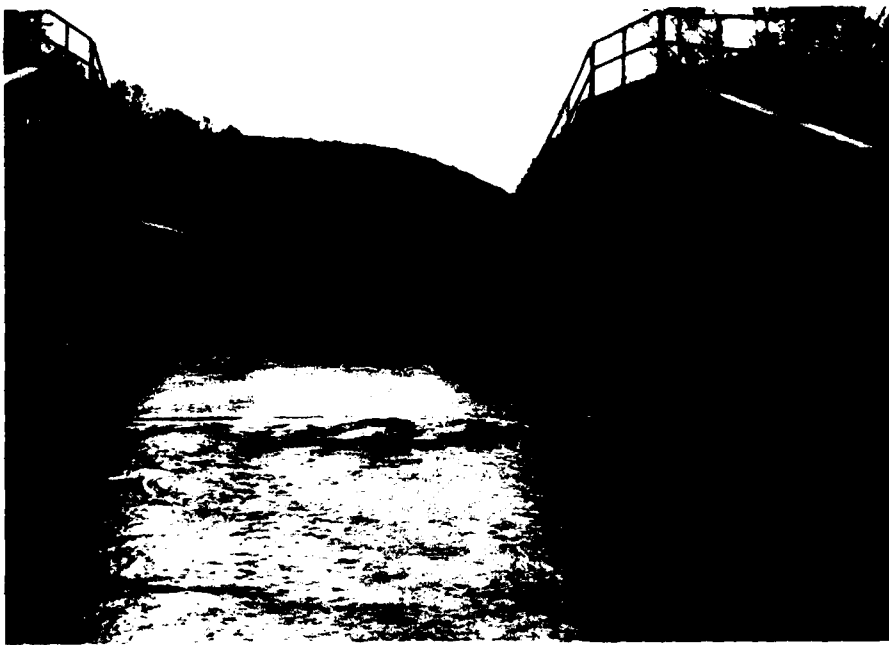
The spillway structure, shown in Photos No. 7, 8 & 12, consists of two elements, an overflow control (the low and high stage crests of the spillway) and an open sluiceway type discharge channel. The spillway structure is located in the center of the dam. Visual inspection revealed that the spillway structure appeared to be in good condition except the sluiceway walls which have experienced temperature cracks. Inspection of training walls shows concrete temperature cracks, water staining and evidence of efflorescence, a whitish crystalline deposit at the concrete cracks. A lack of construction joints in the training walls was noted.

PHOTO NO. 7 - View of spillway section looking upstream.

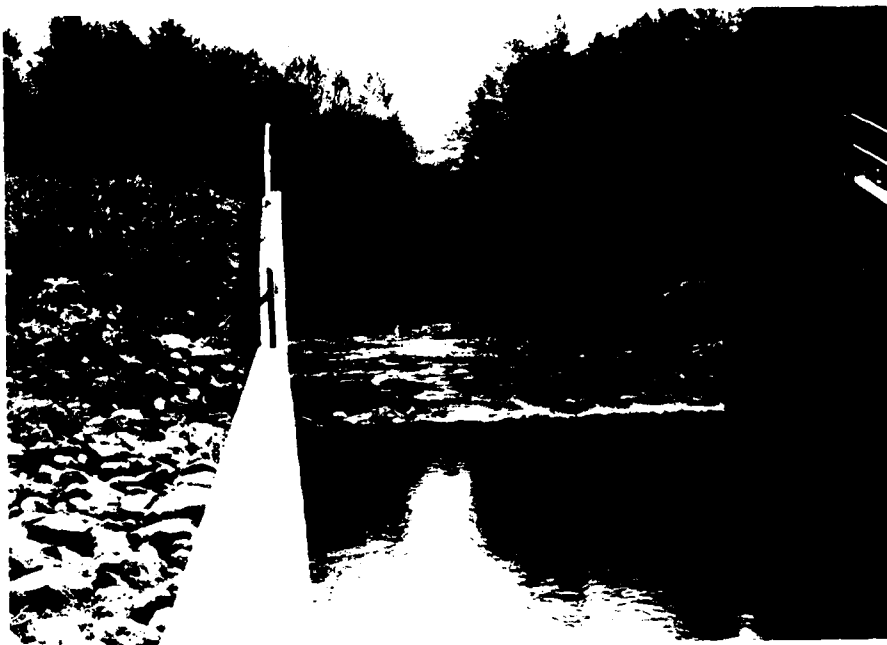
PHOTO NO. 8 - Spillway section through embankment.

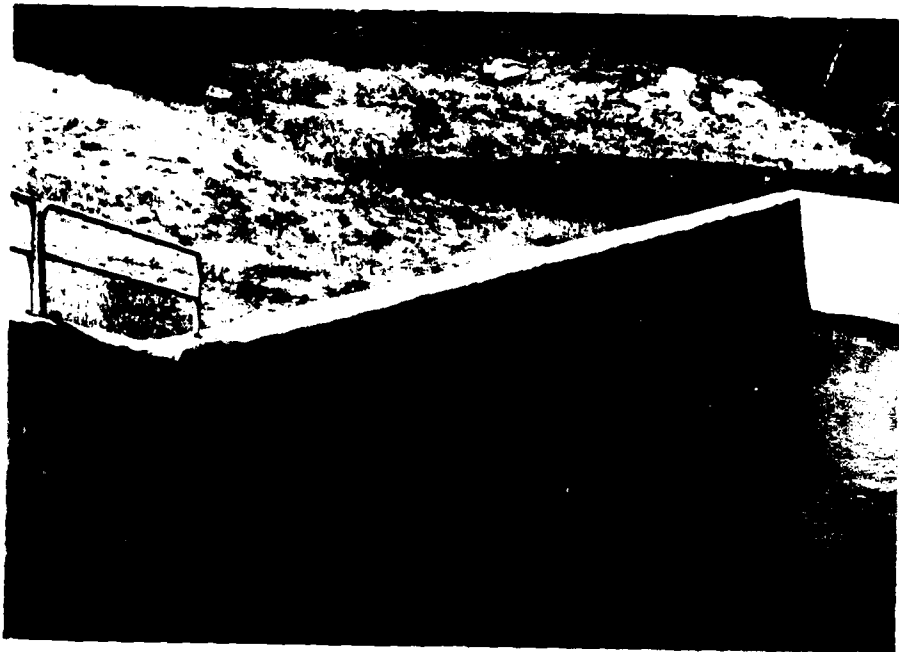
The high water table along the right training wall plus possible frost action due to the fines deposited in the back-fill along the wall may have caused the deterioration of the upstream right training wall. Photos No. 9 & 11 show the right training wall and Photo No. 10 shows the upstream left training wall for comparison.

c. Appurtenant Structure. The visual inspection of the concrete box spillway with high and low stage inlets, pond drain with a stop log control and the discharge sluiceway channel did not reveal any evidence of stability problems. The concrete surface and vertical alignment of the spillway structure are in good condition except for numerous vertical cracks, staining and deposit of efflorescence around concrete cracks as shown in Photos No. 9 & 10.

a. Visual Observation. The visual inspection Baker Dam Site 6 did not disclose any immediate stability problems. The cracks in the spillway training wall do not present any immediate danger to the dam. The cracks may be due to temperature changes and a lack of construction joints. The ponding along the right training wall may aggravate the situation due to hydrostatic pressure and frost heaving. The surface water should be diverted away from the training wall.

PHOTO NO. 9 - Right upstream wall of spillway.

(e) Repair all spalled concrete on the spillway and training walls.

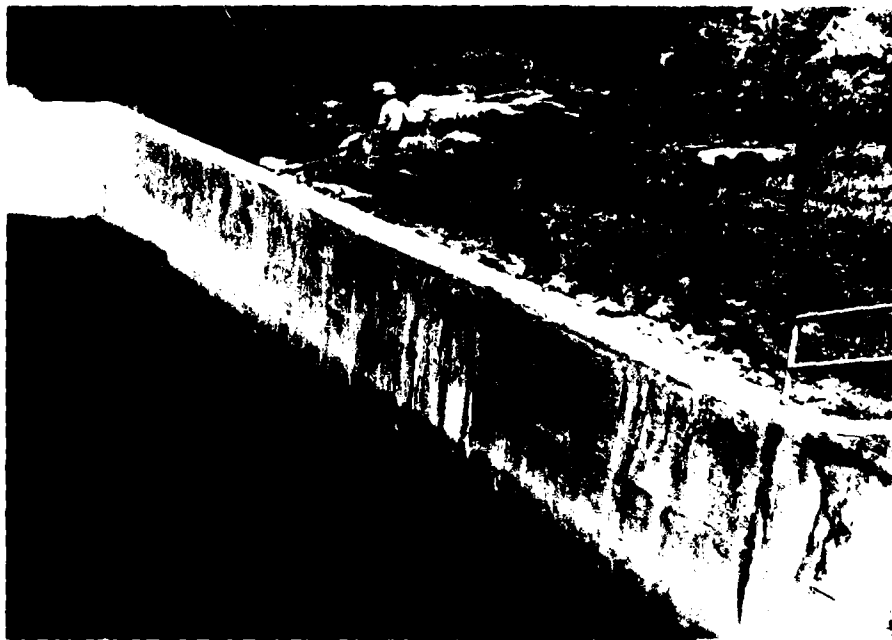
PHOTO NO. 10 - Left upstream wall of spillway.

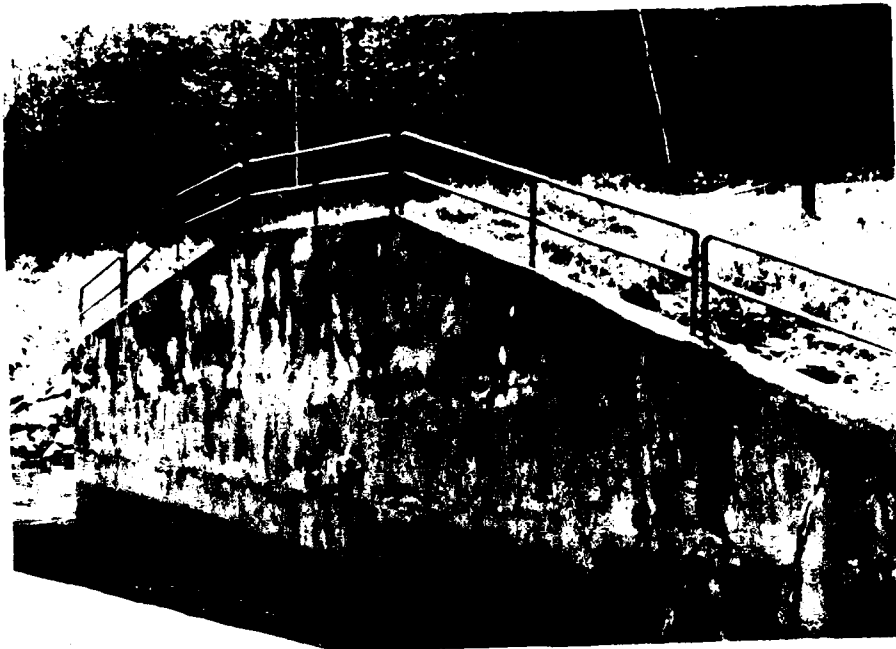
PHOTO NO. 11 - View of right wall of spillway at embankment.

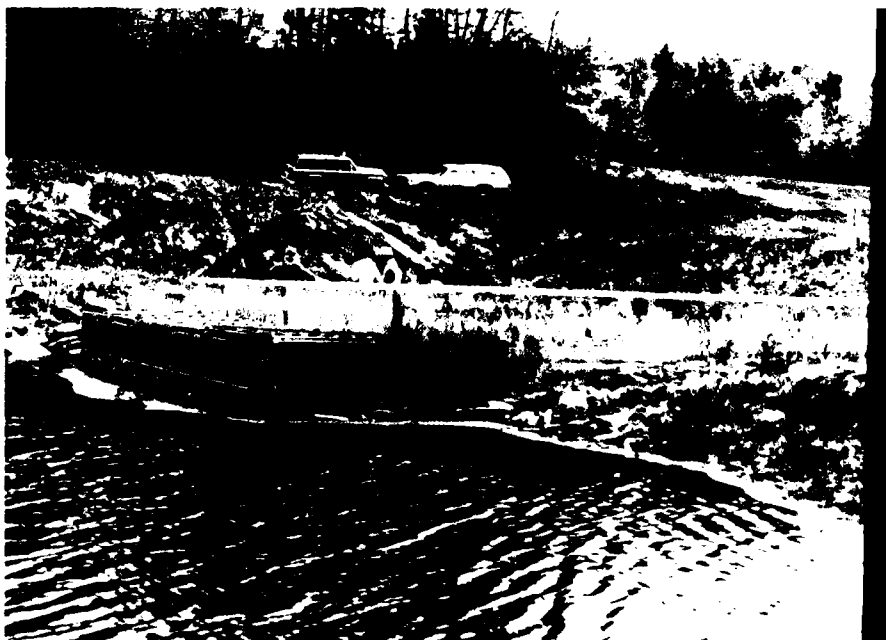
PHOTO NO. 12 - Upstream end of spillway from the right reservoir bank.

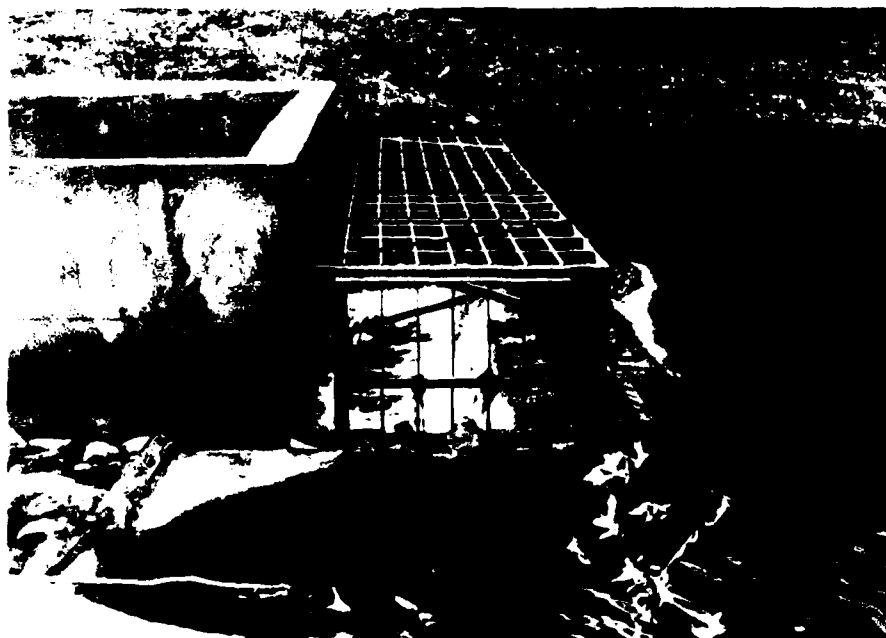
The galvanized trash rack at the low stage spillway crest consists of structural steel shapes. The trash rack assembly is in good condition, no rust or peeling of the protective coating was noted, see Photos No. 13 and 14. Debris was noted on the trash rack.

PHOTO NO. 14 - Detail of trash rack.

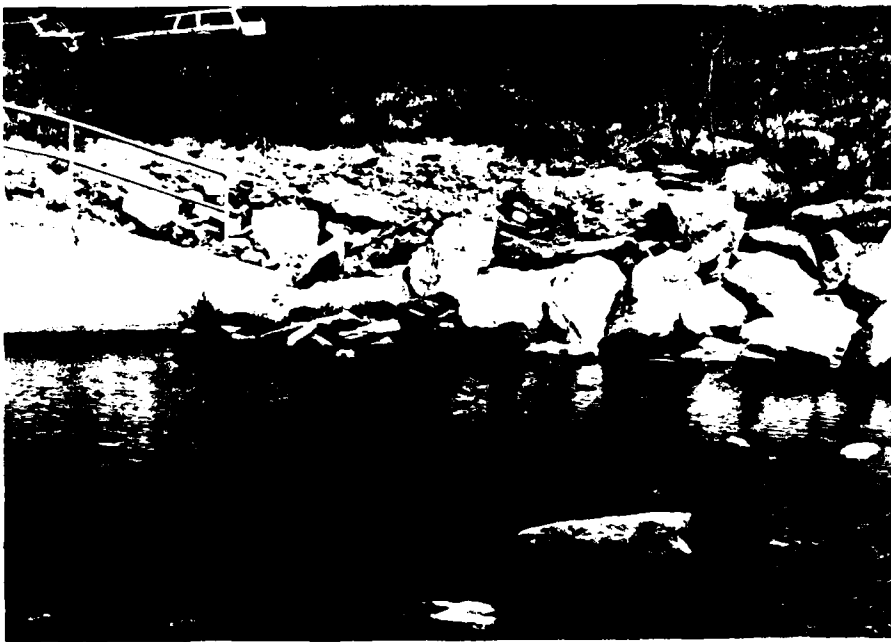
The foundation drainage system has 12-inch diameter outlet pipes on each side of the outlet channel just below the concrete training walls, see Photos No. 15 & 16. A slight outflow was observed from the right side drain pipe, and no flow was observed from the left side drain pipe.

PHOTO NO. 15 - Left drain outlet pipe downstream of the spillway.

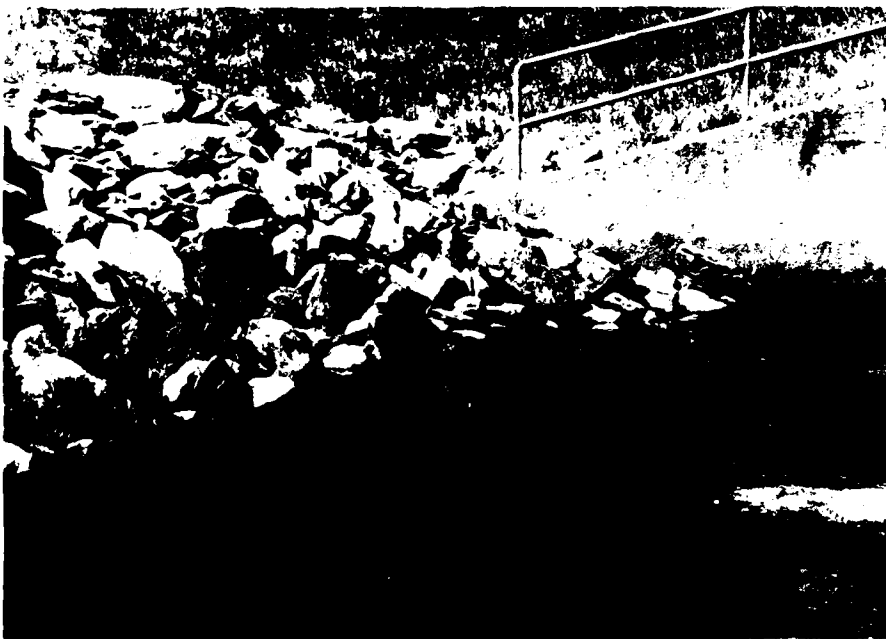
PHOTO NO. 16 - Right drain outlet pipe downstream of the spillway.

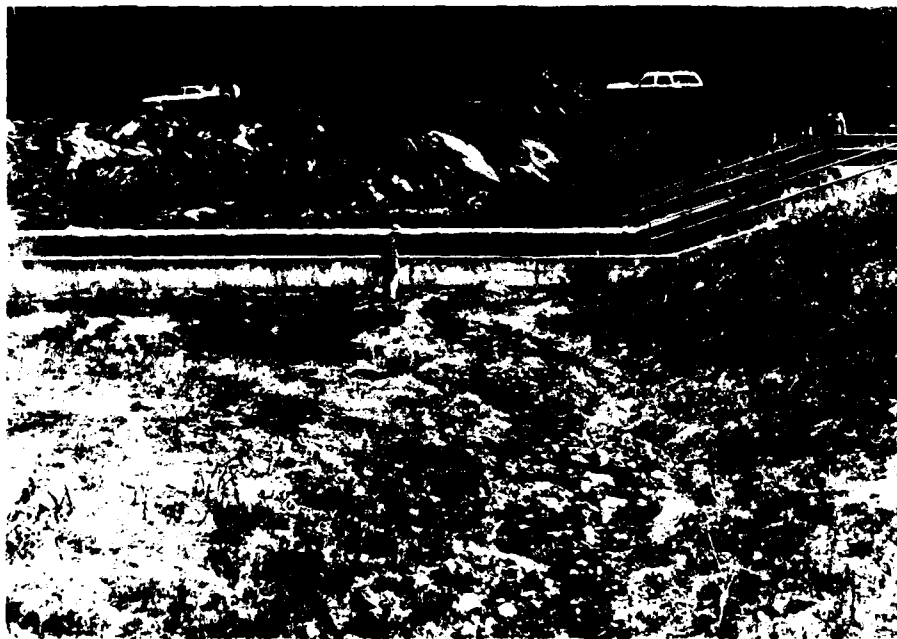
PHOTO NO. 20 - Drainage of right abutment.

(a) The owner should engage a qualified registered engineer to design a surface water diversion system that would eliminate ponding of water and erosion along the upstream right training wall of the box-inlet structure. The engineer should also evaluate the condition of the backfill adjacent to the wall to determine if it has become frost susceptible due to deposition of fines from the surface water ponding.

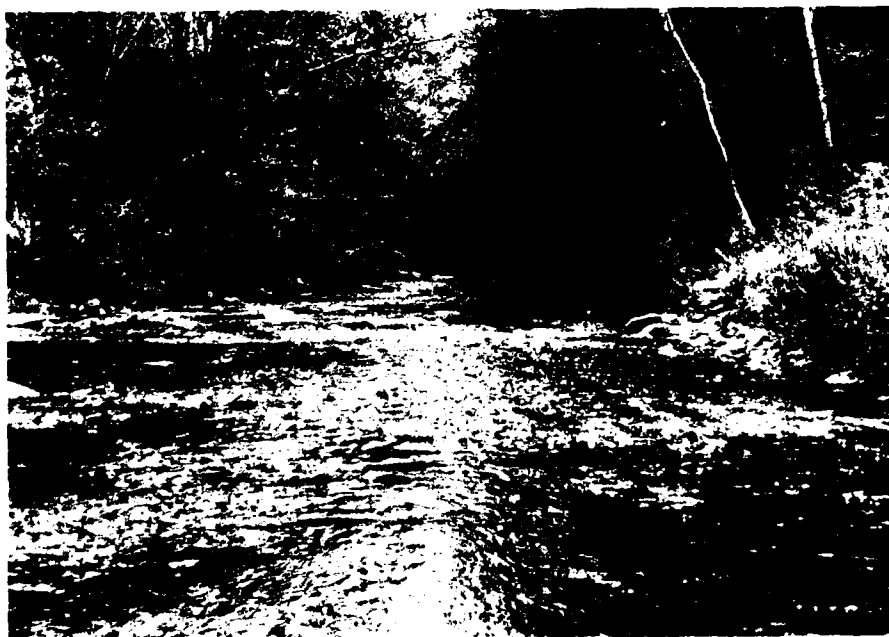
PHOTO NO. 22 - Channel downstream of the dam.
