MERRIMACK RIVER BASIN
BENNINGTON, NEW HAMPSHIRE

POWDER MILL POND DAM
NH 00248

PHASE I INSPECTION REPORT
NATIONAL DAM INSPECTION PROGRAM

DEPARTMENT OF THE ARMY
NEW ENGLAND DIVISION, CORPS OF ENGINEERS
WALTHAM, MASS. 02154

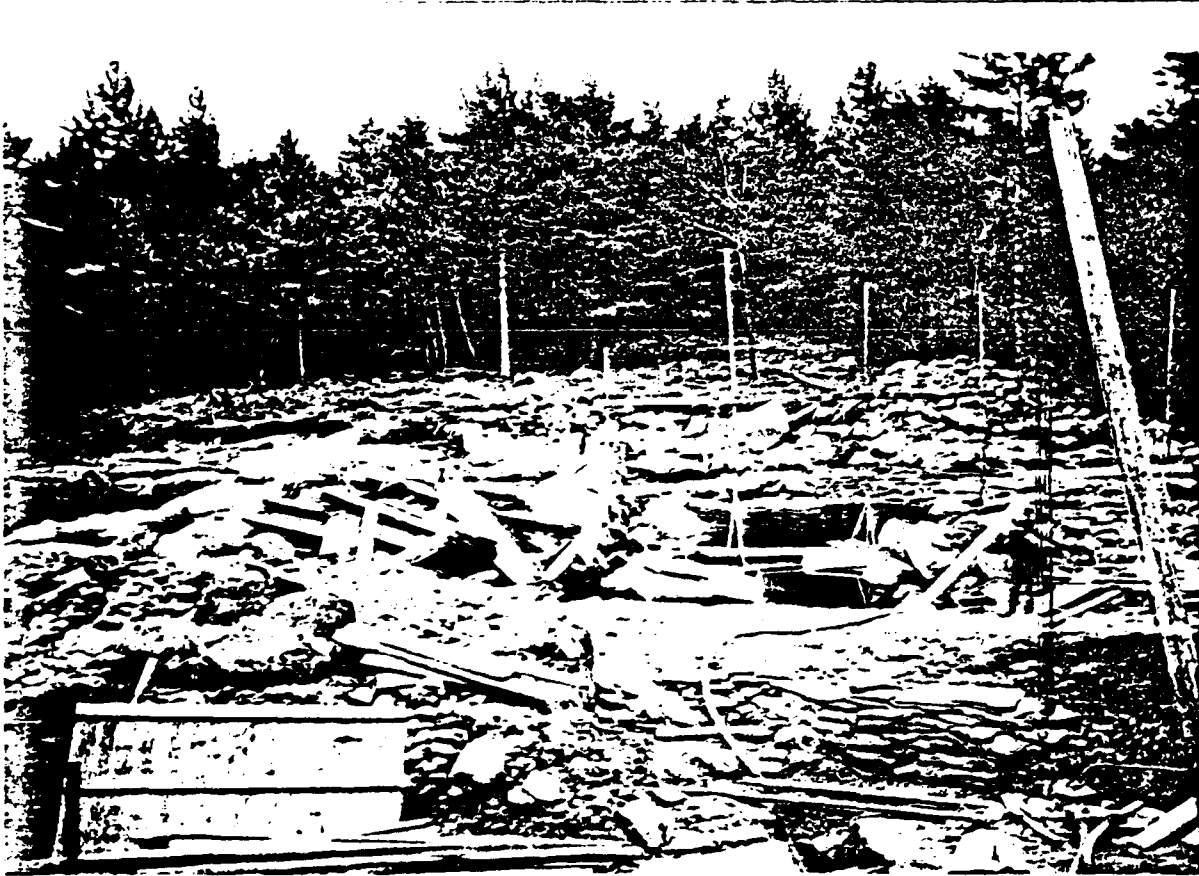
No. 1. Bennington Dam. Taken from the southerly bank of the river, looking northerly along proposed crest line of dam. July 1, 1924. 10:50 A.M.

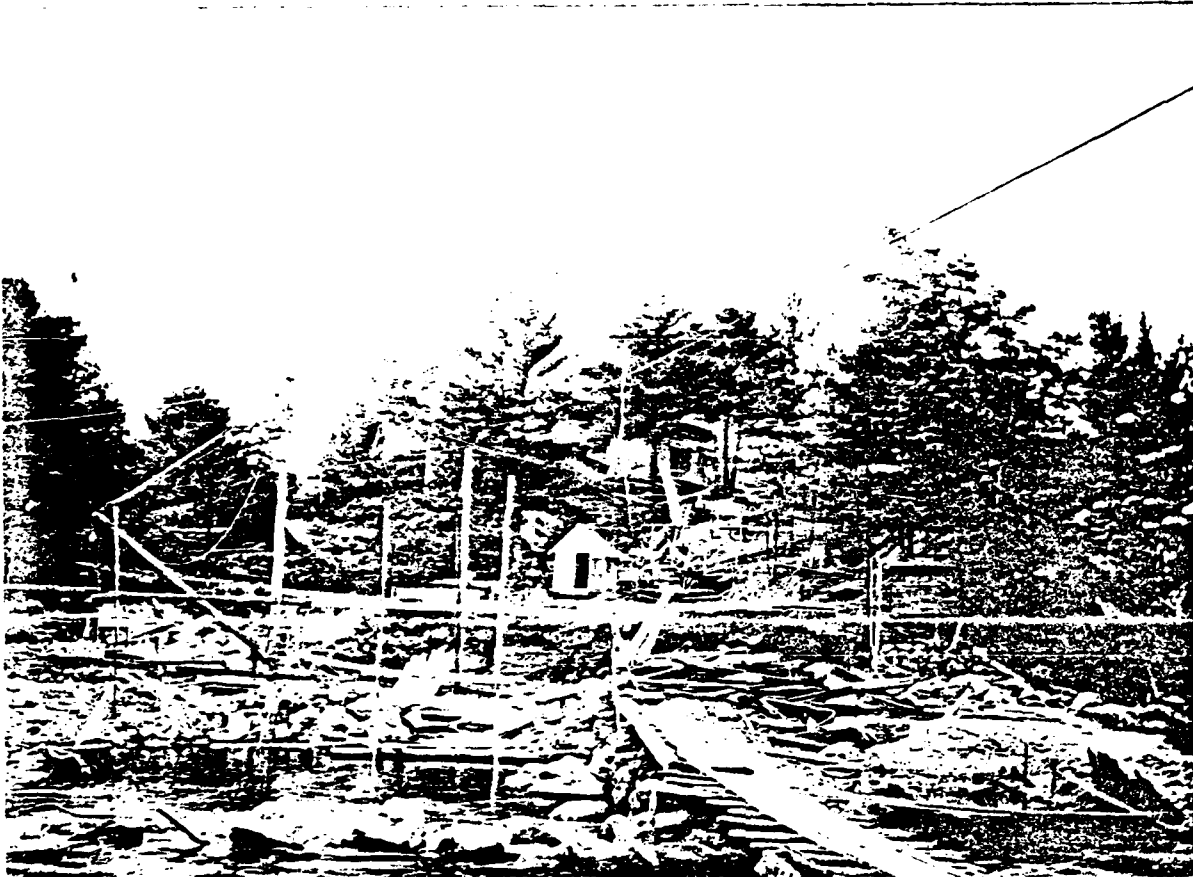
No. 2. Bennington Dam. Taken from the northerly bank of the river, looking southerly along proposed crest line of dam. July 1, 1924, 10:55 A.M.
