HIGHLAND LAKE NORTH OUTLET

NH 00238

PHASE I INSPECTION REPORT
NATIONAL DAM INSPECTION PROGRAM

AUGUST 1978

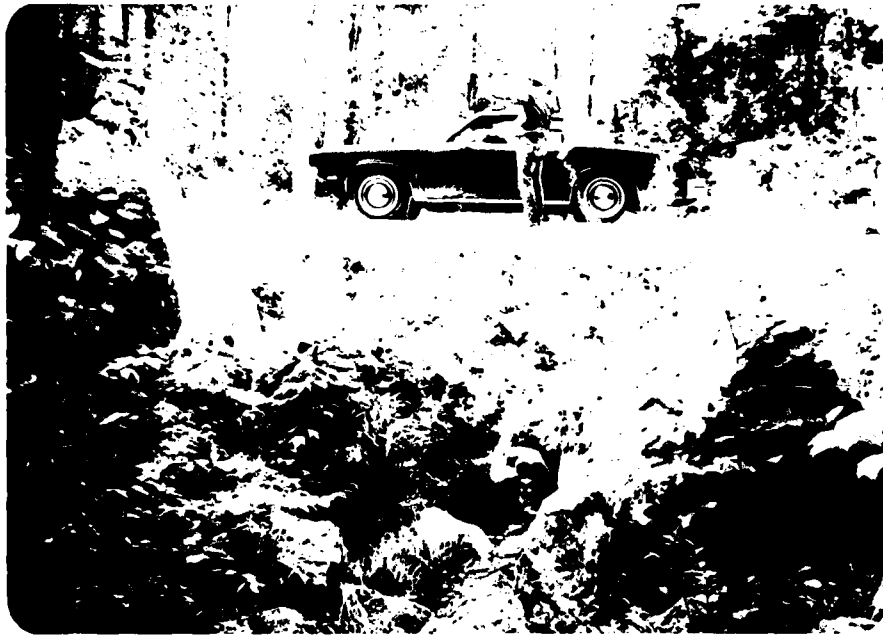
Overview photo of Tumlin Road crossing looking upstream

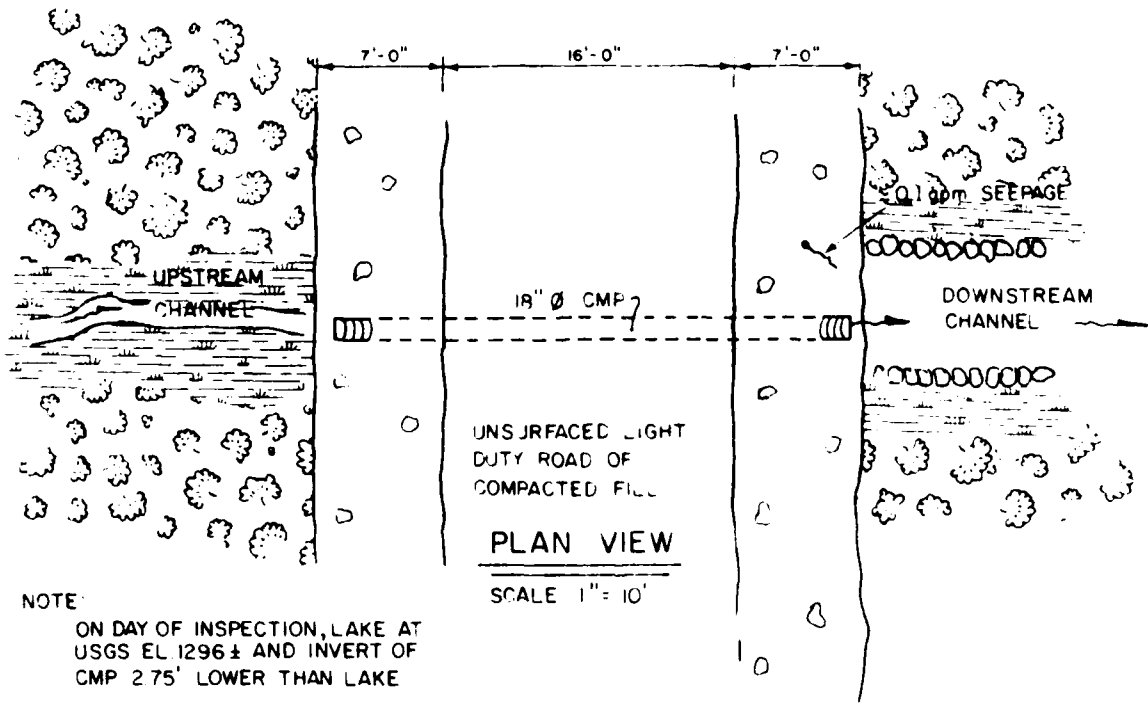
TUMLIN ROAD CROSSING
JULY 1978 SCALE AS NOTED FIG. 2

way. The top of the embankment is at USGS El. 1299.5+ or 3.5 feet above the normal pond (Figure 2). An 18 inch diameter corrugated metal culvert, with upstream invert at USGS El. 1293.3+, or 2.75 feet below normal lake level, carries Shedd Brook under the embankment, but the culvert inlet is completely blocked by beaver placed debris. If the lake rises above El. 1296+, the embankment would impound water to a maximum of 2500 acre-feet since the 18 inch culvert, even if cleared, could only pass a fraction of the flow in Shedd Brook under these conditions. Local residents refer to this structure as the North Outlet and it acts as a hydraulic control on the lake until overtopped.

NOTE:
ON DAY OF INSPECTION, LAKE AT USGS EL 1296 ± AND INVERT OF CMP 2.75' LOWER THAN LAKE

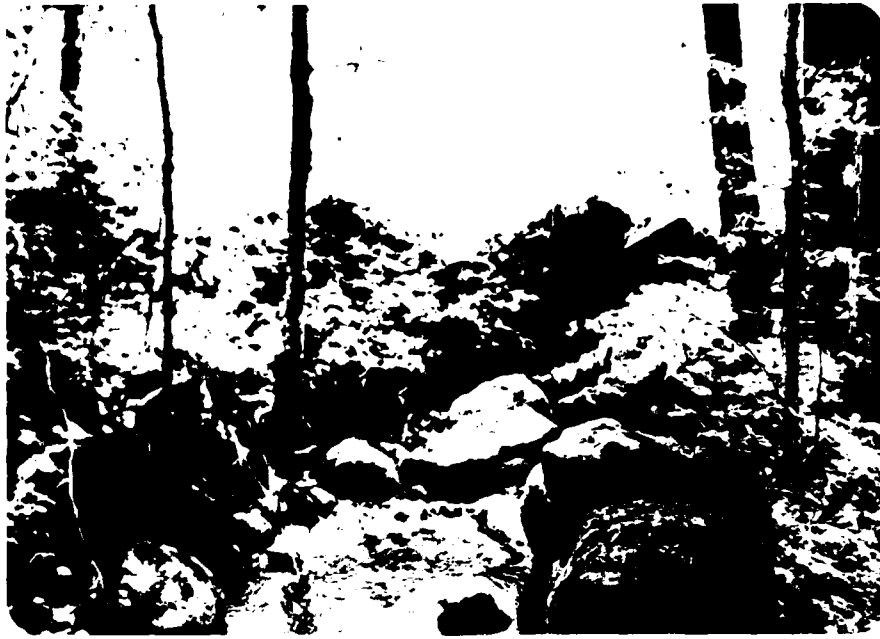
3. Outlet area for 2-36" CMP culverts under Bailey Road
