MILLEN LAKE DAM

NH 00236

PHASE I INSPECTION REPORT
NATIONAL DAM INSPECTION PROGRAM

MARCH 1980

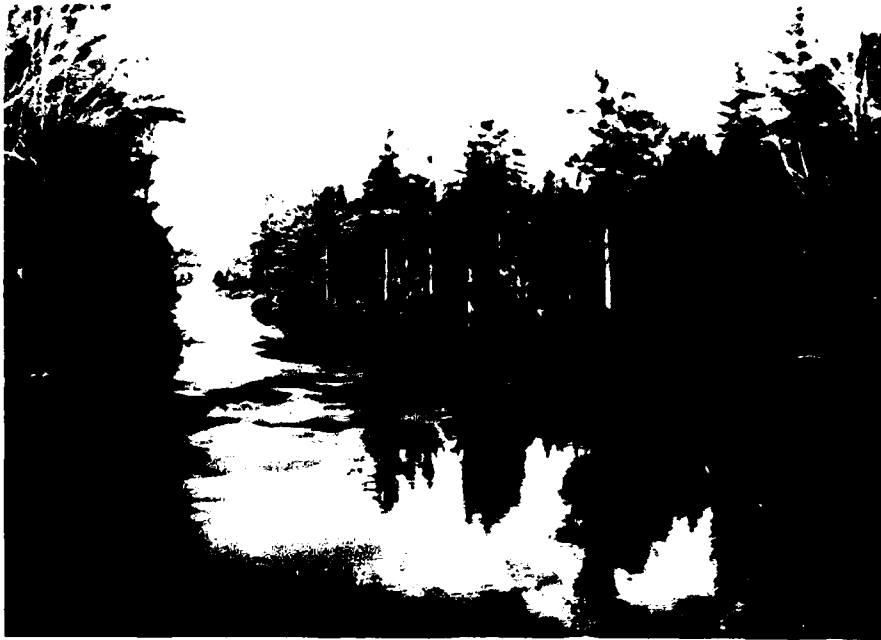
d. Reservoir Area. The slopes of the reservoir appear to be stable. No evidence of significant sedimentation was observed. Trees are growing on the banks of the approach channel upstream of the dam, but the channel is wide and unobstructed (See Photo No. 1).

Photo No. 1 - General view of lake from dam.

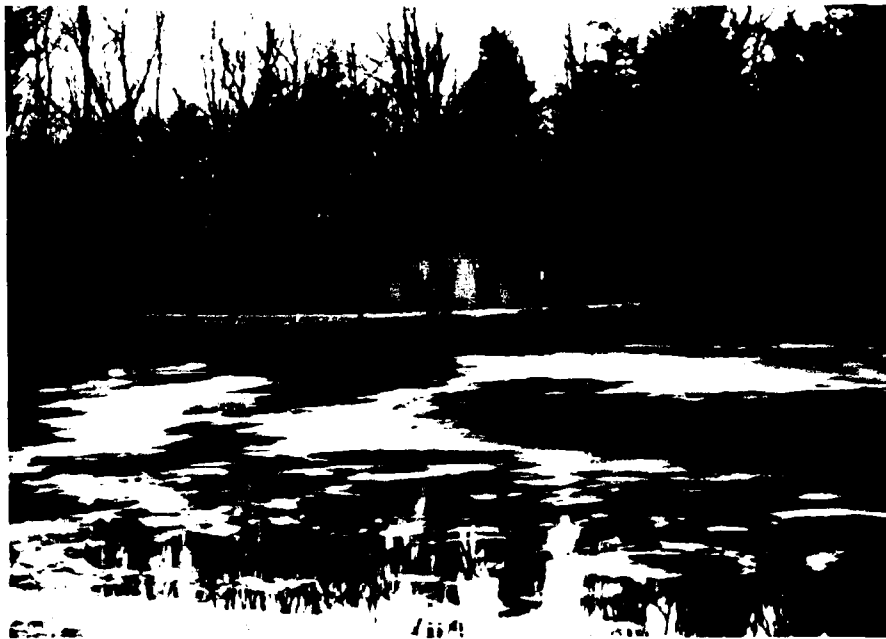
Photo No. 2 - General view of dam from lake.

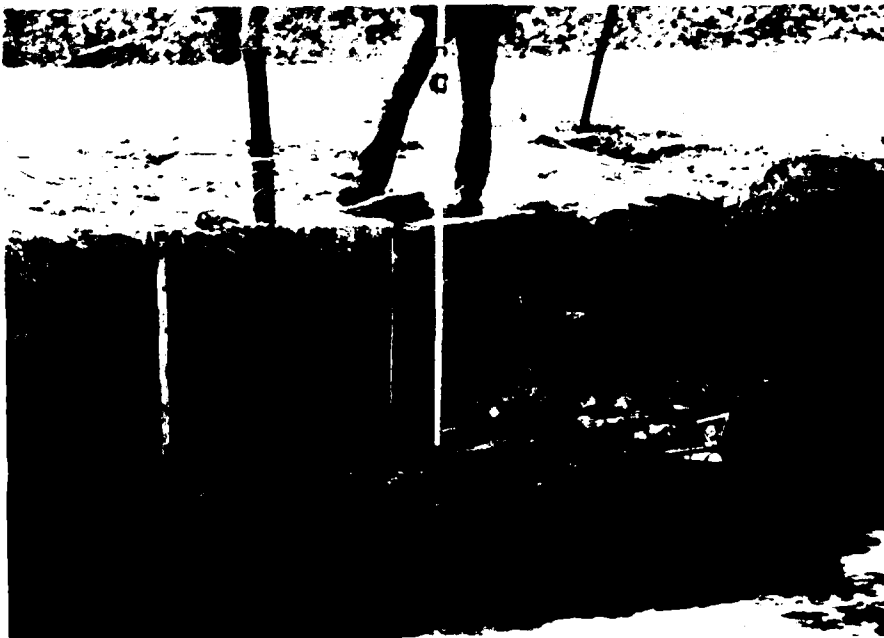
The upstream face of the dam is retained by a stone-masonry retaining wall which is in good condition. (See Photo Nos. 3, 4 and 5.) A concrete facing has been constructed against this wall up to an elevation about 4 inches above the overflow spillway crest. (See Photo No. 6 and Plans and details in Appendix B.)

Photo No. 6 - Closeup view of upstream face of spillway.
