CONNECTICUT RIVER BASIN  
PITTSBURG, NEW HAMPSHIRE

**FIRST CONNECTICUT LAKE DAM****NH 00186****NHWRB 194.02**

**PHASE I INSPECTION REPORT**  
**NATIONAL DAM INSPECTION PROGRAM**

MAY 1979

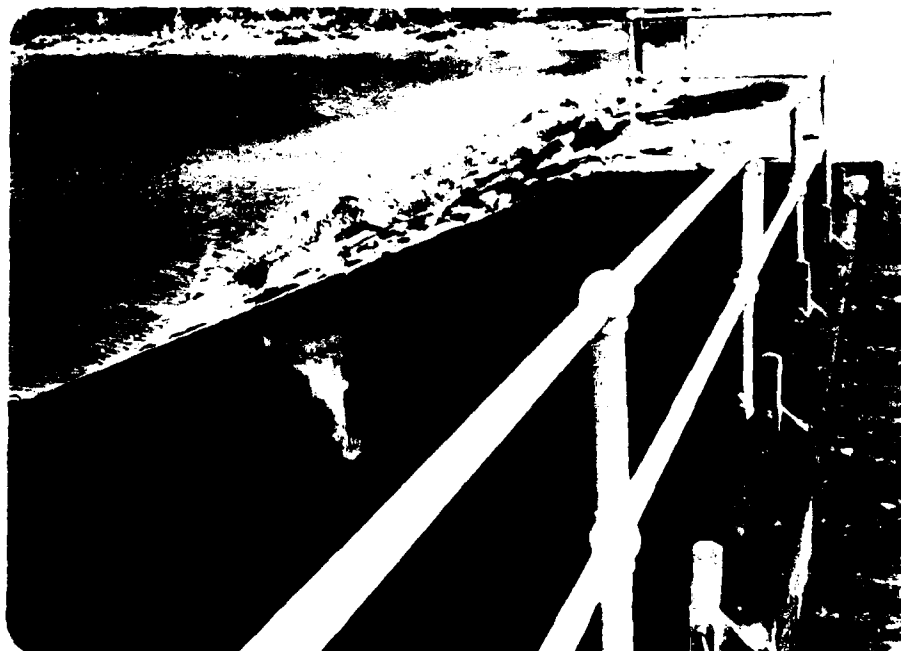
12. South abutment on the upstream side.

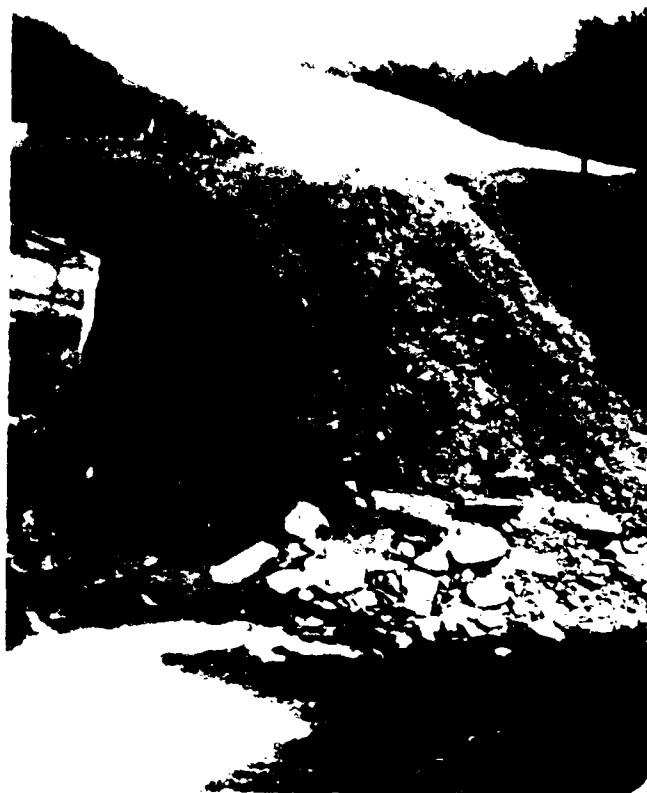
There is an area between the southern abutment and southern spillway wall where the slope has failed. Seepage, minor in nature, was also observed in this area. This area is protected by the spillway wall and the abutment, both of which are founded on bedrock. It appears that this slope failure occurred years ago and the grass has reestablished. This was also observed by the Water Resource Board in 1976 and it is being monitored by the owner, New England Power Co.

15. Erosion of south bank downstream. On the left; south abutment above, retaining wall below.

d. The monitoring of the area between the southern abutment and spillway retaining wall, which previously failed, should be continued by the New England Power Co. As soon as the cause is determined, corrective measures should be undertaken.
