CONNECTICUT RIVER BASIN
MONROE, NEW HAMPSHIRE

TYLER TREE FARM DAM
NH00325

PHASE I INSPECTION REPORT
NATIONAL DAM INSPECTION PROGRAM

JUNE 1979

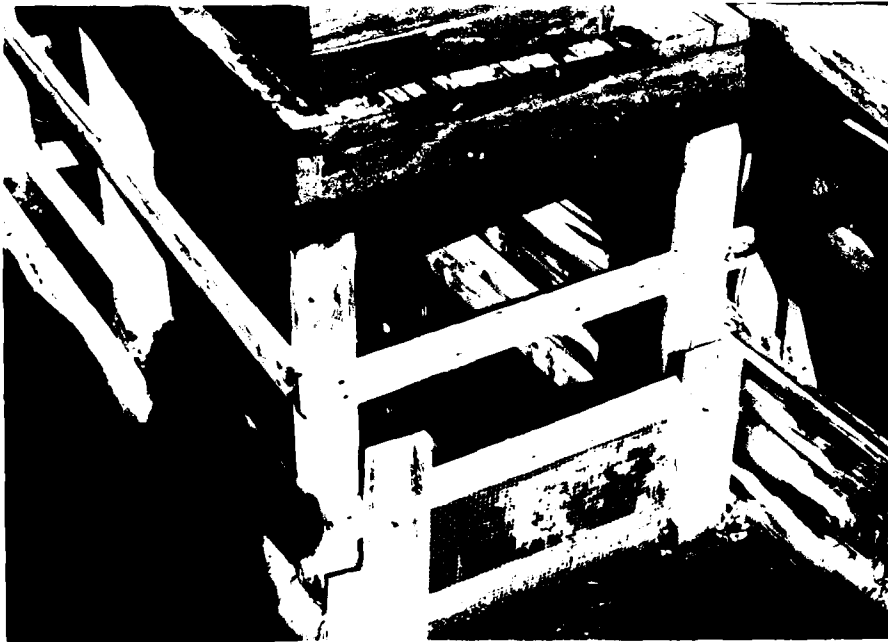
Figure 7 - View of the drop-inlet principal spillway.

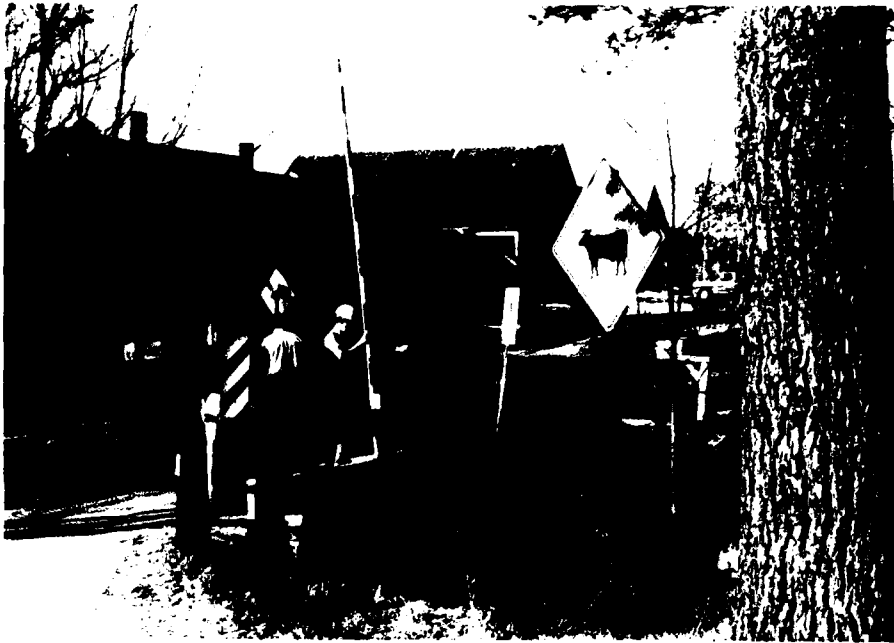
Figure 10 - Looking at State Route 135 located about one mile downstream of the dam.
