MERRIMACK RIVER BASIN
NASHUA, NEW HAMPSHIRE

HOLT DAM
NH 00327

PHASE I INSPECTION REPORT
NATIONAL DAM INSPECTION PROGRAM

AUGUST 1978

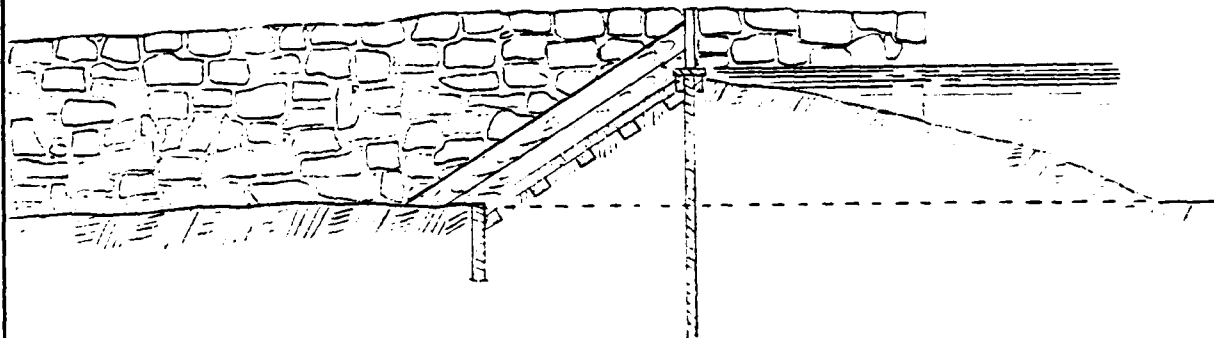
SECTION THROUGH SPILLWAY
Scale 8' to 1"

*Traced from print of original
plan dated Nov. 17, 1914 - as rebuilt in 1890.*
