NATIONAL PROGRAM FOR INSPECTION OF NON-FEDERAL DAM
LAKEPORT DAM (NH 00218..(U) CORPS OF ENGINEERS WALTHAM
MA NEW ENGLAND DIV AUG 80

REPORT DOCUMENTATION PAGE		READ INSTRUCTIONS BEFORE COMPLETING FORM
1. REPORT NUMBER NH 00216	2. GOVT ACCESSION NO.	3. RECIPIENT'S CATALOG NUMBER
4. TITLE (and Subtitle) Lakeport Dam NATIONAL PROGRAM FOR INSPECTION OF NON-FEDERAL DAMS		5. TYPE OF REPORT & PERIOD COVERED INSPECTION REPORT

LAKEPORT DAM

NH00216

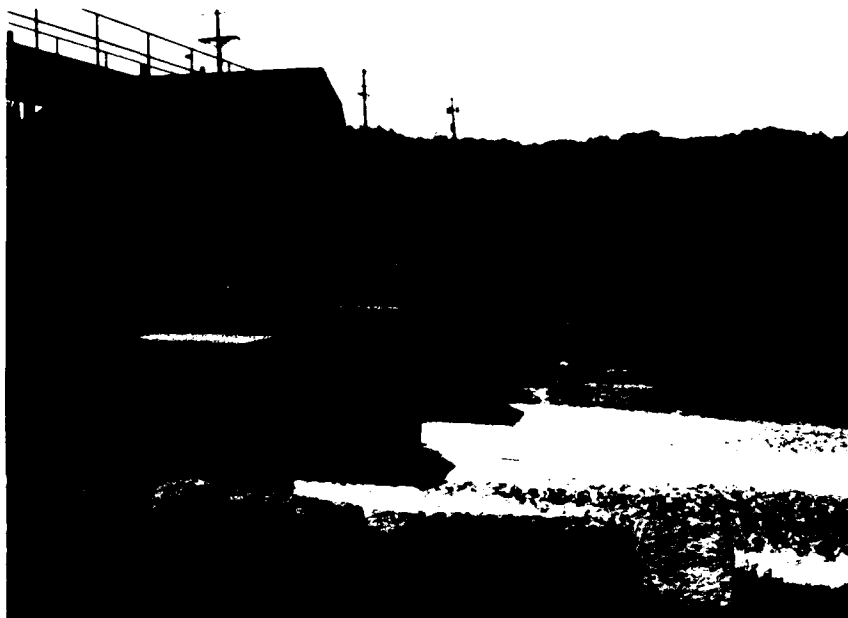
The flow through the stoplog spillway and over the overflow spillway discharges into a side channel 13 feet wide and about 50 feet long and runs parallel to the axis of the dam. (See Appendix C - Photo 6.) The floor of this channel is wooden plank. Some discharge is maintained over the stoplogs to keep this planking wet to prevent deterioration. The wall opposite the spillways is stone masonry. This side channel discharges into the main channel.

July 9, 1980
Photo 6 - View of the downstream face of the dam
from the northwest abutment. Note the
side channel at the far end of dam.

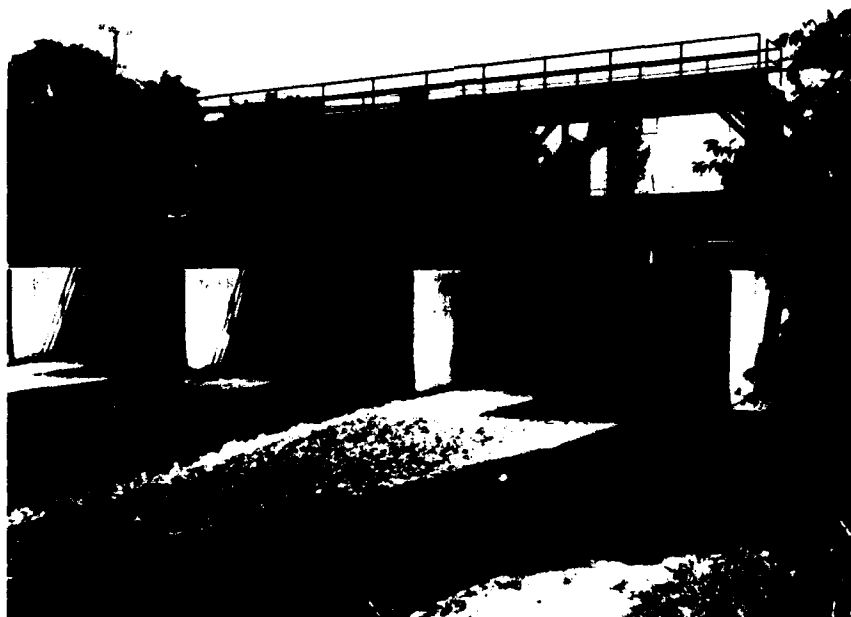
The gated section was found to be in generally good condition with only minor surface erosion on the bottom of the downstream pier walls. The gates themselves consist of three (3) 18'W x 10'H vertical lift gates. Some leakage was observed around the ends of the gates. (See Appendix C - Photo 12.) On the steel components, minor spot rusting was observed. The embedded gate supports were surface rusted. The three gates are electrically operated. Each gate has a 2-hp, 208-volt, 3-phase motor. All three gates were opened and closed without difficulties. In addition, each gate has 2.5-kW, 208-volt, 3-phase side sill heaters and seal heaters. All motors and heaters are in good condition. The existing 200-A, 120/180-volt service in the generator house is in good condition. There is a manual double throw switch to transfer to emergency power. The emergency power consists of a 25-kW LPG Fuel Onan generator that is in good condition. The emergency generator was started and was up to full output in eight seconds. This generator is manually exercised once each month by operating personnel. All conduit, panel boards, wiring, lighting fixtures, etc. appeared to be in good condition.

July 9, 1980
Photo 7 - Looking at the gated section of the dam.
