MERRIMACK RIVER BASIN
NEW DURHAM, NEW HAMPSHIRE

MERRYMEETING LAKE DAM
NH 00342

PHASE I INSPECTION REPORT
NATIONAL DAM INSPECTION PROGRAM

OCTOBER 1978
85 06 27 027

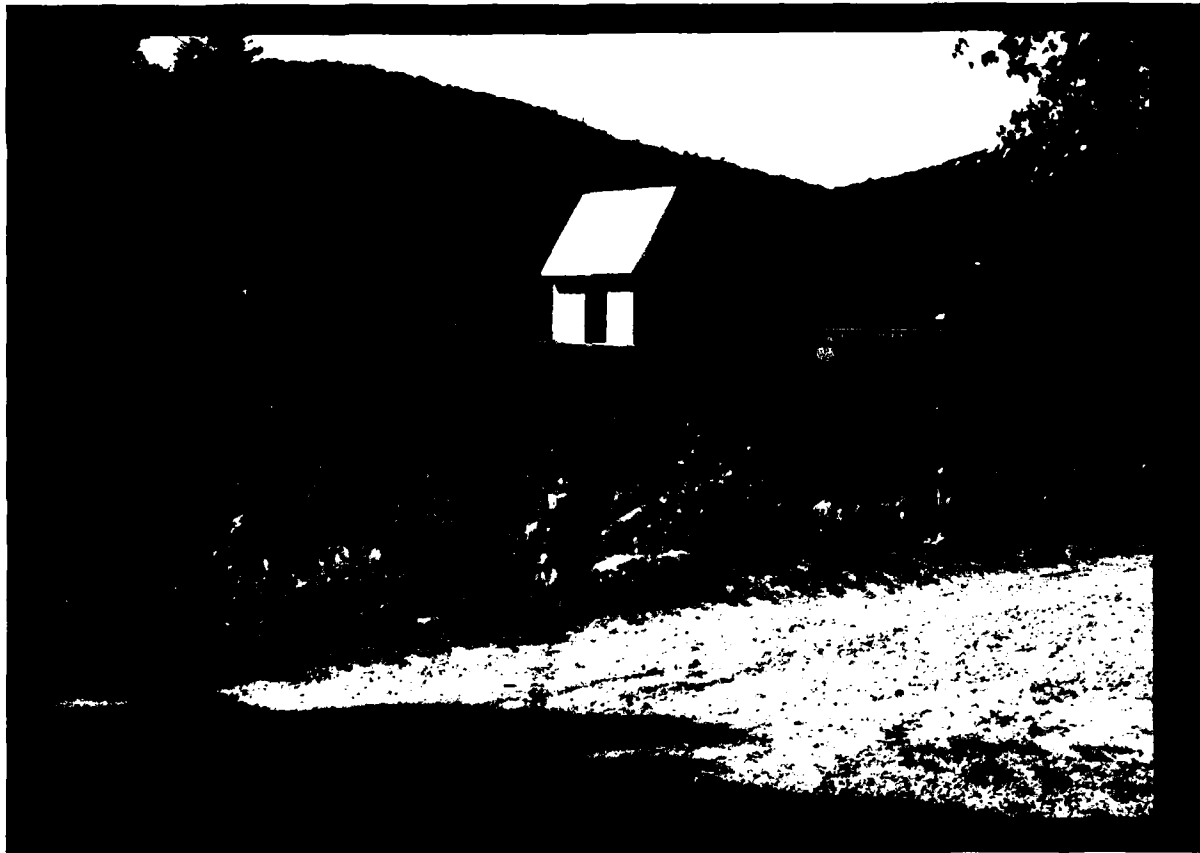
MERRYMEETING LAKE DAM

View of the dam from the downstream side. The low level outlet gate house is in the center. The zone of seepage is demarcated by the end of the cut grass area and the swamp-type vegetation below it.

A zone of seepage was observed in the downstream face of the embankment, approximately 11 feet below the top of the embankment and extending from a point about 54 feet to the right of the low level outlet continuously to a point about 36 ft. to the left of the outlet. The seepage was clean at the time of the inspection. While a considerable quantity of water was observed, an accurate estimate of the seepage could not be made due to the extent of the zone. A measurement made in March 1965, however, records the seepage as being 79 gpm, based on a stream gauge at the Powder Mill Fish Hatchery.

The seepage of the embankment is of concern, even though the operator of the Fish Rearing Station has stated that the dam's seepage condition is stable and unchanged in the 28 years he has operated it, going back to 1950. It is unclear whether the addition of the new concrete facing wall on the upstream face of the dam has reduced seepage volumes. It is also not clear whether the seepage observed has any connection with the cobble drains installed under the embankment, according to available plans. Further investigations will be recommended to evaluate the source and seriousness of the seepage.

It is recommended that the owner, within 12 months after receipt of this Phase I Report, acquire basic engineering data that would allow the proper assessment of the seriousness of the observed seepage and its effect on the stability of embankment's toe slope.

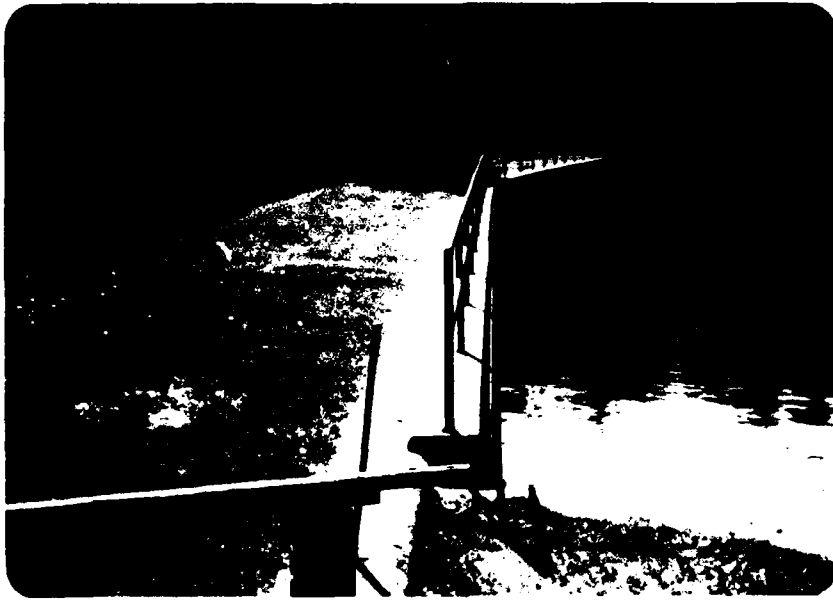
Photo 1 - View of the dam from the left abutment showing the upstream masonry wall and the downstream embankment wall.
