CONNECTICUT RIVER BASIN  
KEENE, NEW HAMPSHIRE

GOOSE POND DAM  
NH 00101  
NHWRB 126.03

PHASE I INSPECTION REPORT  
NATIONAL DAM INSPECTION PROGRAM

FEBRUARY 1980

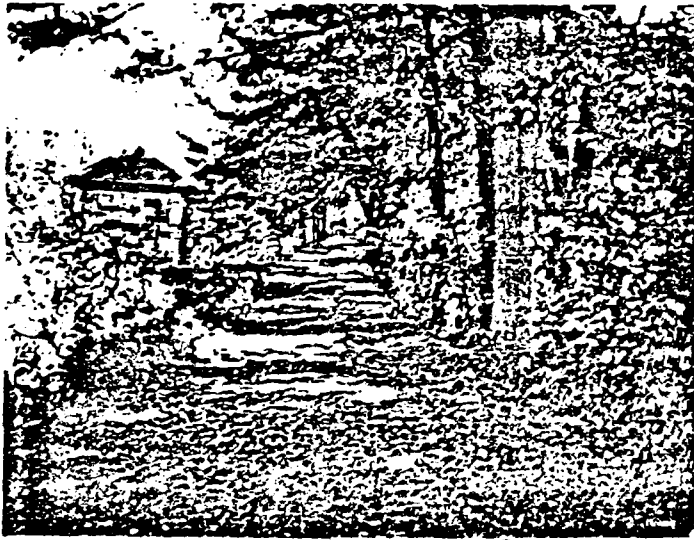
Photo 1

Trees on Embankment  
debris in spillway

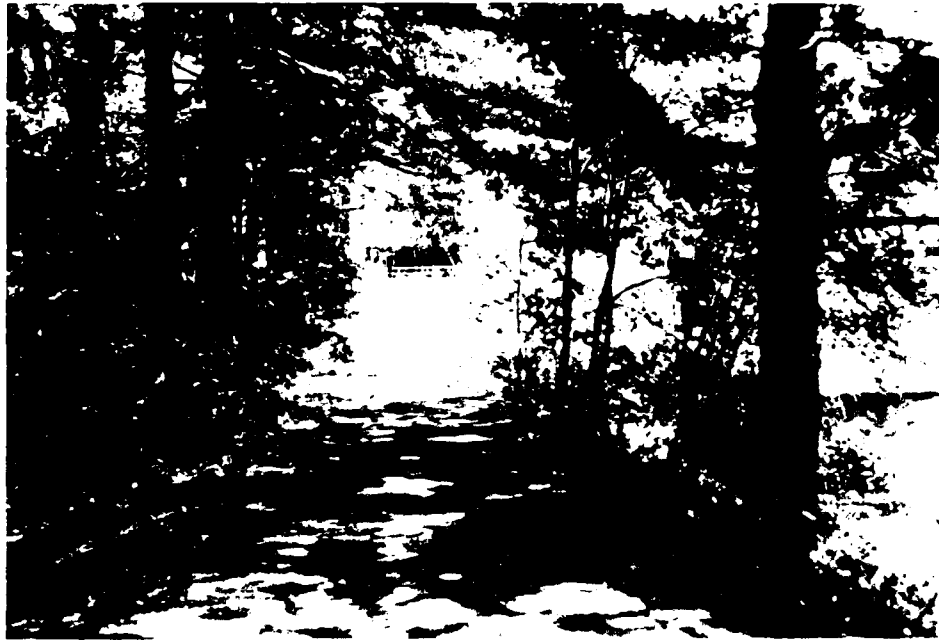
1. Crest of Dam from Left Abutment

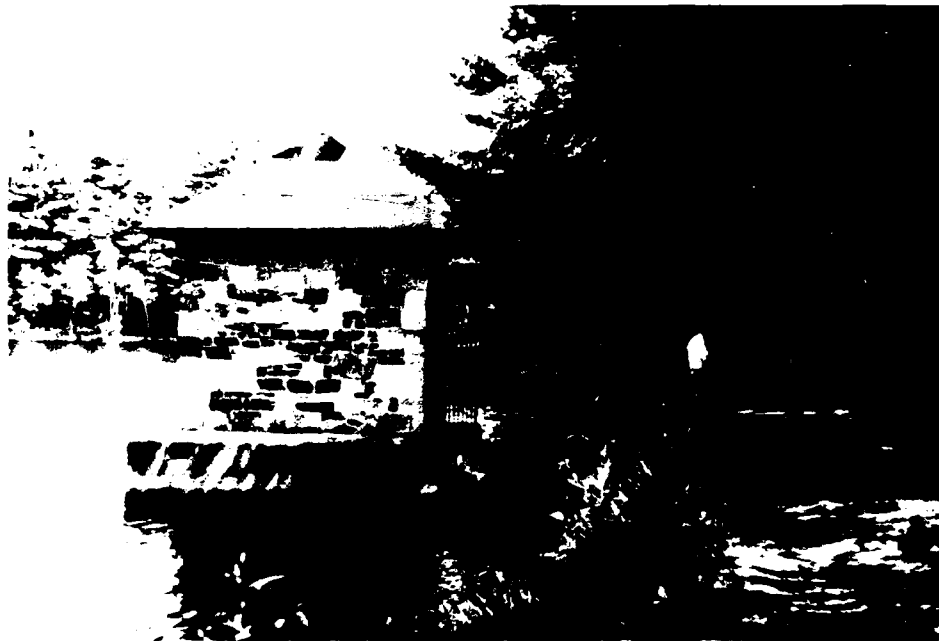
2. Crest of Dam and Gatehouse from Right Side
