CONNECTICUT RIVER BASIN
SWANZEY, NEW HAMPSHIRE

UPPER WILSON POND DAM

NH 00202

PHASE I INSPECTION REPORT
NATIONAL DAM INSPECTION PROGRAM

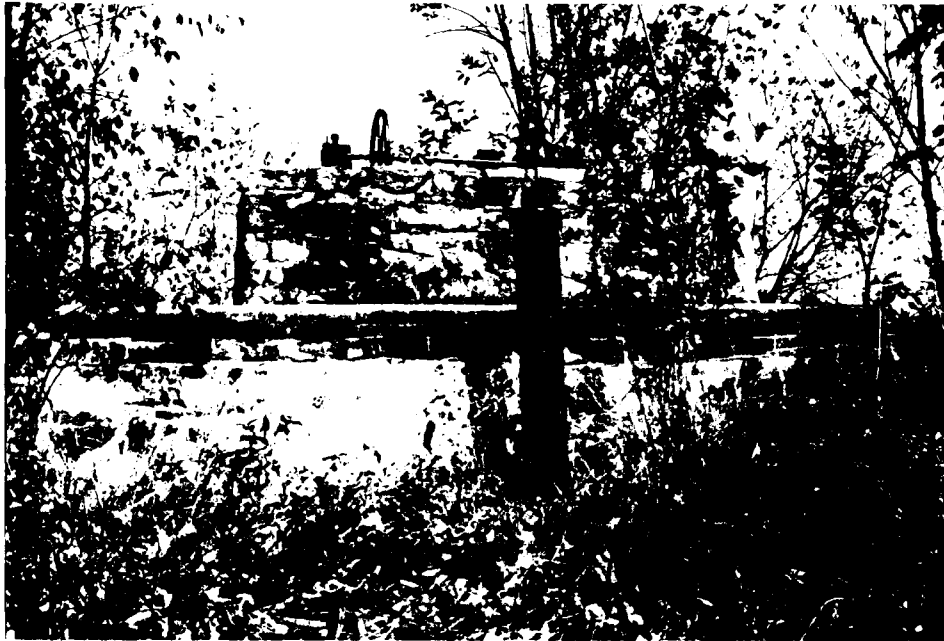
5. Downstream Side of Intake Structure and Gate Control Mechanism.

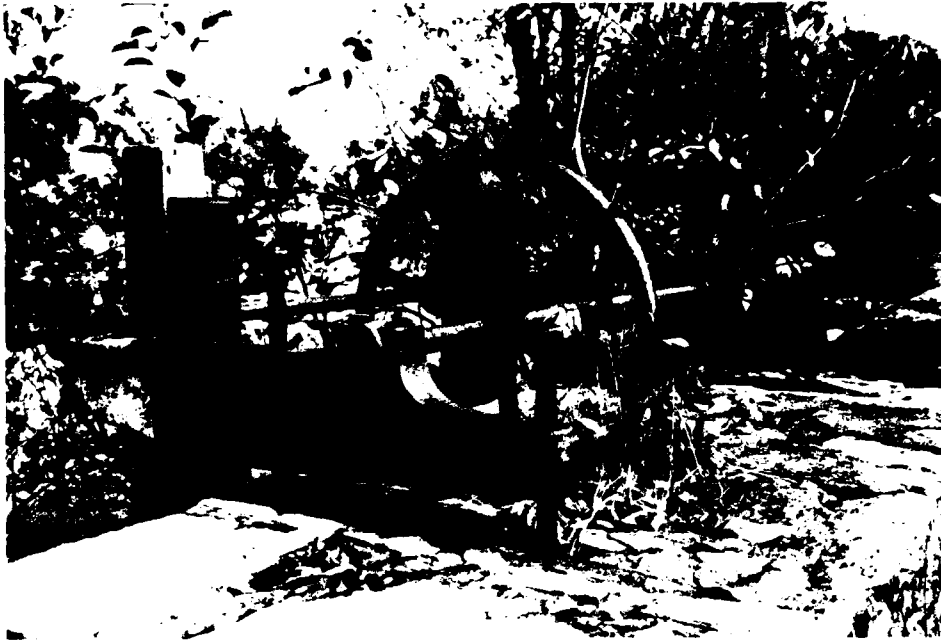
- (a) The head gate has been permanently sealed, leaving no means of lowering the reservoir.
- (b) Erosion gullies exist on the downstream slopes.
- (c) There is heavy tree growth on the earth dike. The loss of a tree could cause failure of the dike due to uprooting or rotting of the roots.
- (d) There is erosion of concrete at the spillway interfaces.

7. Detail of Gate Control Mechanism - Note Gate is not Operable
