MERRIMACK RIVER BASIN  
WILTON, NEW HAMPSHIRE

HILLSBOROUGH MILLS DAM

PHASE I INSPECTION REPORT  
NATIONAL DAM INSPECTION PROGRAM

APRIL 1979

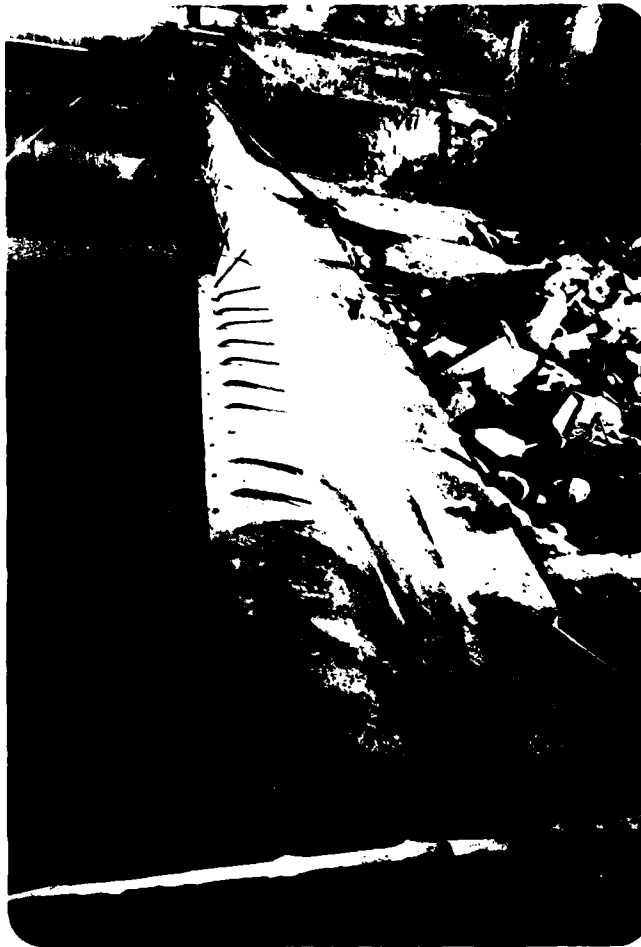
Overview from right abutment

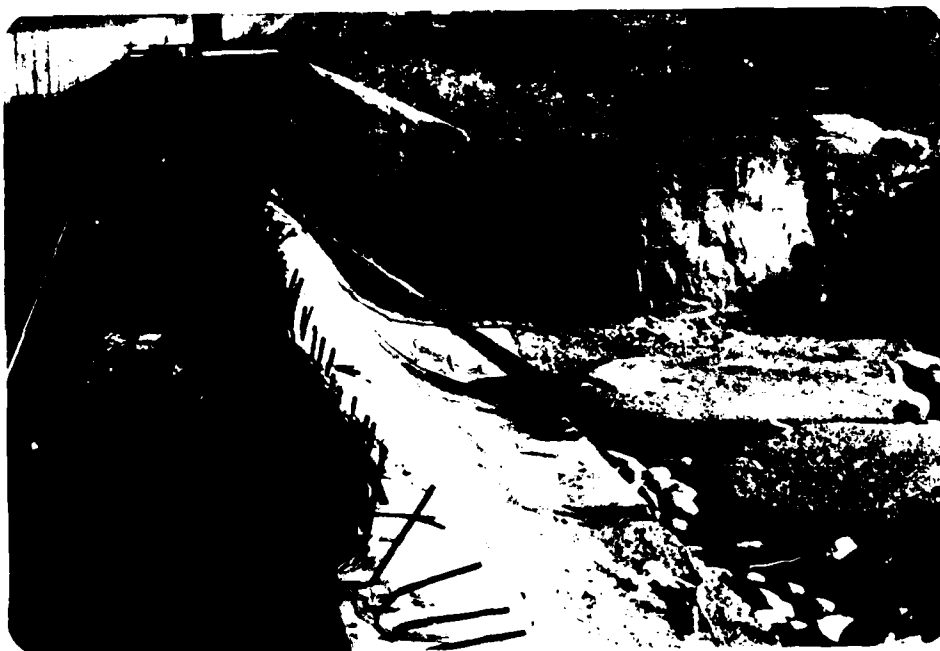
Two rows of flashboard stanchion sockets are located over the entire length of the spillway crest (Photo 2). These sockets are 26 inches deep. Solid flashboard stanchions, which are 1.5 inches in diameter and extend 3 feet above crest elevation, are in place over the entire length of the structure. Most of the stanchions are bent from ice damage. Flashboards are located over approximately 50 percent of the spillway crest. The flashboards are in poor condition.

The top surface of the cyclopean concrete cap has spalled over 20 percent of its surface area to a depth of up to 2 inches (Photo 2). This spalling is attributed to moisture intrusion which has been subjected to alternating freeze and thaw cycles. The gunited portions of the structure and downstream training wall are in good condition with no evidence of displaced stones, bulges, or other signs of distress. The dry stone masonry wall extension is in poor condition with displaced stones, settlement, and bulges. Seepage at the rate of 10 to 20 gpm

2. View from right abutment of left abutment showing guniting of squared stone masonry training wall and displaced apron

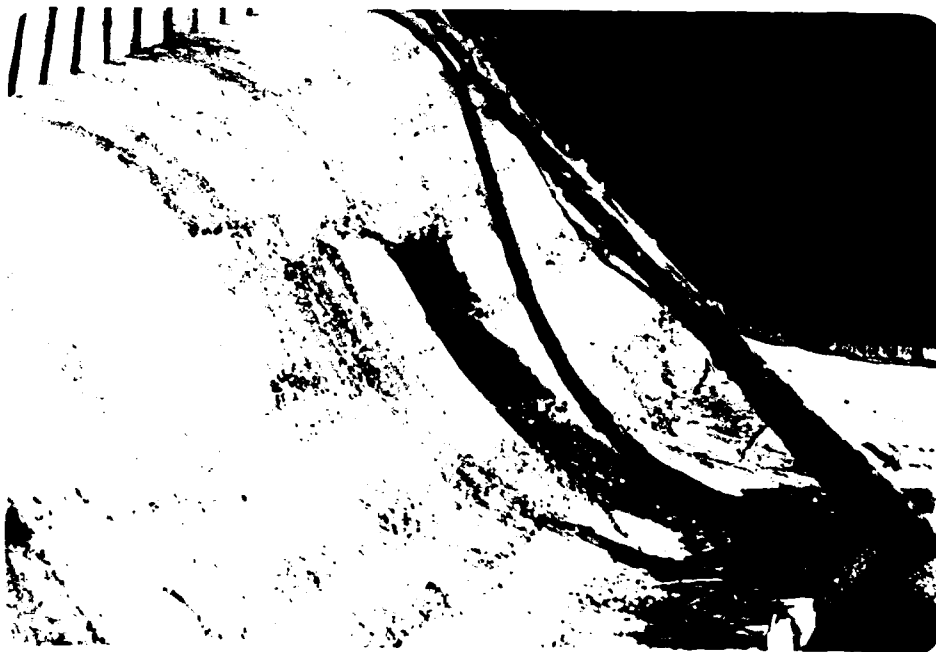
The horizontal sluice gate adjacent to the left end of the spillway is operated by a hand wheel in the gate house. The operating mechanism for this gate is in good condition, and representatives of the owner indicated that this gate is operable. Seepage at the rate of 1 to 2 gpm was flowing through the seated end of the gate at the time of inspection (Photos 4 and 5).

4. View from downstream channel of left side of spillway showing leakage through old sluiceway

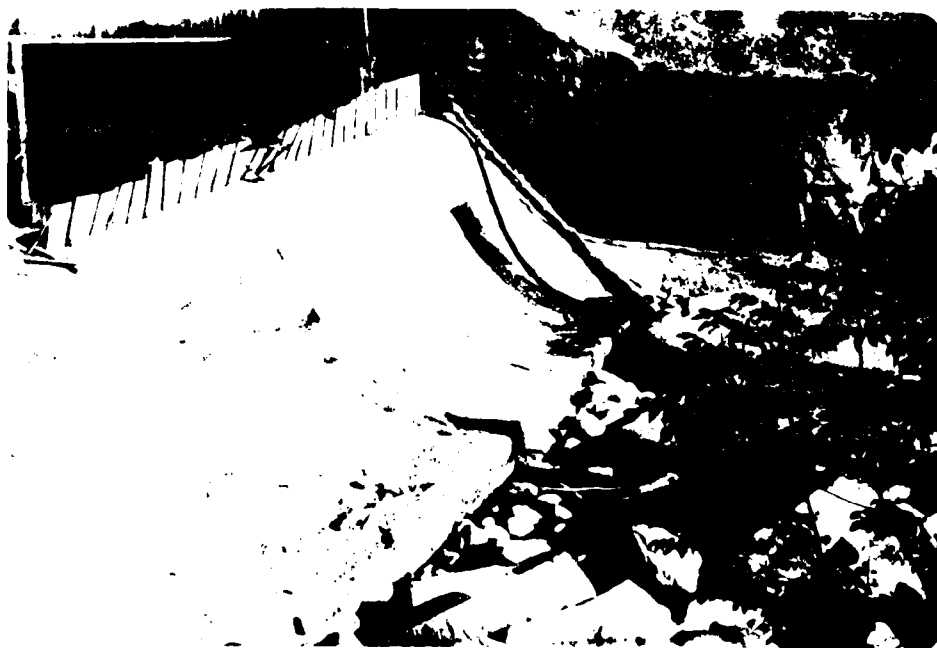
6. View of spillway from right abutment showing horizontal and vertical cracks and general deterioration

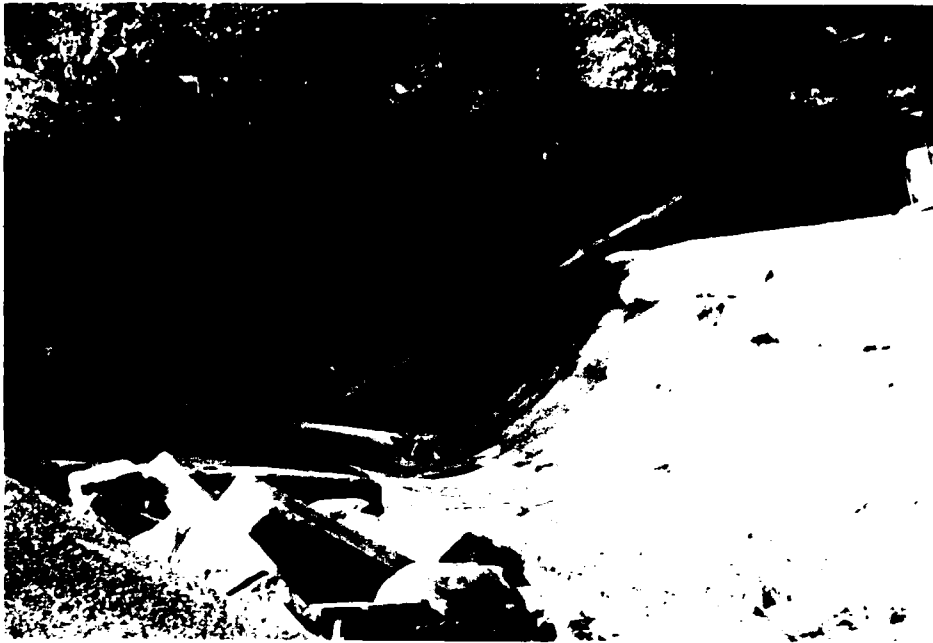
The spillway was constructed in three sections of approximately equal length. The right third of the structure (Photo 8) appears to have settled. All vertical construction joints are eroded to depths of 2 inches and widths of 2 inches. This erosion is attributed to cavitation and ice damage. The pressure relief drain (Photo 7) is located within the toe of the spillway adjacent to the vertical joint which is closest to the left end of the spillway. The concrete at this location is eroded for a length of 4 feet, a width of 12 inches, and a depth of 2 feet. The downstream face of the spillway, including the toe cut-off, is eroded in several places. Two horizontal construction joints (Photo 6), which extend over the entire length of the spillway, have opened. In some places these joints have eroded to widths of 12 inches and depths of 6 inches. The underside of the toe cut-off wall for the right and middle thirds of the spillway (Photo 6), has eroded to within 6 inches of its top surface. This erosion is attributed to scour and ice damage. The toe of the spillway at these locations is undermined. The left spillway section does not appear to be undermined.

8. Right abutment structure and  
spillway
