MERRIMACK RIVER BASIN
HARRISVILLE, NEW HAMPSHIRE

HARRISVILLE POND DAM
NH 00065

PHASE I INSPECTION REPORT
NATIONAL DAM INSPECTION PROGRAM

MAY 1979

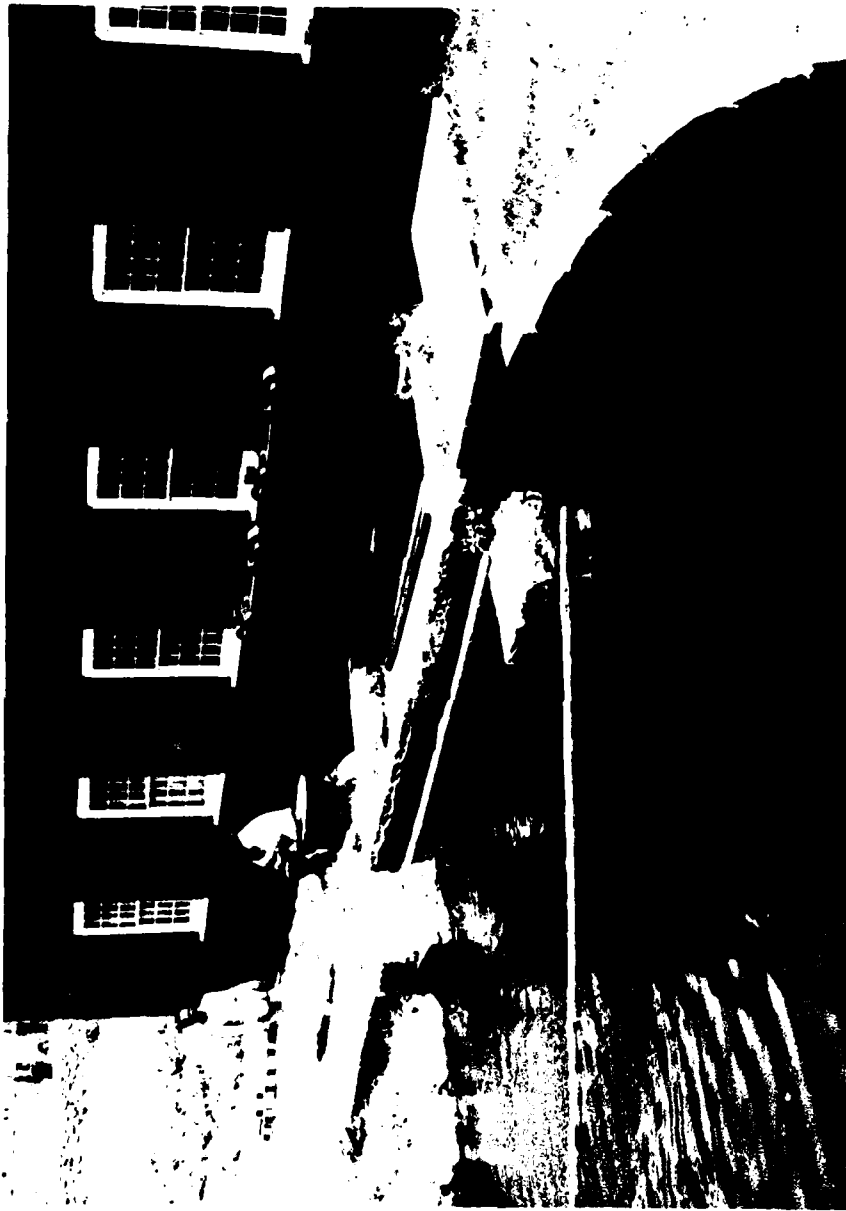
OVERVIEW PHOTOGRAPH

HARRISVILLE DAM, LOOKING SOUTHEAST
Negative No. 1-13

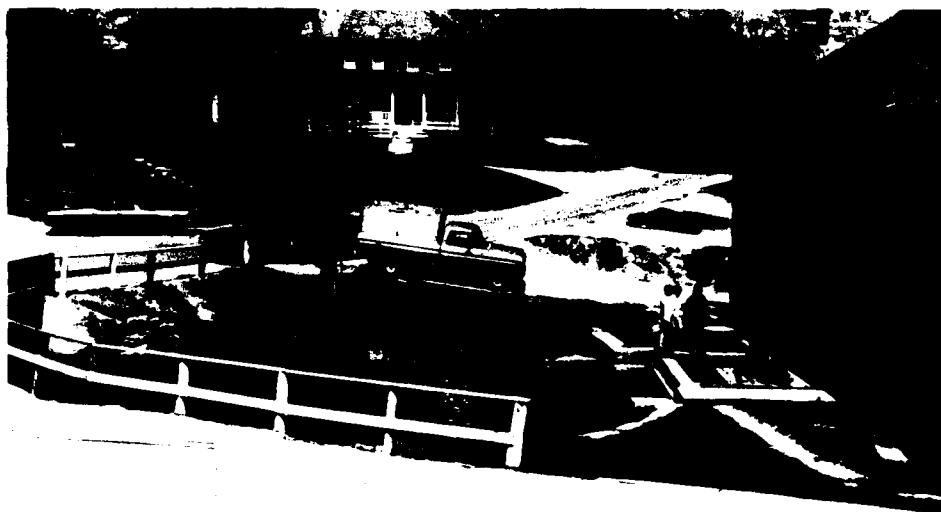
A two-story mill building was built adjacent to this dam with the dam serving as a foundation for the north wall. The abutments of this masonry dam are of earth, granite faced (Photographs No. 1 and 2, Appendix C).

1. Intake Channel and the Dam Intake Structure,
Looking Northeast.

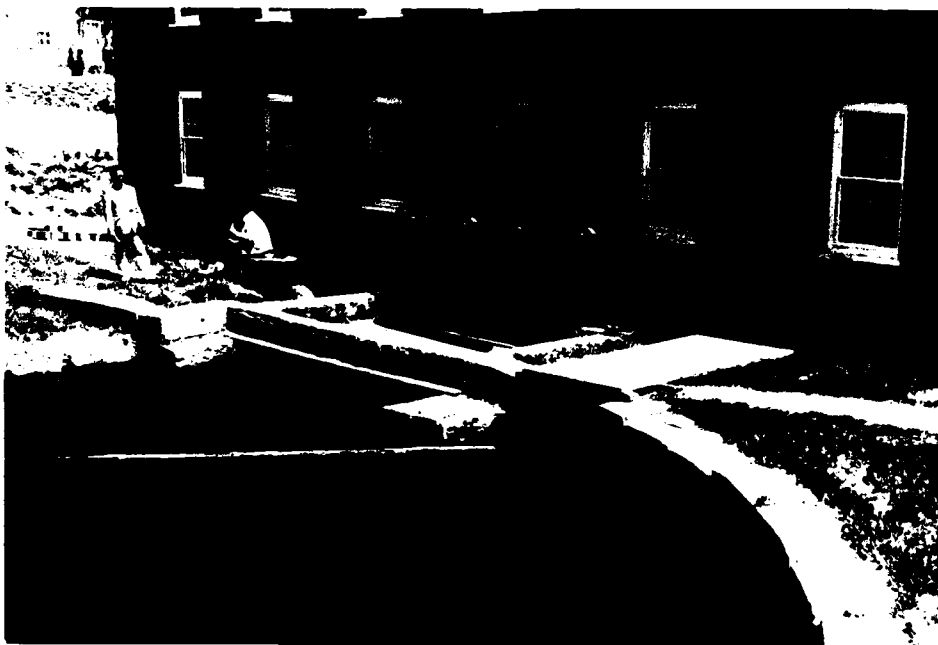
2. Intake Structure. View - Intake Channel to Mill Building
Mill Building Built on Top of Dam.

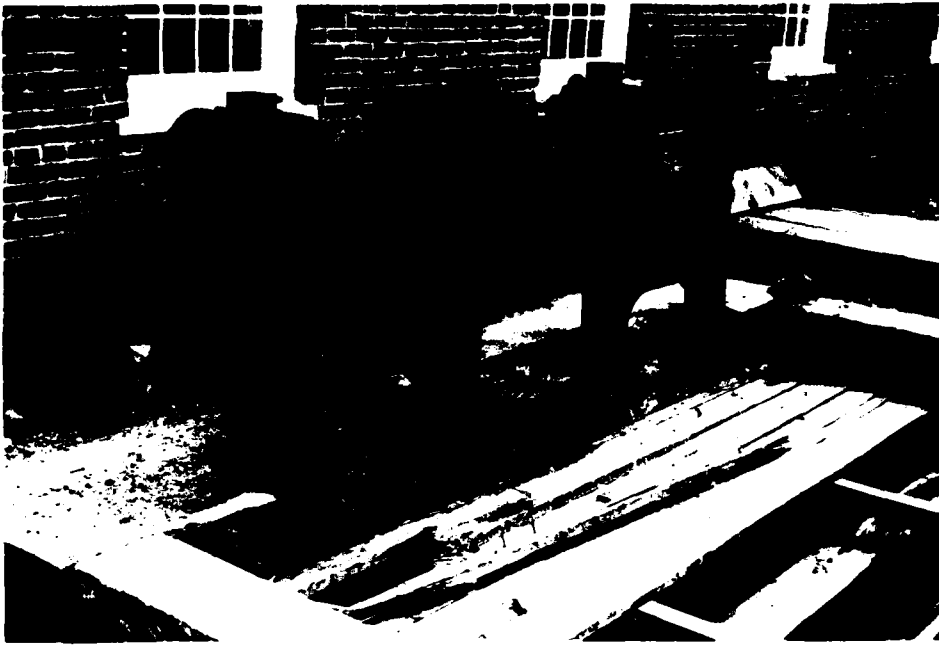
3. Rack-and-Finion Gate Operators Over the Intake Structure.

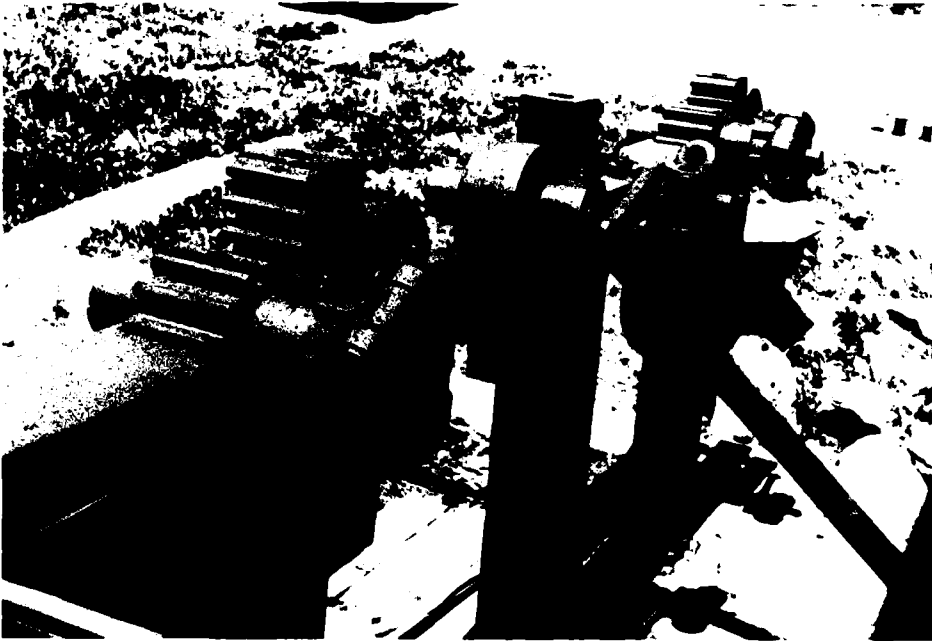
4. Detail of Rack-and-Finion Gate Operators.

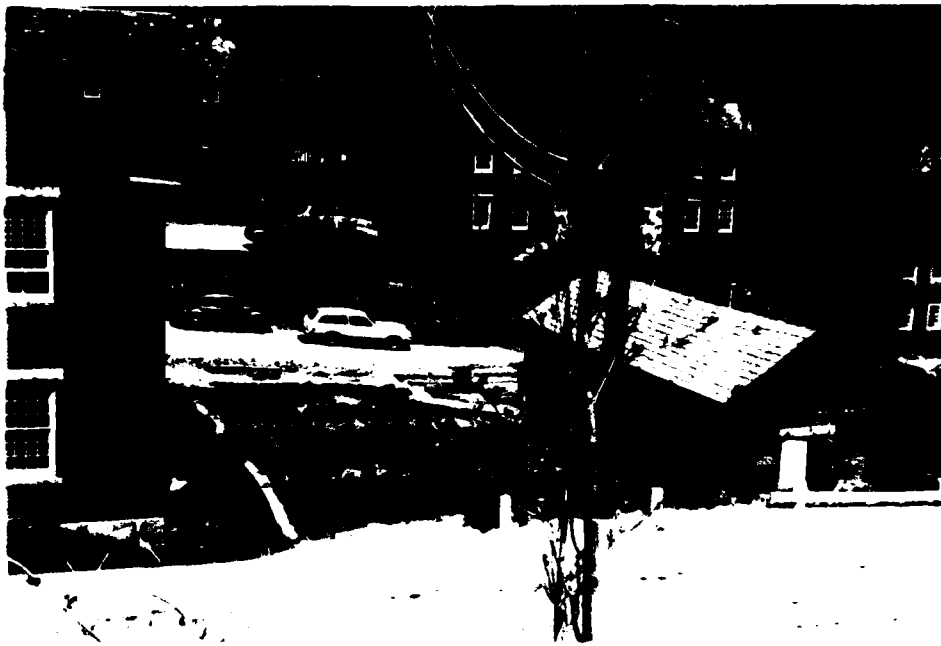
13. Upper Mill (Over the Dam) and the Toy Shop (Right).
Downstream Channel Below These Buildings.

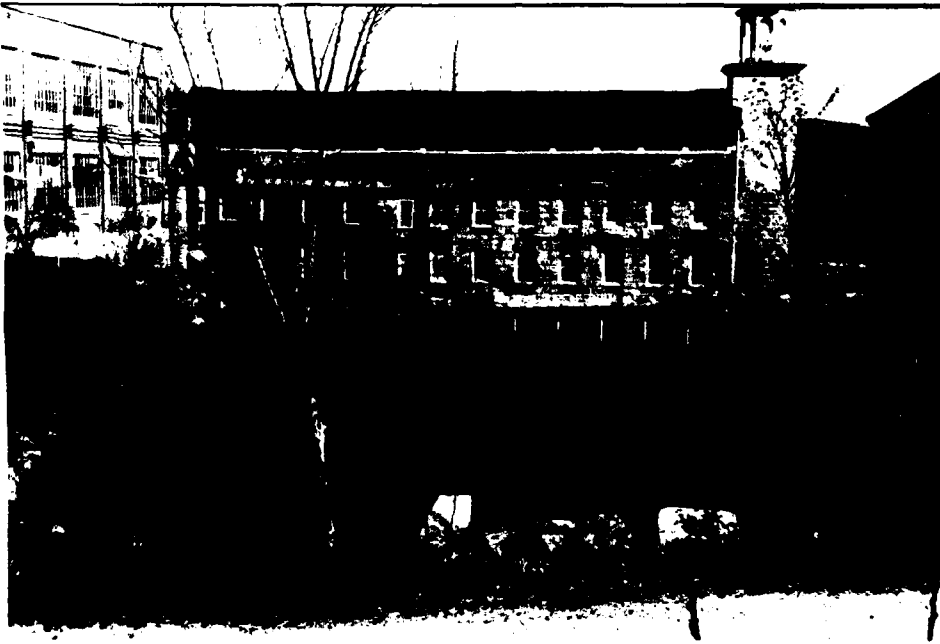
16. Lower Mill and Pond, Looking from the Road Below the Toy Shop.
