SOUHEGAN RIVER WATERSHED  
DAM NO. 35

NH 00435  
NHWRB 175.21

PHASE I INSPECTION REPORT  
NATIONAL DAM INSPECTION PROGRAM

AUGUST 1979

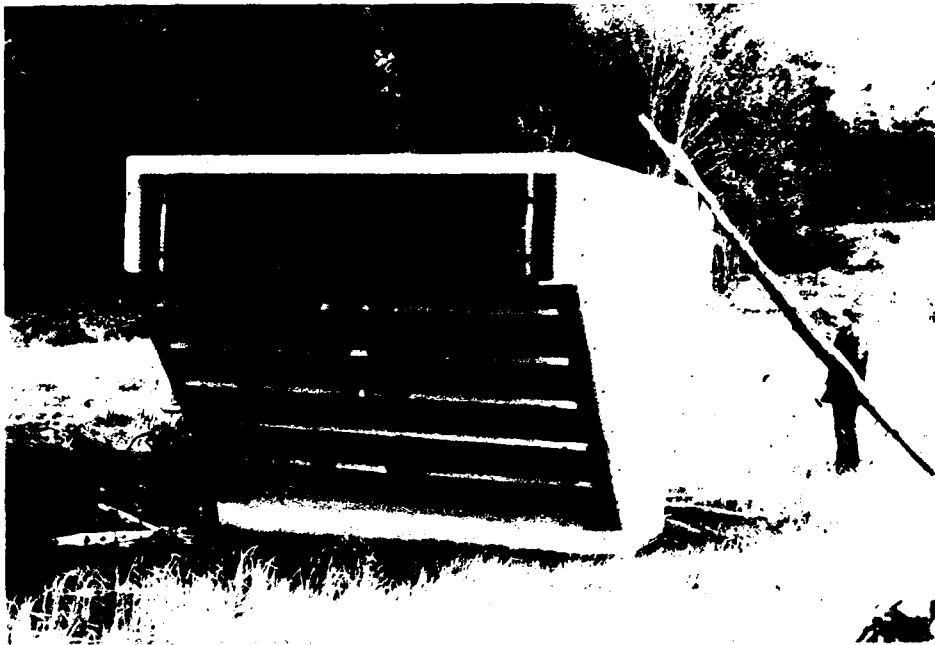
3. View of right side of inlet structure showing high stage inlet and trash rack
