AVERY DAM

NH 00465

PHASE I INSPECTION REPORT
NATIONAL DAM INSPECTION PROGRAM

NOVEMBER 1978

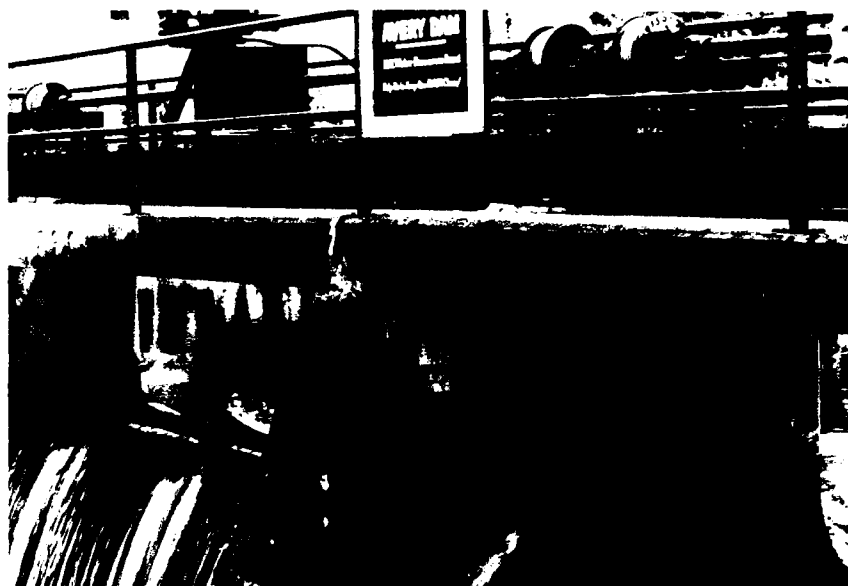
Additionally, the construction joint between this wall and the adjacent buttress is open with minor evidence of efflorescence. The stoplogs contained within this structure are in good condition.

3. View from downstream of open joint
in concrete service bridge

- (b) Repair the eroded slope revetment along the right training wall and monitor this area for future deterioration.
- (c) Repair all areas of cracked, spalled or eroded concrete, paying particular attention to the proper filling and sealing of joints and cracks.

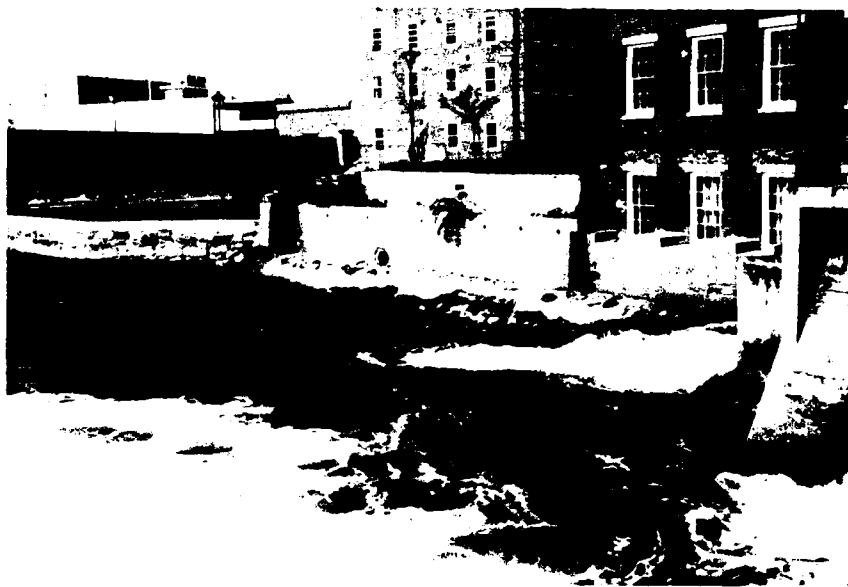
The concrete in both the front and back walls is in good condition. However, the slope revetment placed as toe protection adjacent to the front wall has been seriously eroded. Probing reveals that voids up to 6 feet in depth occur under the foundation of the front wall; approximately 6 feet of the front wall footing are exposed.

The erosion of the slope revetment along the right training wall presents no hazard to the dam, but requires attention to prevent potential undermining of the building foundations.

4. View from dam of erosion on right
side of downstream channel
