PISCATAQUA RIVER BASIN  
MILTON , NEW HAMPSHIRE

MILTON LEATHER BOARD DAM  
N.H. - 00316

PHASE I INSPECTION REPORT  
NATIONAL DAM INSPECTION PROGRAM

FEBRUARY 1979

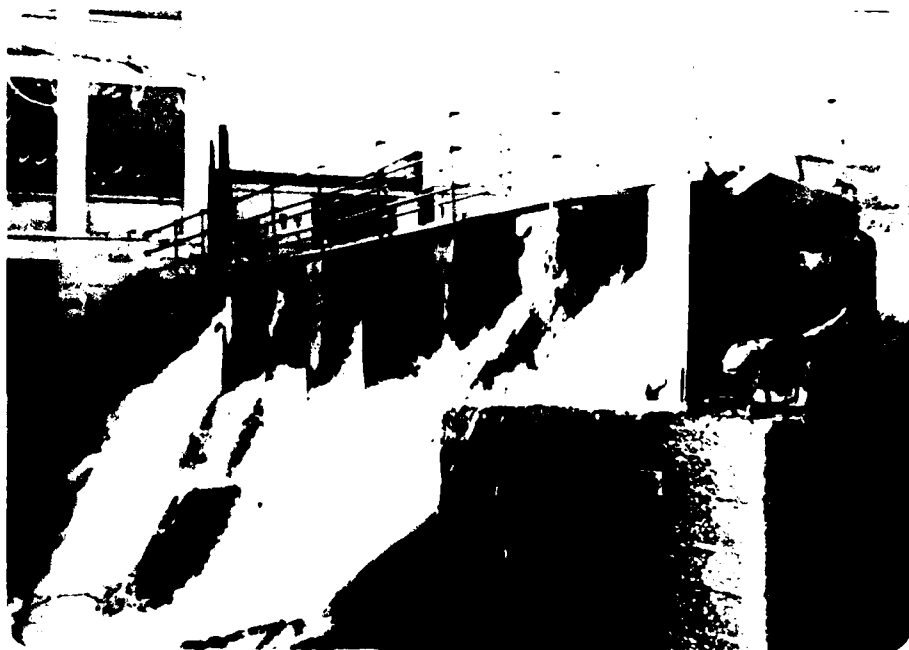
1

STOP LOG SPILLWAY

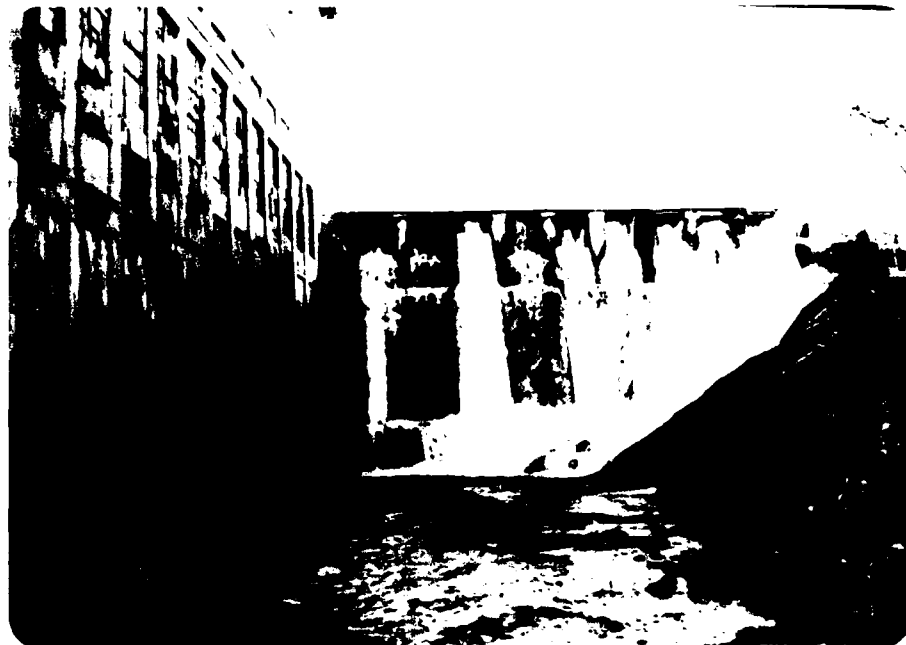
4

- (a) There is no evidence of horizontal or vertical movement of the structure. It appears true to line and grade.
- (b) The stone masonry portion of the dam appears to be in good condition. The masonry appears tight and no unusual seepage or leakage was observed.
- (c) The westerly section of the dam has apparently been rehabilitated since original construction. Four concrete buttresses and a sill have been added to the downstream face and the stop log support piers have been replaced. The buttresses and sill appear to be in good condition. The concrete stop log piers

are badly spalled and reinforcing steel is exposed.

The stop log piers are severely spalled and eroded. The buttresses and sills beneath the piers appear to be in generally good condition with only minor concrete surface erosion.

DOWNSTREAM FACE-STOP LOG SPILLWAY

- (1) The concrete stop log piers should be repaired or replaced to prevent further deterioration of the concrete.
- (2) The concrete dike section should be rehabilitated, either by sealing of the upstream face and cleaning and filling of the voids and cracks in the downstream face or replacement.
- (3) Provide around-the-clock surveillance during periods of heavy runoff.
- (4) Develop and implement a formal warning system for use in the event of an emergency.
- (5) Provide for annual inspections of the facility by qualified engineers.

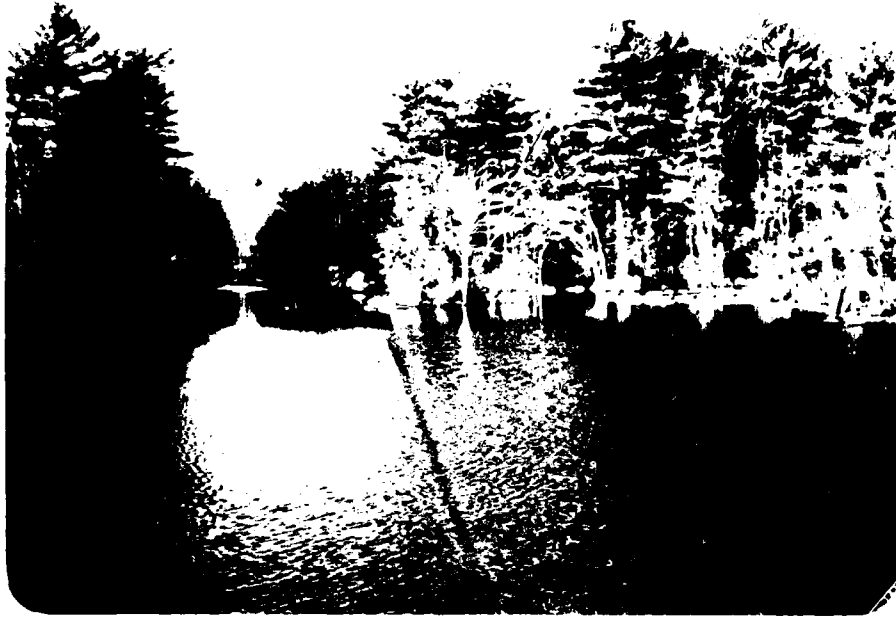
5

UPSTREAM CHANNEL
